<b>Coal Tip Name</b>	Godre'r-graig Quarry / Cilmaengwyn	Tip Ref Number	L044A
		Tip Category	D
Date of Inspection	24/07/2023	Inspection led by

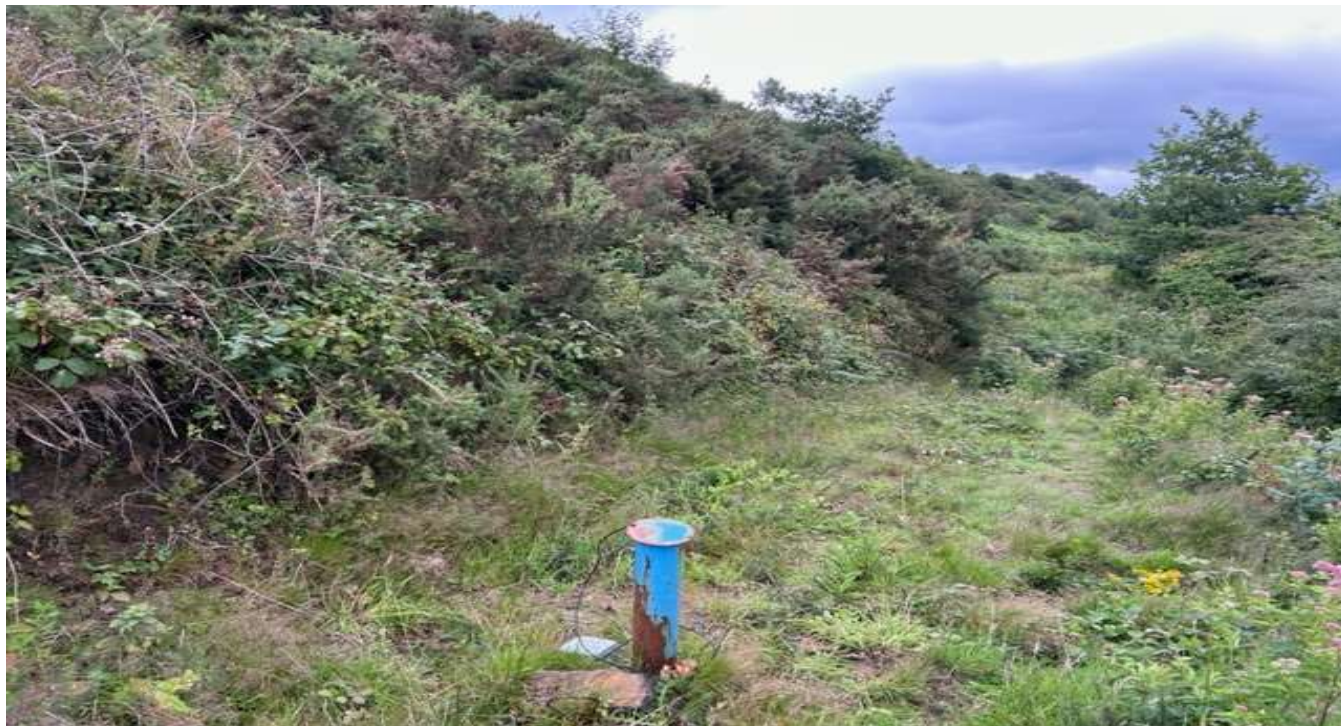
<b>Photo No.</b>	1	<b>Comment</b>	Piezometer borehole located on the site access track, downslope of the tip.

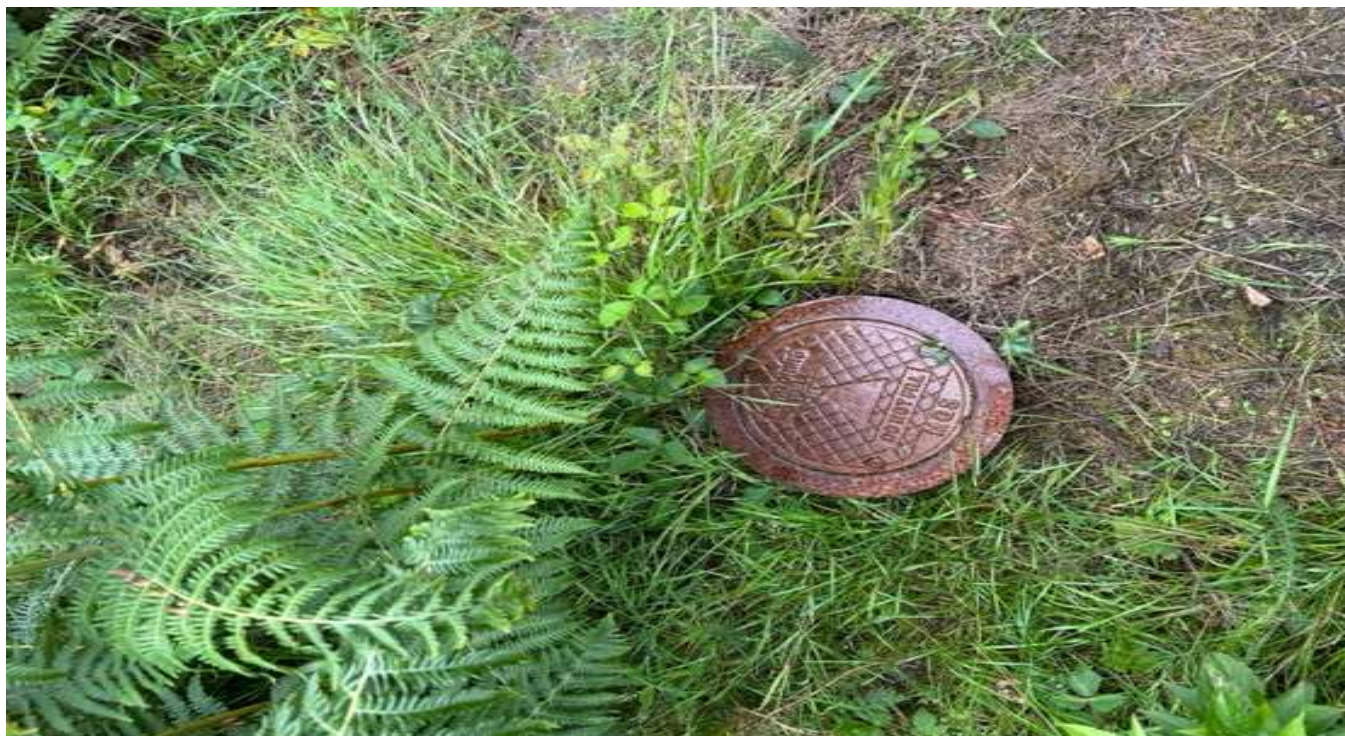
<b>Photo No.</b>	2	<b>Comment</b>	Monitoring well located on the site access track, downslope of the tip.

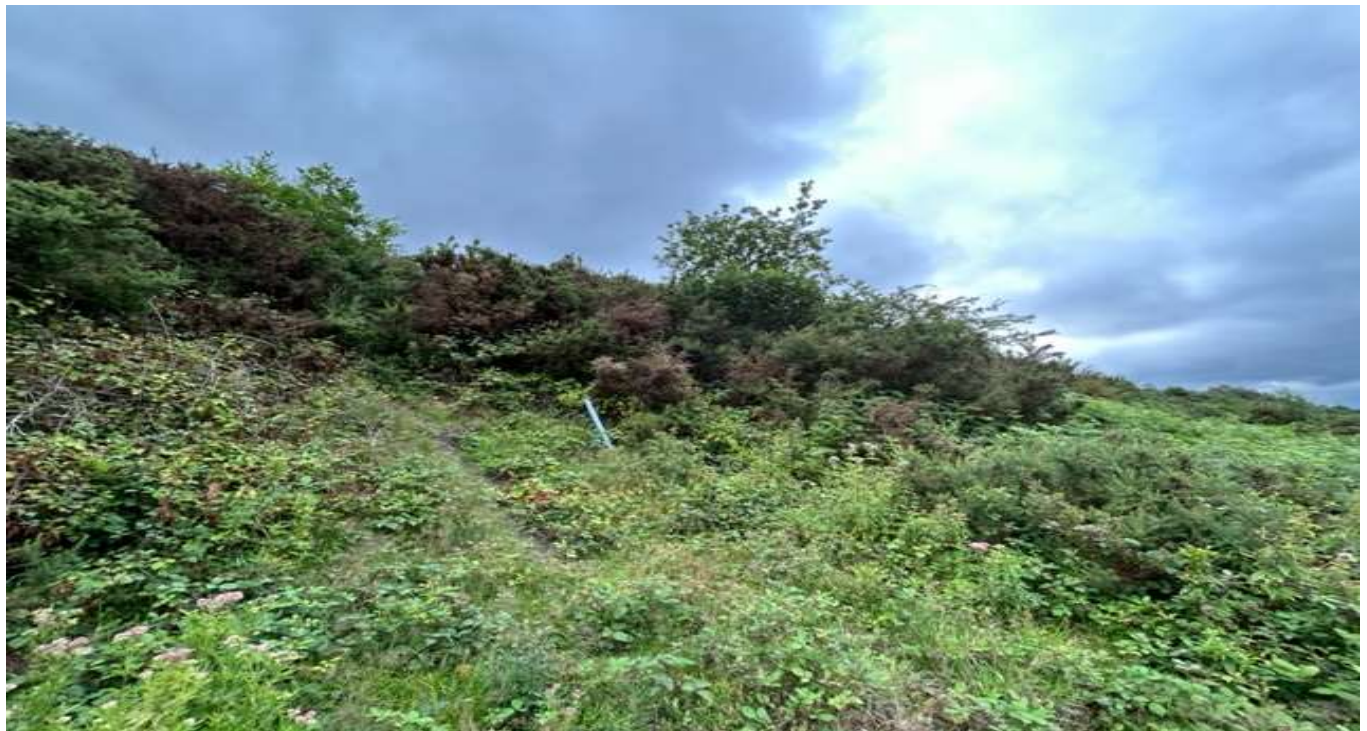
<b>Photo No.</b>	3	<b>Comment</b>	Minor surface erosion exposing bare spoil material along a narrow, overgrown access path; of which extends up-slope off the main site access path, towards the site.

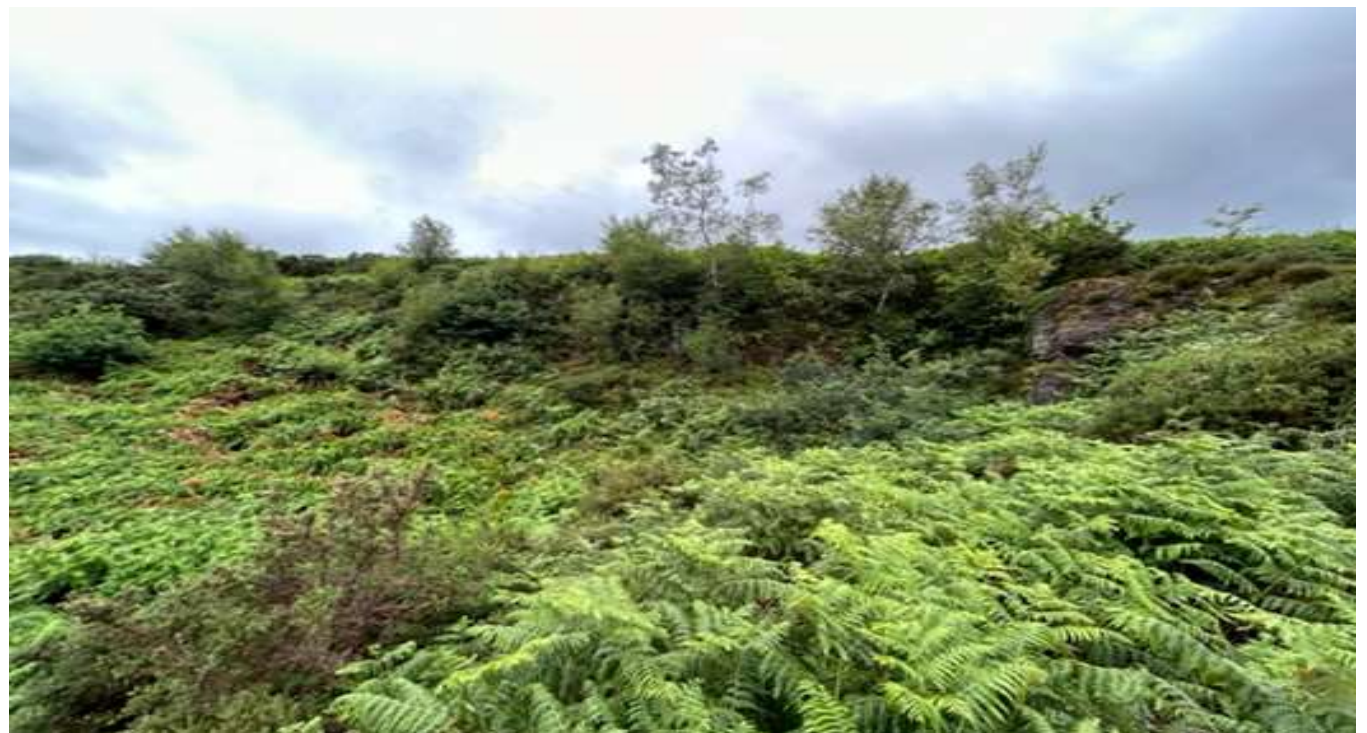
<b>Photo No.</b>	4	<b>Comment</b>	View looking towards an outcrop of bedrock at the rear of the tip; likely the quarry high wall.

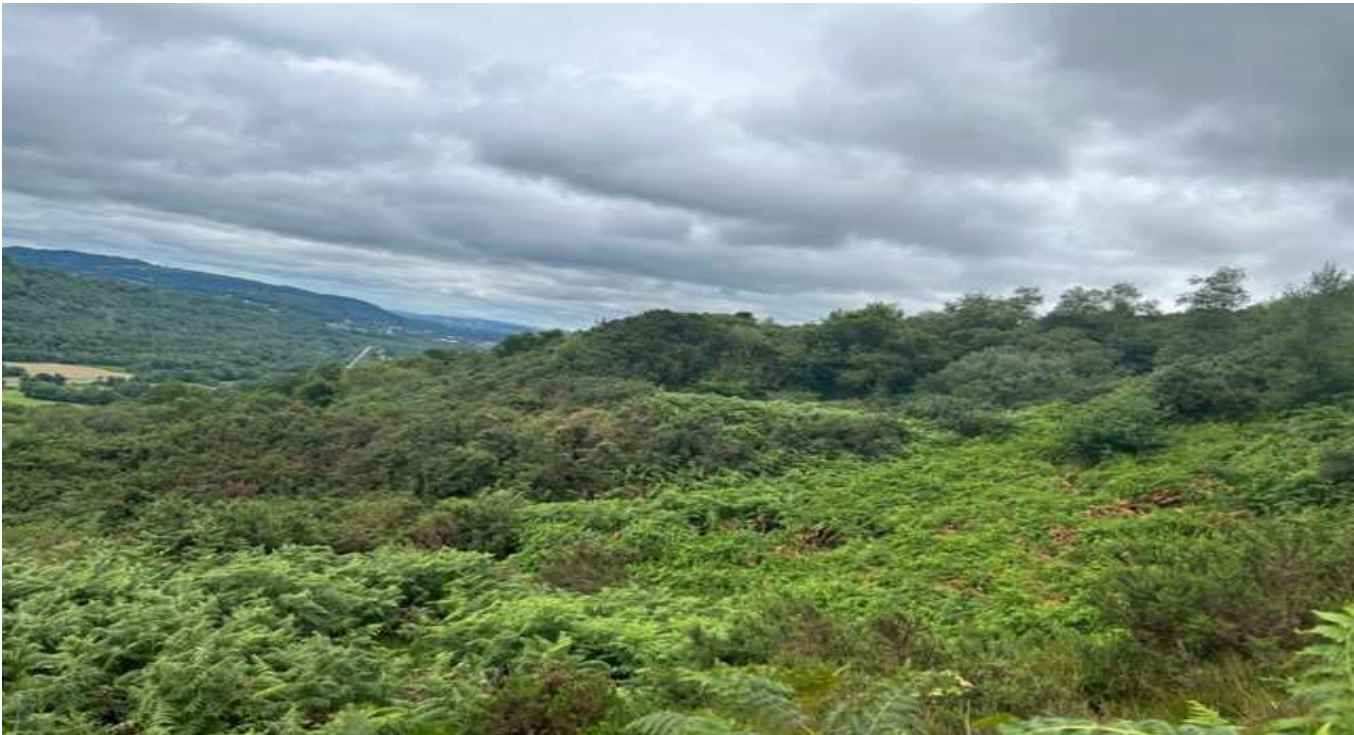
<b>Photo No.</b>	5	<b>Comment</b>	View looking south-west across the very densely vegetated lobes of tip material. Image conveys associated accessibility issues.
