Coal Tip Name	Godre'r-graig Quarry / Cilmaengwyn	Tip Ref Number	L044A
		Ownership Status	Private
Located in	Godre'r-graig, Neath-Port Talbot	Tip Category	D
Led by	██████████	Undertaken on behalf of	Welsh Government
Date	08/11/2023	Date of last Detailed Inspection	24/07/2023
Weather	Overcast	Damp	Calm
Comments on access and any limitations	<p>Access to the site was gained via an access path situated just off the Pentwyn Farm access track. The access path extends up the hillside in a north-easterly direction, passing through Cwar Pentwyn Quarry before reaching a narrow, overgrown path which extends up-slope towards the site.</p> <p>It should be noted that this inspection was conducted without the benefit of a detailed site plan; whilst dense vegetation significantly limited accessibility and visual inspection. Therefore, instability within these areas could exist, but was not detectable at the time of the inspection. The densely overgrown nature of the site prevented inspection of the spoil material; it is presumed that the site is comprised of sandstone quarry waste material, however some exposures of colliery spoil material were present downslope (outside the provided site boundary

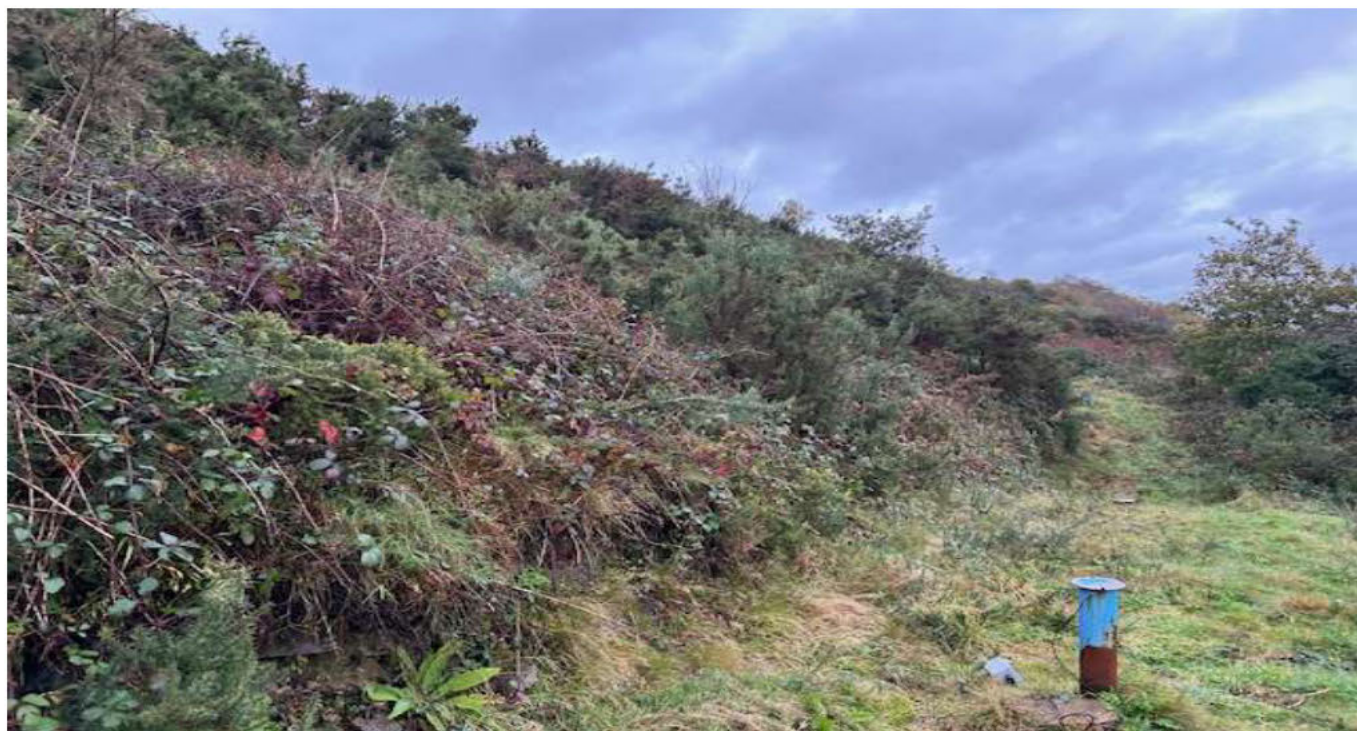
Photo No.	1	Comment	Piezometer borehole located on the site access track, downslope (outside the provided site boundary).
Feature ID	23/IM/01

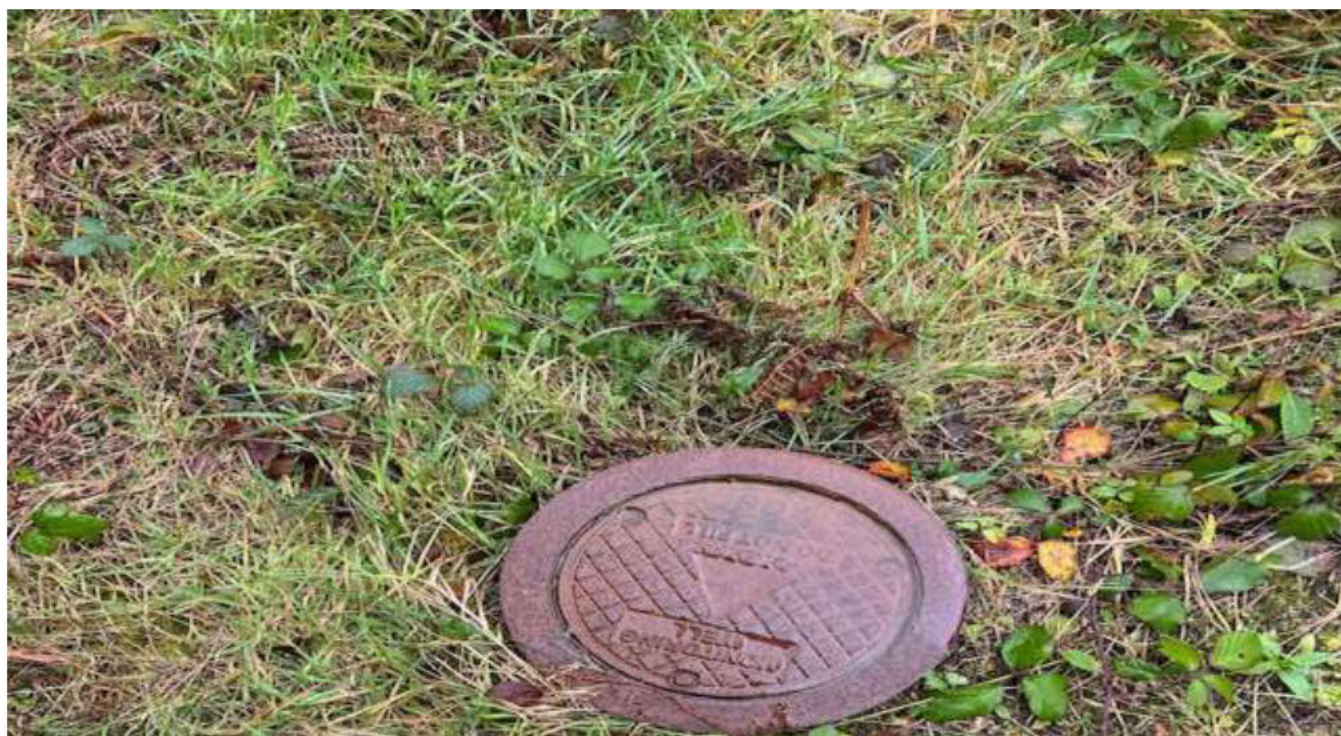
Photo No.	2	Comment	Monitoring well located on the site access track, downslope (outside the provided site boundary).
Feature ID	23/IM/01

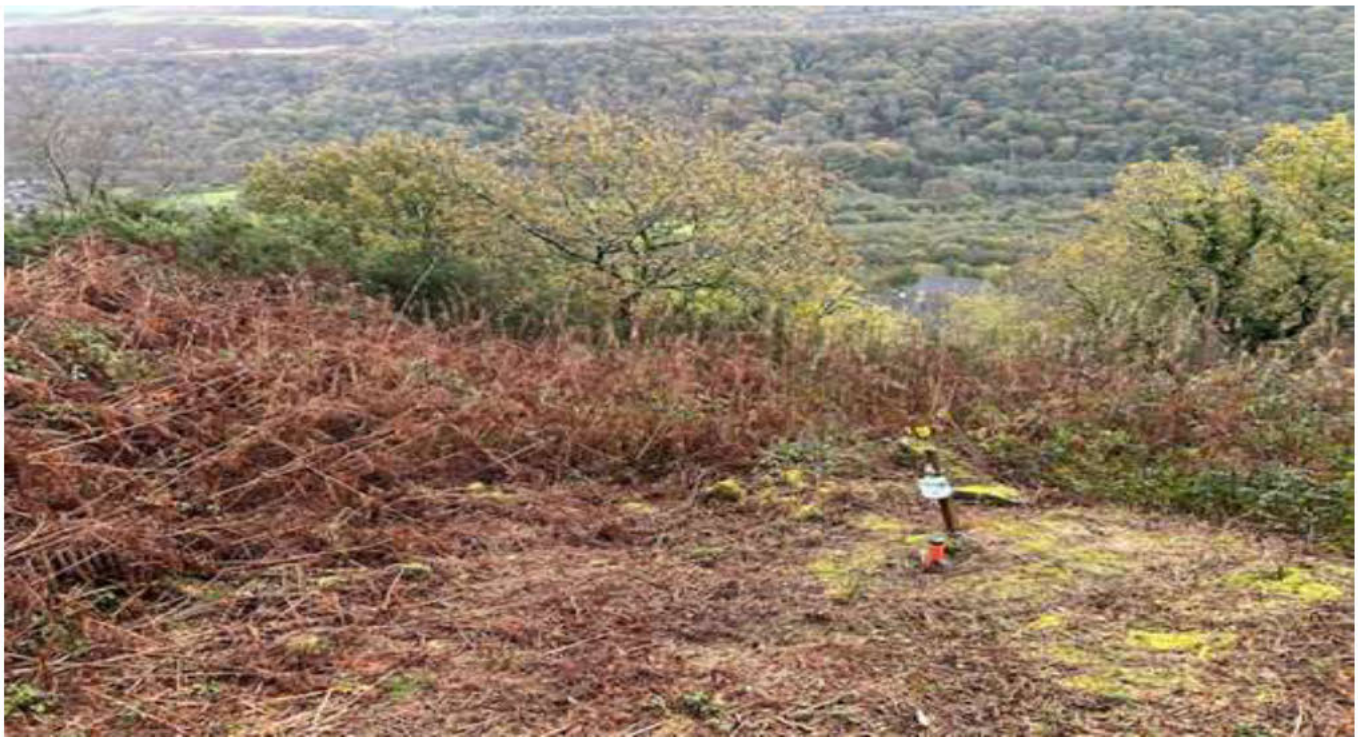
Photo No.	3	Comment	Piezometer located downslope (outside the provided site boundary). Recent vegetation clearance has been undertaken to provide access.
Feature ID	23/IM/01

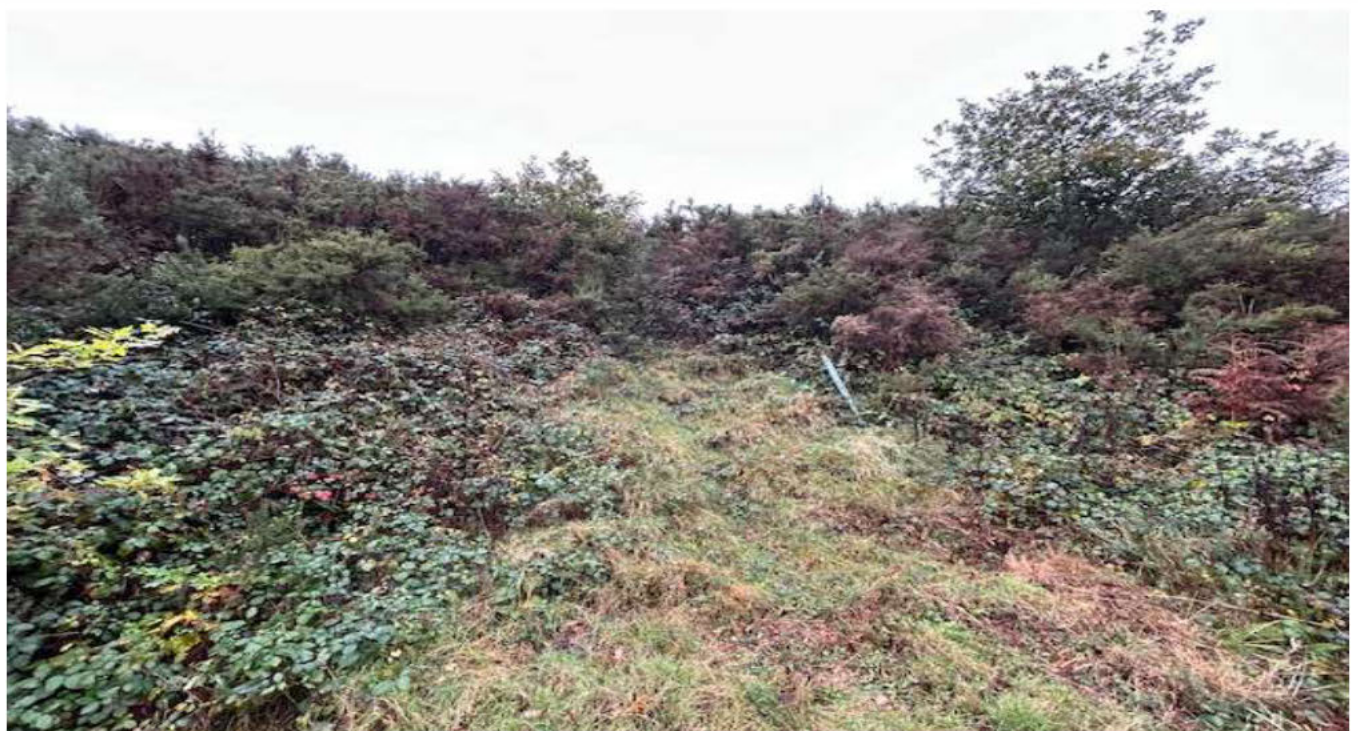
Photo No.	4	Comment	Minor surface erosion exposing bare spoil material along a narrow, overgrown access path; of which extends up-slope off the main site access path, towards the site. Plastic casing associated with a piezometer appears to have been discarded next to the path.
Feature ID	23/IM/01

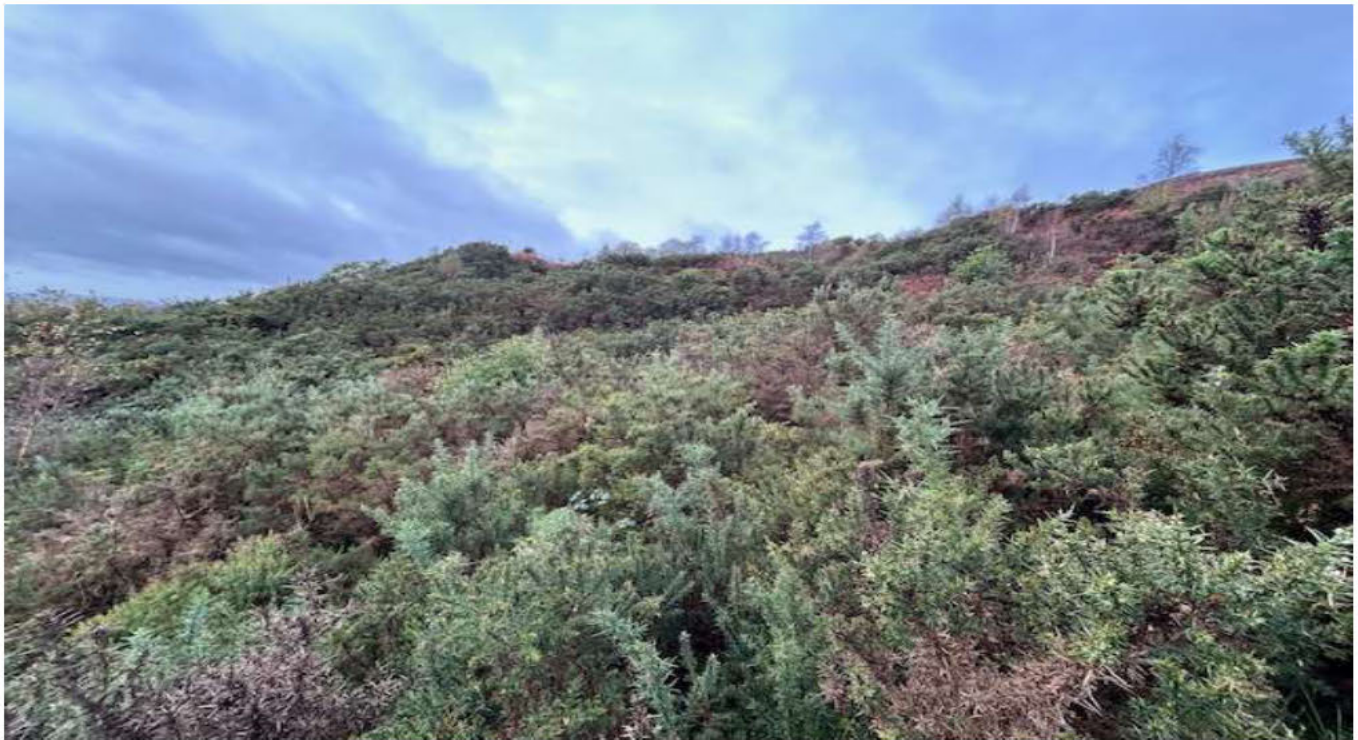
Photo No.	5	Comment	View looking south-west across the very densely vegetated lobes of tip material. Image conveys associated accessibility issues.
Feature ID	23/L/01

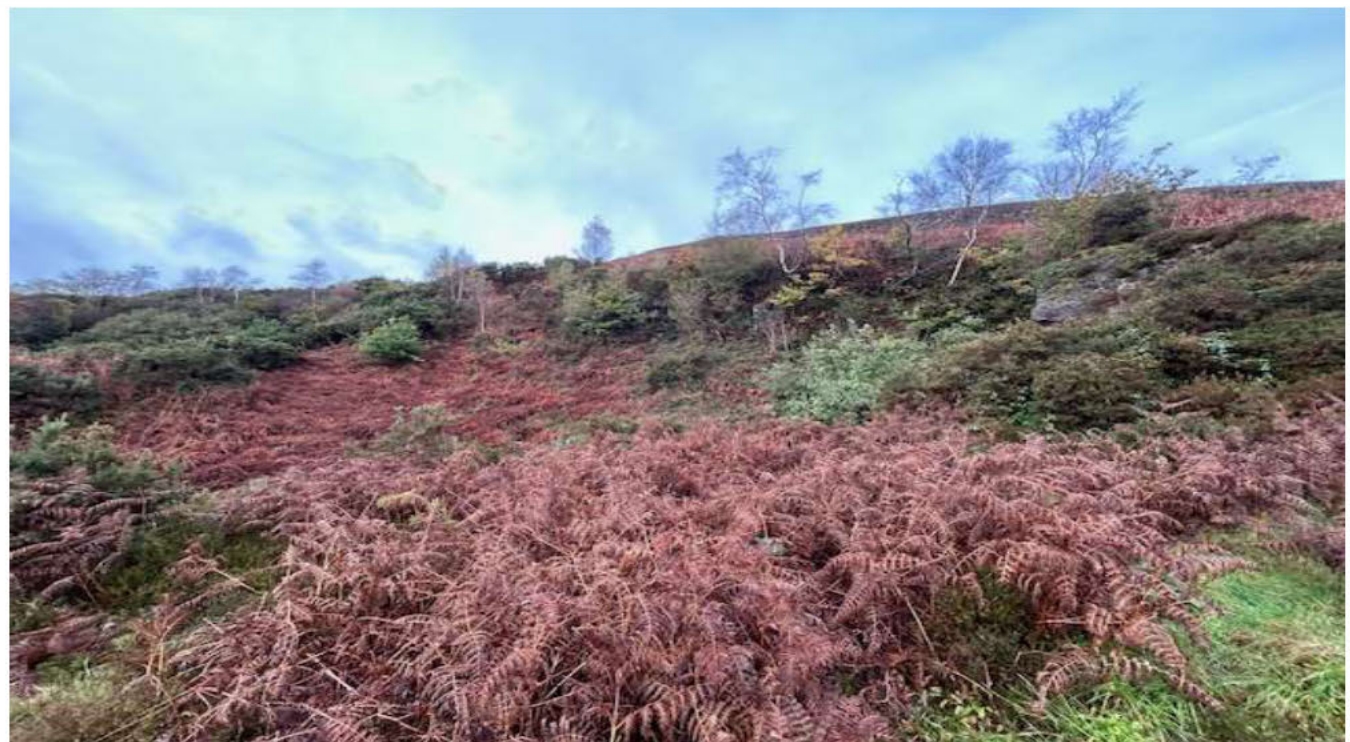
Photo No.	6	Comment	View looking towards an outcrop of bedrock at the rear of the tip; likely the quarry high wall.
Feature ID	23/L/01
