Coal Tip Name	Godre'r-graig Quarry / Cilmaengwyn		Tip Ref Number	T37552	
			Ownership Status	Private	
Located In	Godre'r Graig, Neath-Port Talbot		Tip Category	D	
Inspection Led By		Date of Inspection	09/09/2024	Date of last Inspection	08/11/2023
Weather	Sun		Dry		Calm
General Remarks (e.g. access, limitations)	<p>Access to the site was gained via an access path situated just off the [REDACTED] access track. The access path extends up the hillside in a north-easterly direction, passing through Cwar Pentwyn Quarry before reaching a narrow, overgrown path which extends up-slope towards the site.</p> <p>It should be noted that this inspection was conducted without the benefit of a detailed site plan; whilst dense vegetation significantly limited accessibility and visual inspection. Therefore, instability within these areas could exist, but was not detectable at the time of the inspection. The densely overgrown nature of the site prevented inspection of the spoil material; it is presumed that the site is comprised of sandstone quarry waste material, however some exposures of colliery spoil material were present downslope (outside the provided site boundary), adjacent to the access path

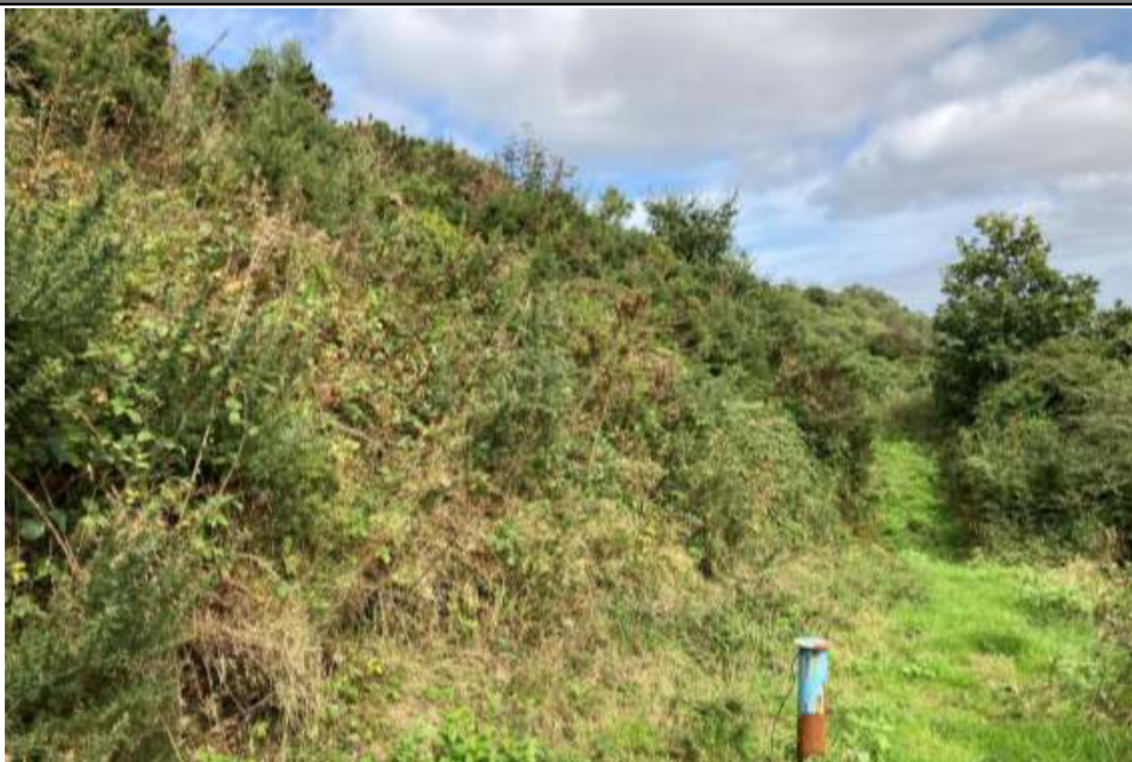
Photo No.	1	Comment	Piezometer borehole located on the site access track, downslope (outside the provided site boundary).

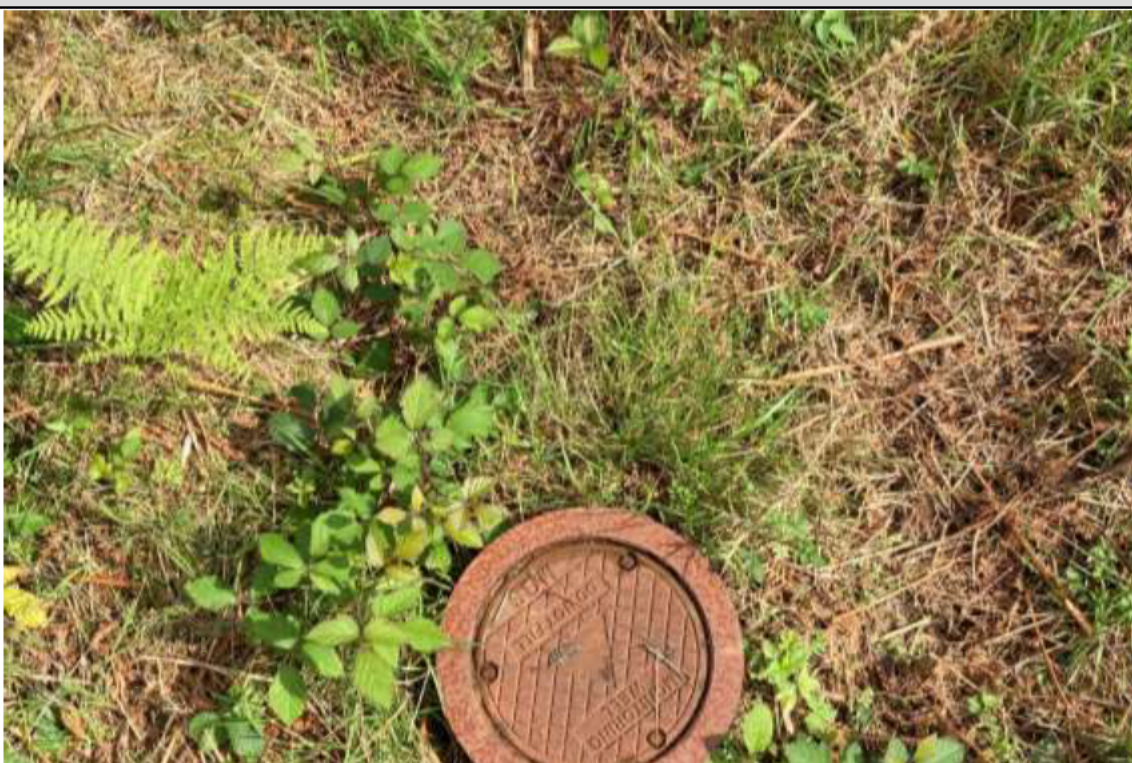
Photo No.	2	Comment	Monitoring well located on the site access track, downslope (outside the provided site boundary).

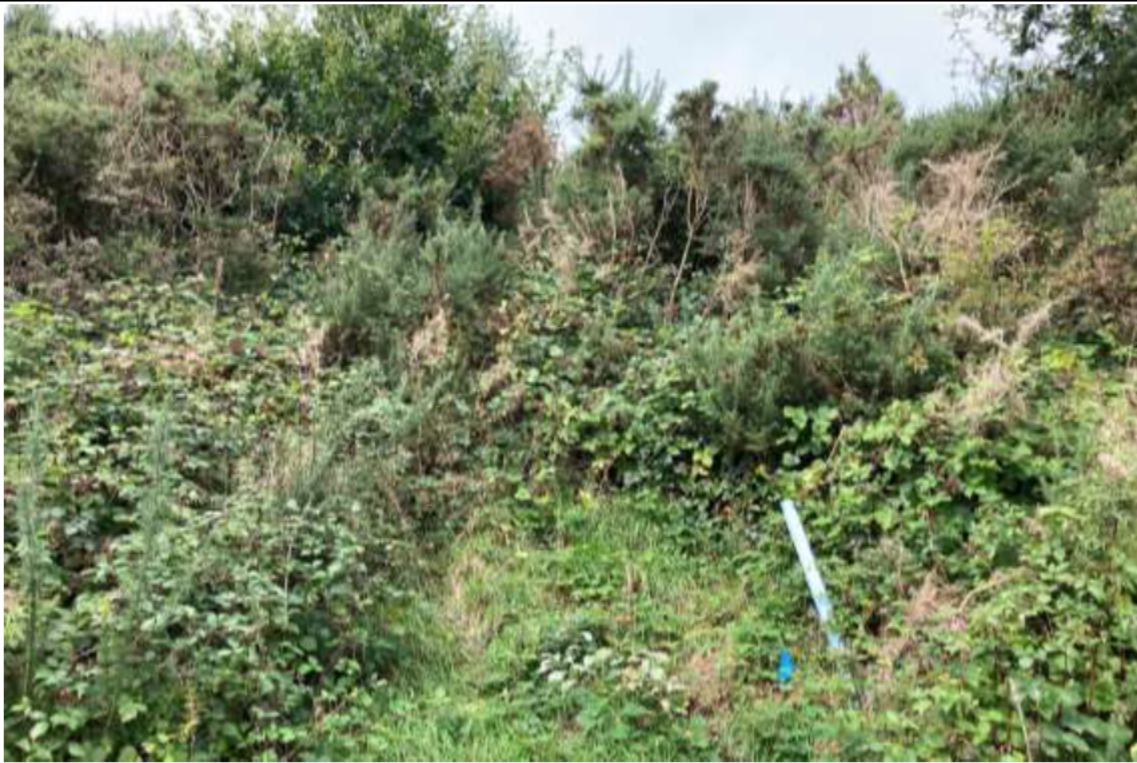
Structures			
9	Within body of the tip	N/A	
10	Other	No Change	Series of piezometer boreholes and monitoring wells, situated on the site access track (outside the provided site boundary). Plastic casing associated with a piezometer appears to have been discarded next to a path which ascends towards the tip. Inclinometers are recorded as being installed within some of the boreholes.
Seepage			
11	Within body of the tip	N/A	Previous investigation conducted by ESP suggesting that: monitoring has revealed a variable head of water within the tip; the Quarry Spoil Tip may be, or has become, actively unstable; downward continuous and/or intermittent movements have been recorded via inclinometers.
12	Above the tip	N/A	Previously recorded (by ESP) issues/springs above and below the tip.
13	Below the tip	N/A	Previously recorded (by ESP) issues/springs above and below the tip.
Erosion			
14	Surface erosion	N/A

Photo No.	3	Comment	View looking towards the narrow, overgrown access path; of which extends up-slope off the main site access path, towards the site. Plastic casing associated with a piezometer appears to have been discarded next to the path.
