## Questions and Comments on Tip 2 Stability Reports

**171 Graig Road, Godre'r Graig, Ystalyfera, Swansea  
(Formerly Godre'r Graig Infants School)**

JANUARY 10, 2023

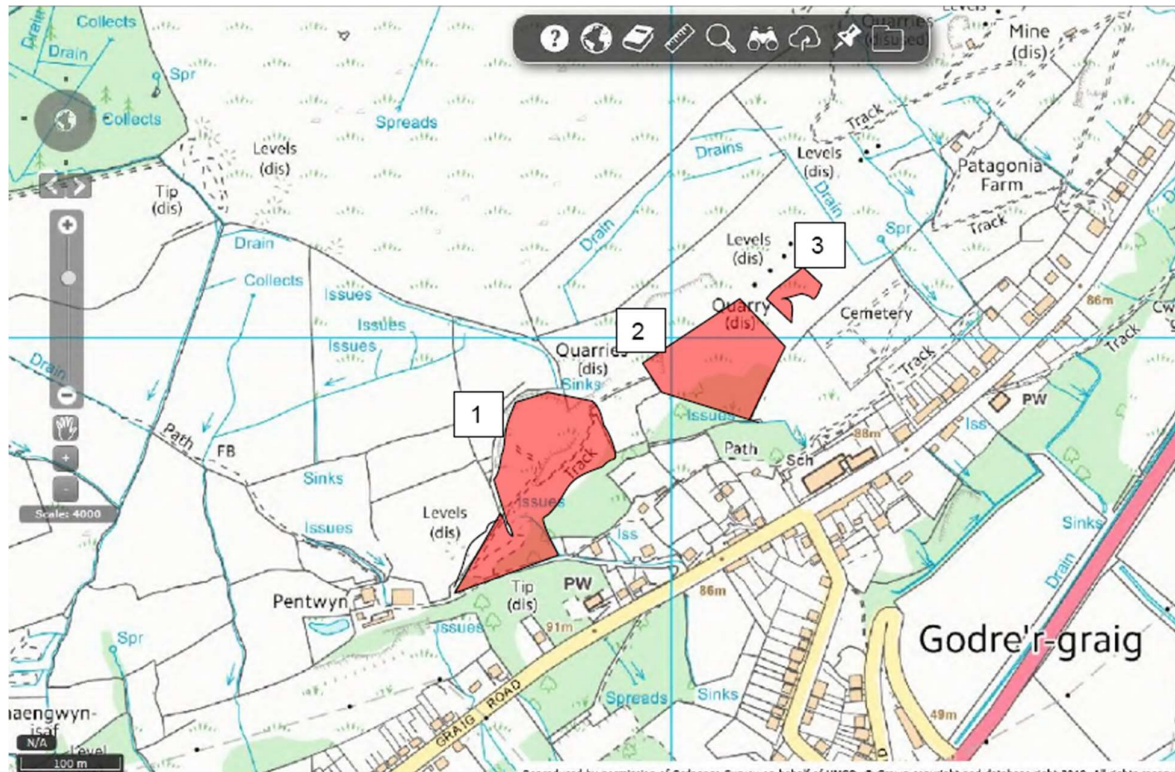
Figure copied from the Coal Authority L44 – Godre'r Graig Tips Site Inspection Report. Tip 2 is the subject tip. Neath Port Talbot Council (NPTC) identified Tip 2 as an asset requiring further exploration.

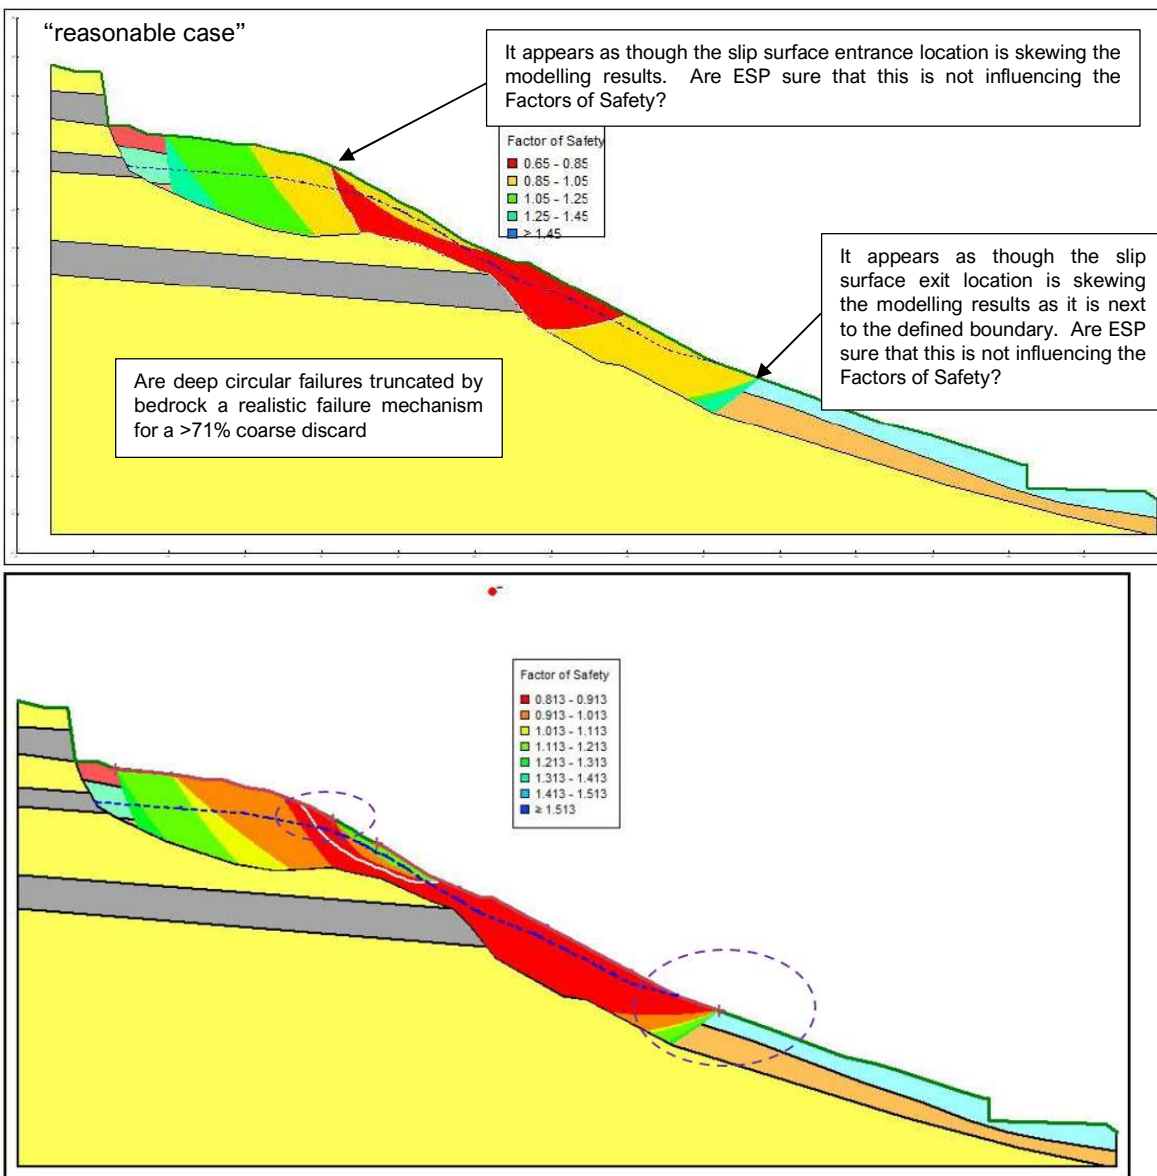
The “reasonable case” model shows Factors of Safety as low as 0.65 to 0.85 (below 1.0). Are NPTC (and ESP) supporting this is not a realistic Factor of Safety as the slope would have failed if the Factors of Safety were that low. This supports the suggestion that the modelling material properties are overly conservative.

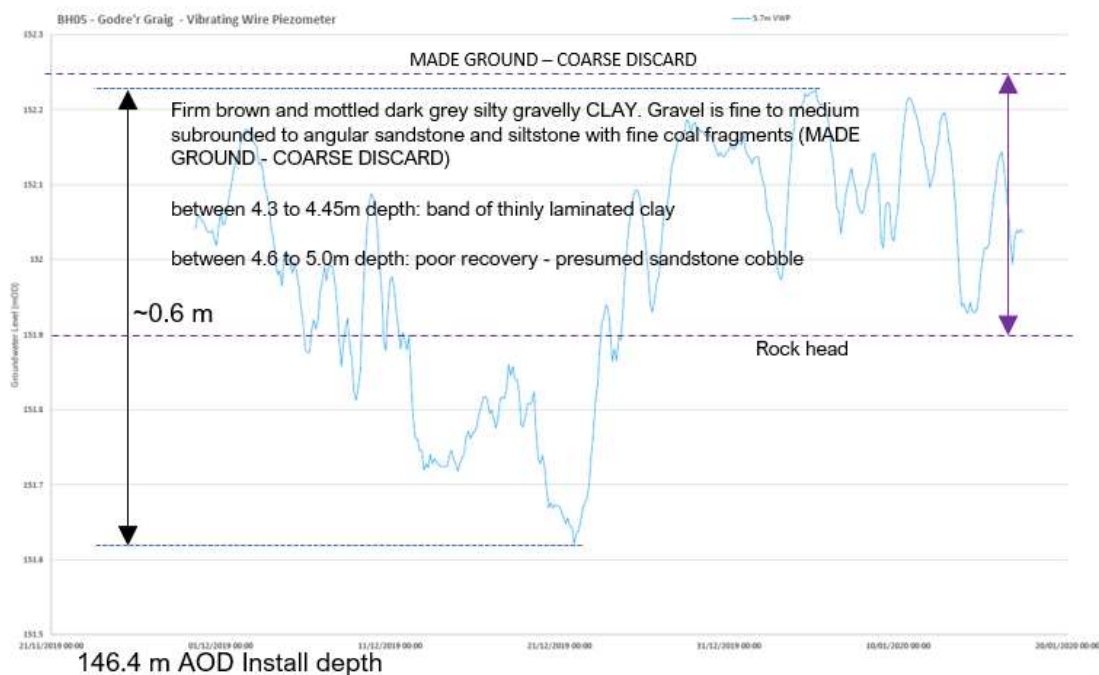
## BH05 – Collar 157.05

BH05 – appears to show rapid rise and fall of water but the fluctuations appear to be within the clay layer and have not reached the coarse discard. The figure above shows the elevation of rock head and where coarse discard starts. (scale and dates are difficult to read though)

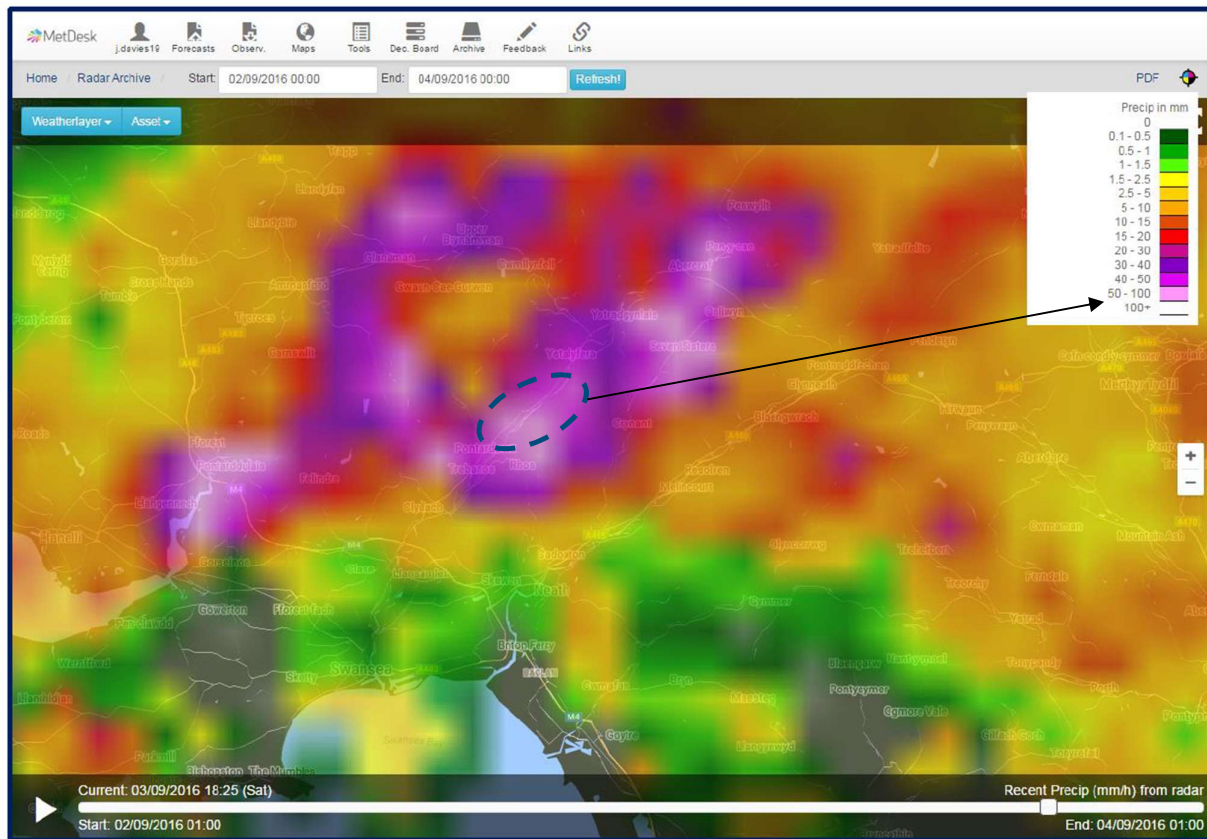
**Figure 3.7-1 – Rainfall event at 18:25hrs 3 September 2016**

The site was exposed to a significant magnitude rainfall event between 2016-09-02 and 2016-09-04 (NPTC, 2016). This occurred without a slope failure, deformation, or fluidization of the tip material. *Figure 2* is copied above as Figure 3.7-1.

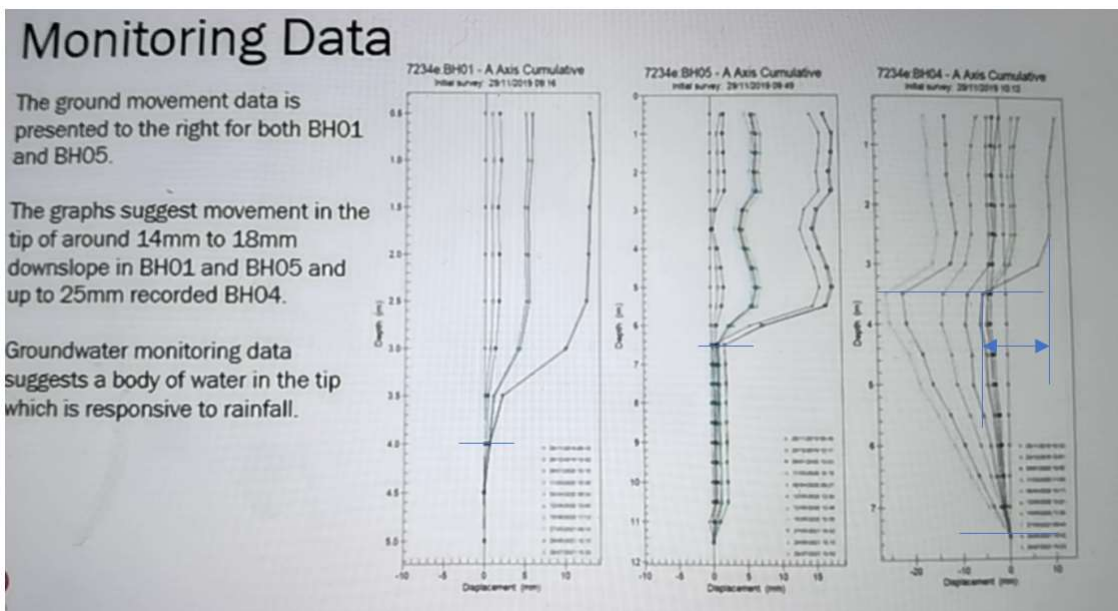
To put this into the context of the tip, a drill hole 150mm diameter was driven or hammered through the tip material ranging from clay to 700mm boulders. It is conceivable that a larger particle was pushed uphill slightly and through gravity is settling back. The backfill around the annulus of the inclinometer was noted to be “bentonite/cement surround” It is plausible that the bentonite cement slurry drained away into the tip in one of the more permeable layers.

Does BH04 (and other casings) inclinometer casing show movement as modelled in the Limit Equilibrium Models with the same water table??

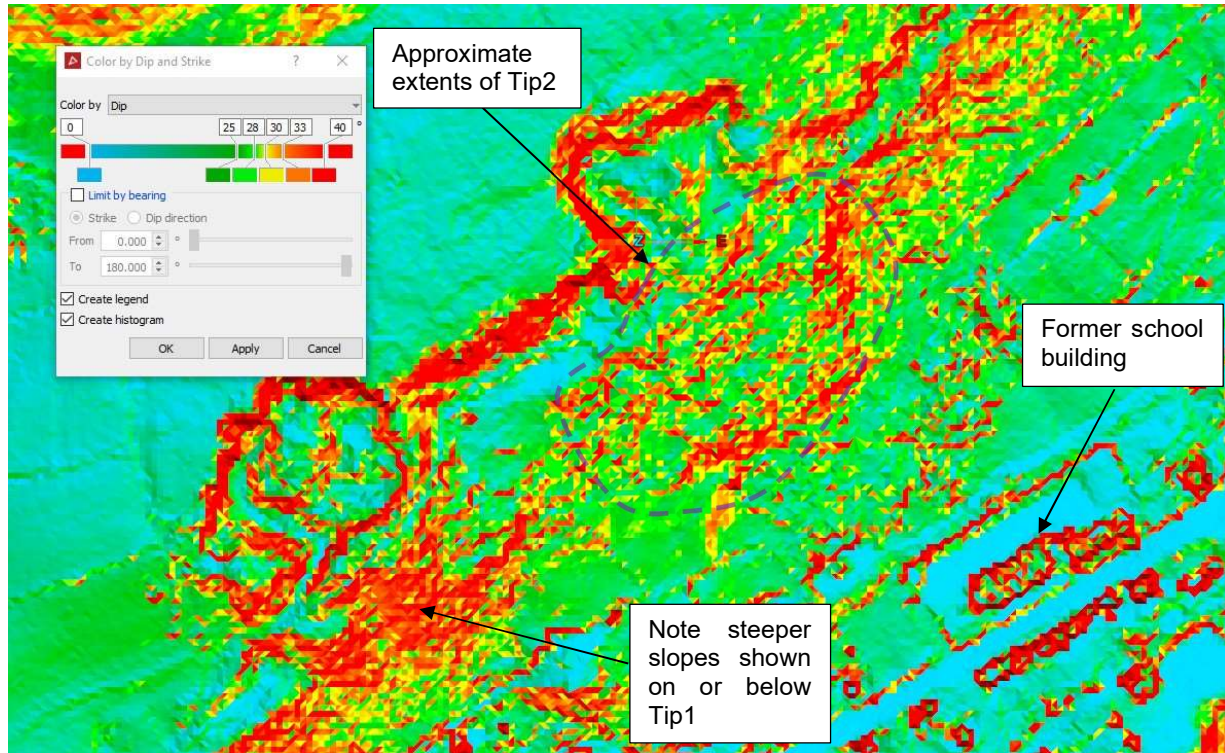
**Figure 3.9-1 – Colourised slope angles from the Digital Surface Model**

A 27° slope is not as steep as contended by NPTC and ESP who refer to the slope as “*over steep*”. The angle was estimated from ESP’s Limit Equilibrium model (assumed to be natural scale X&Y direction)) and subsequently measured from LiDAR data provided by LLE GeoPortal For Wales.

Figure 3.9-1 was developed from a grid created using lowest return values to provide a topographic ground surface to simulate vegetation removal. The steepness of each cell is represented by a colour. The angles can be seen in the key in the figure. The average dip of the approximate tip extents is 26° dipping towards 137° (southeast).

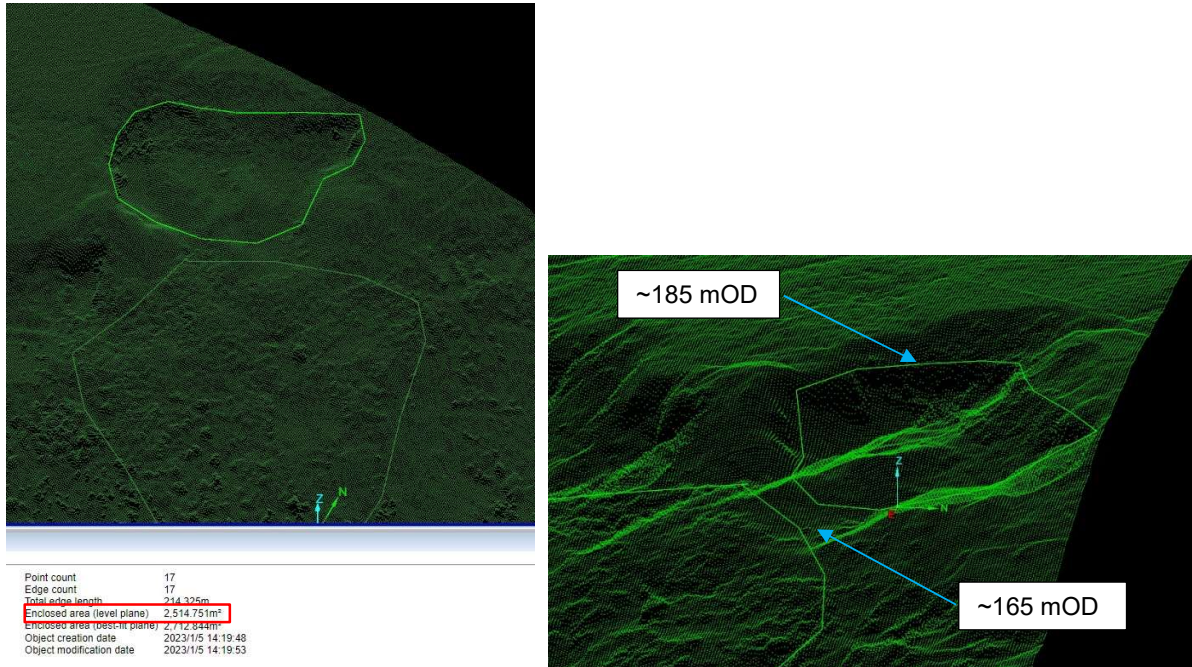
**Figures 3.13-1a and -1b – Crest of highwall in quarry**

Using a conservative approach assuming the rock was quarried leaving vertical slopes as highwalls, and rock was excavated from 185mOD to 165mOD this would give a highwall height of approximately 20m. Simple volume calculations of 2,500m<sup>2</sup> x 20m = 50,000m<sup>3</sup> (no allowance was made for the volume of tipped material currently in the quarry). This suggest that about 50,000m<sup>3</sup> of in situ rock was excavated. It is highly improbable that 100% of the rock was tipped on the slope.

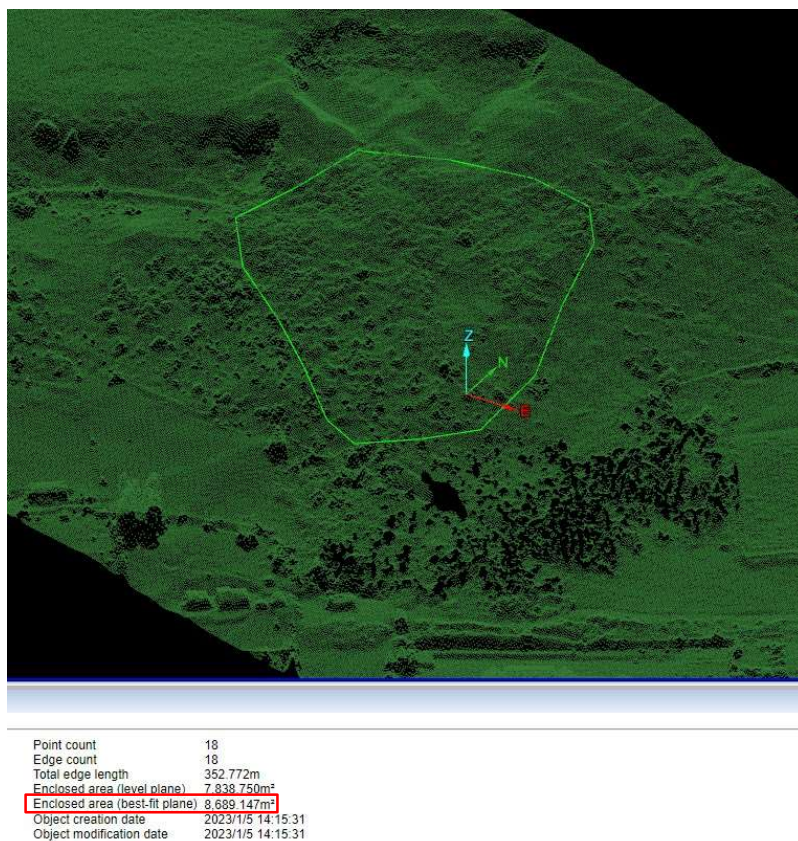
**Figure 3.13-2 – Estimate of area occupied by Tip 2**

The approximate boundary of Tip 2 was estimated to be 9,000m<sup>2</sup> (see Figure 3.13-2). Using NPTC's consultant's estimate of Tip 2's volume of 87,395m<sup>3</sup>.  $87,395\text{m}^3 \div 9,000\text{m}^2 = 9.71\text{m}$  thickness of end tipped coarse discard across the slope. The topography of the slope suggests that this is incorrect as the tipped material tapers into the hillside (See Figure 3.13-3 below). Especially as the thickest deposit as modelled is in the old quarry workings.
