| <b>Coal Tip Name</b> | Godre'r-Graig Higher / Pentwyn No. 3 Levels | <b>Tip Ref Number</b> | L044C |
| <b>Located in</b> | Godregraig, NPT | <b>Tip Category</b> | D |
| <b>Date of inspection</b> | 15/02/2022 | <b>Date of last inspection</b> | Unknown |

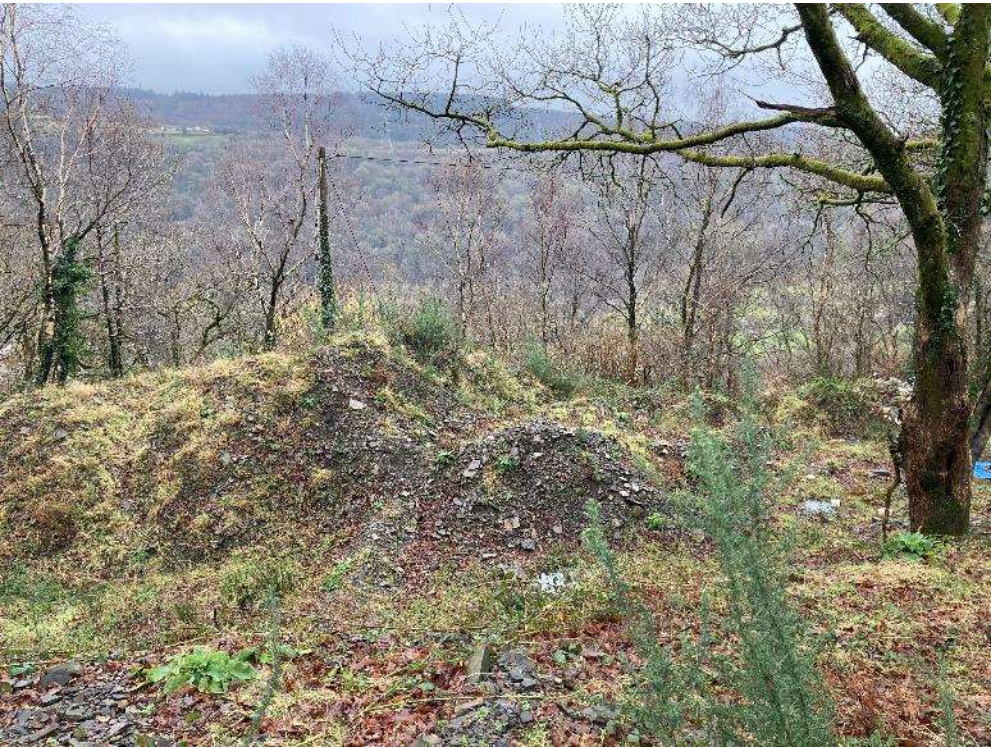
| <b>Photo No.</b> | 07 | <b>Comment</b> | A quarry waste rock tip loading the tip plateau. |

| OBSERVATIONS | | | |
|---|---|---|---|
| 22/L/01 | Deposition | E-274831<br>N-206809 | A quarry waste rock tip likely sourced from the nearby Cwar Pentwyn quarry was observed on the tip plateau. The loading of the tip plateau may potentially cause instability features to form. |

| <b>Feature ID</b> | 22/L/01 | | |

| OBSERVATIONS | | | |
|---|---|---|---|
| Recommendations | | | Consider liaising with the local planning officer to investigate whether planning permission was given for the quarry waste rock to be deposited on the tip plateau. Also potentially consider undertaking a more detailed geotechnical assessment of the stability of the tip due to loading of the tip plateau. The assessment will highlight whether the tip requires any further remediation work to ensure its stable in the future. |
