Coal Tip Name	Godre'r-Graig Higher / Pentwyn No. 3 Levels	Tip Ref Number	L044C		
		Ownership Status	N/A		
Located In	Godre'r-Graig, Neath-Port Talbot	Tip Category	D		
Inspection Led By		Date of Inspection	07/07/2022	Date of last Inspection	15/02/2021
Weather	Sunny	Dry	Calm		
General Remarks (e.g. access, limitations)	Access to the site was gained via an access track situated just off Graig Road, which leads to Pentwyn Farm. It should be noted that this inspection was conducted without the benefit of a detailed site plan. Densely overgrown vegetation across the tip surfaces obstructed visual inspection; therefore, instability within these areas could exist, but was not detectable at the time of the inspection.				
Features Causing Concern	Description

Coal Tip Name	Godre'r-Graig Higher / Pentwyn No. 3 Levels	Tip Ref Number	L044C
		Tip Category	D
Date of Inspection	07/07/2022	Inspection led by

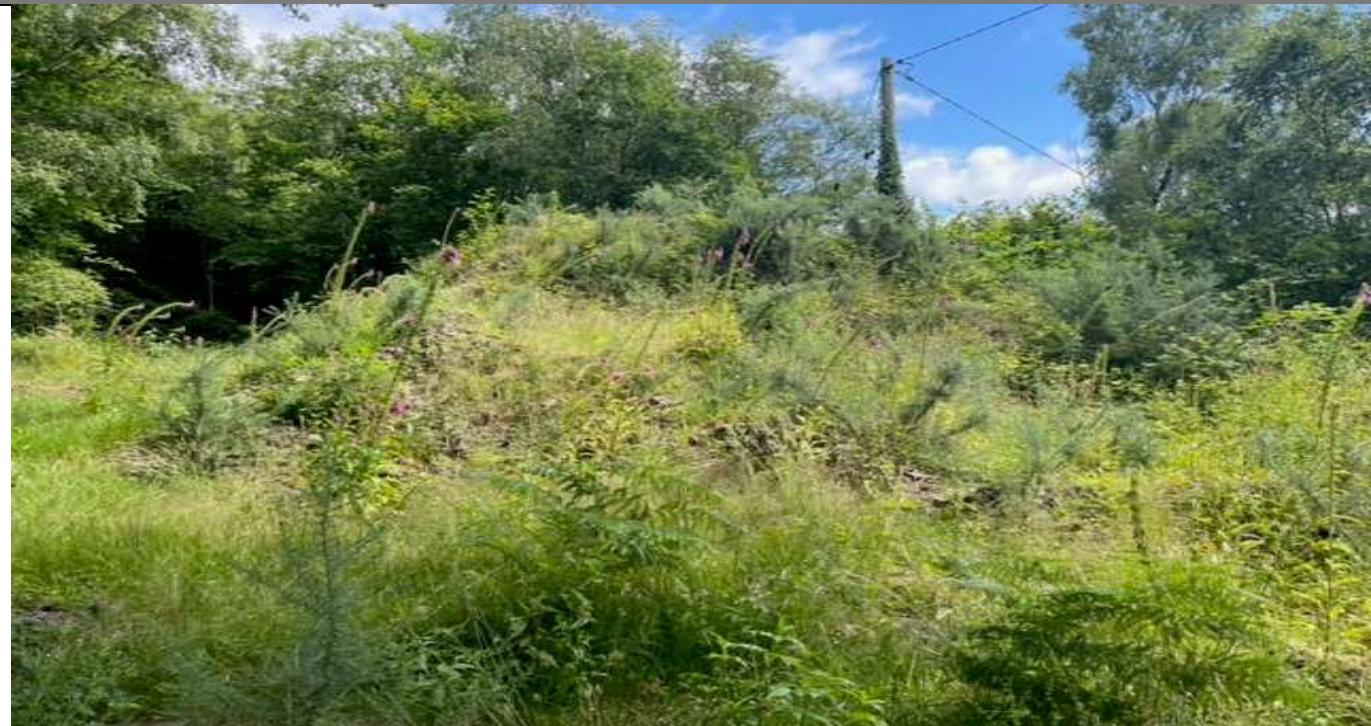
Photo No.	1	Comment	Sandstone quarry waste material deposited on the north-eastern section of the tip plateau. OHP's present in close proximity to the crest.

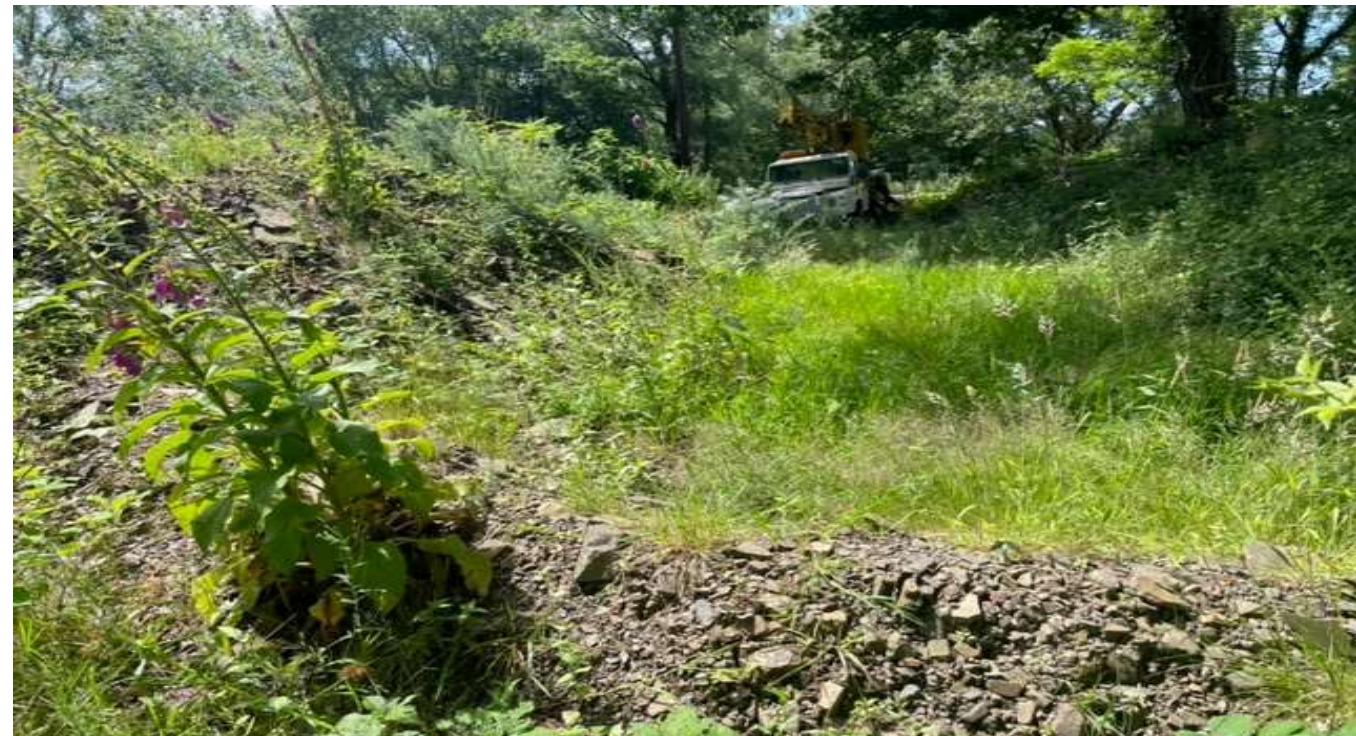
Photo No.	2	Comment	Sandstone quarry waste material deposited on the north-eastern section of the tip plateau. Vehicle and machinery present.

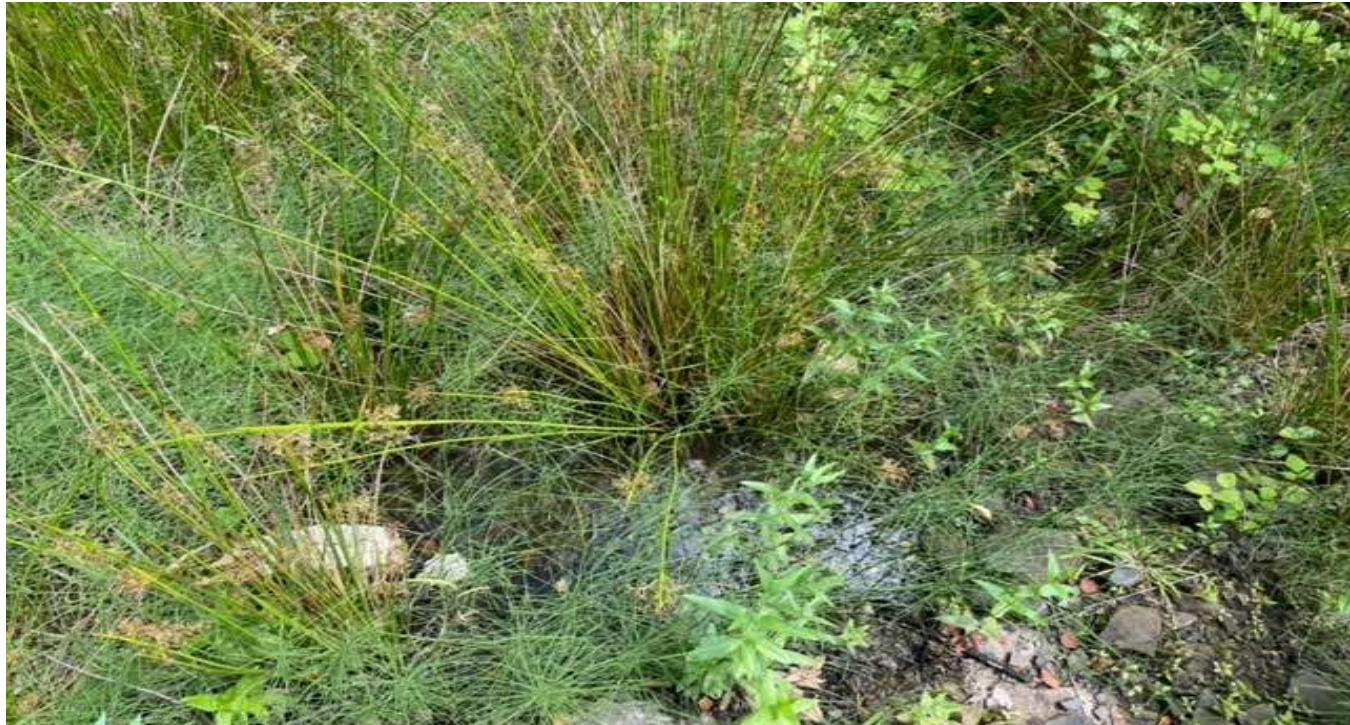
Photo No.	3	Comment	Multiple seepages situated on the north-eastern section of the tip plateau. Associated saturated ground conditions.
------------------	---	----------------	---

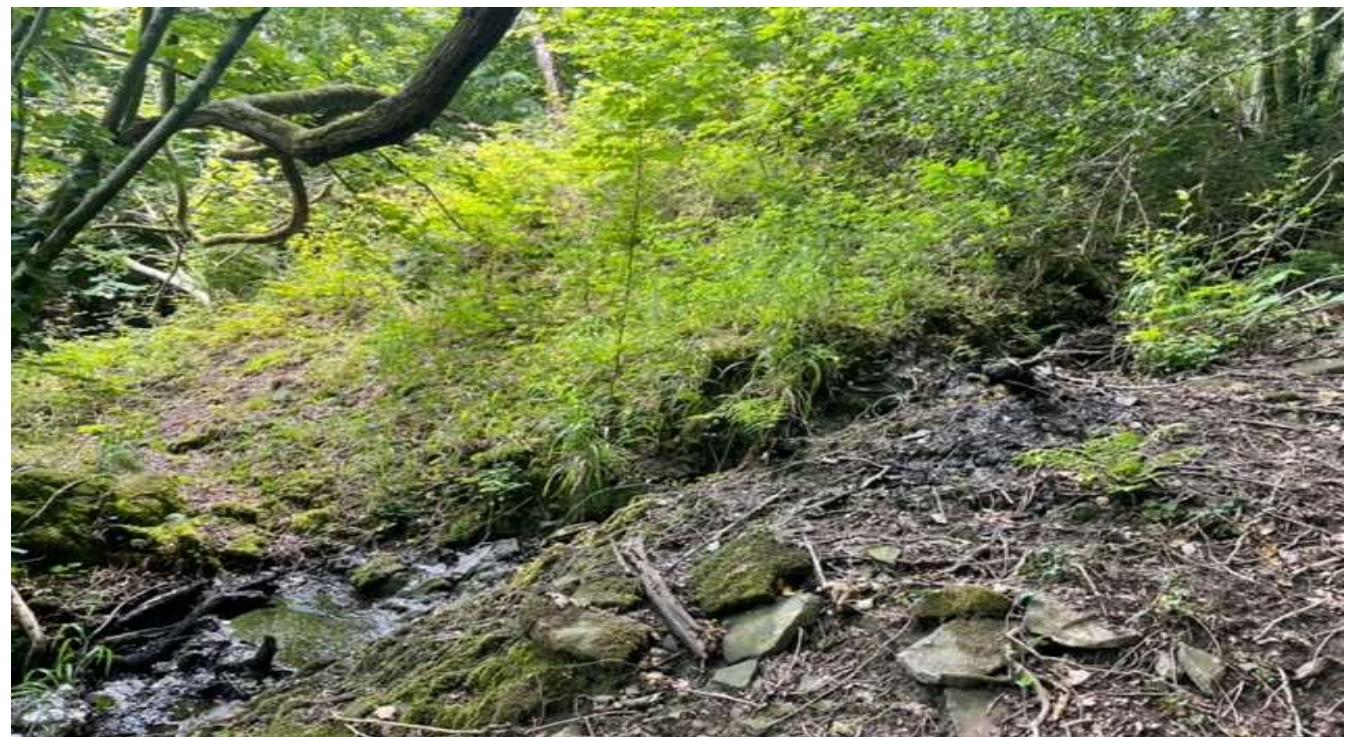
Photo No.	4	Comment	Scoured sections of the flank along the eastern boundary, due to the strong flows from an unnamed issue/watercourse conveying down the hillside.
------------------	---	----------------	--

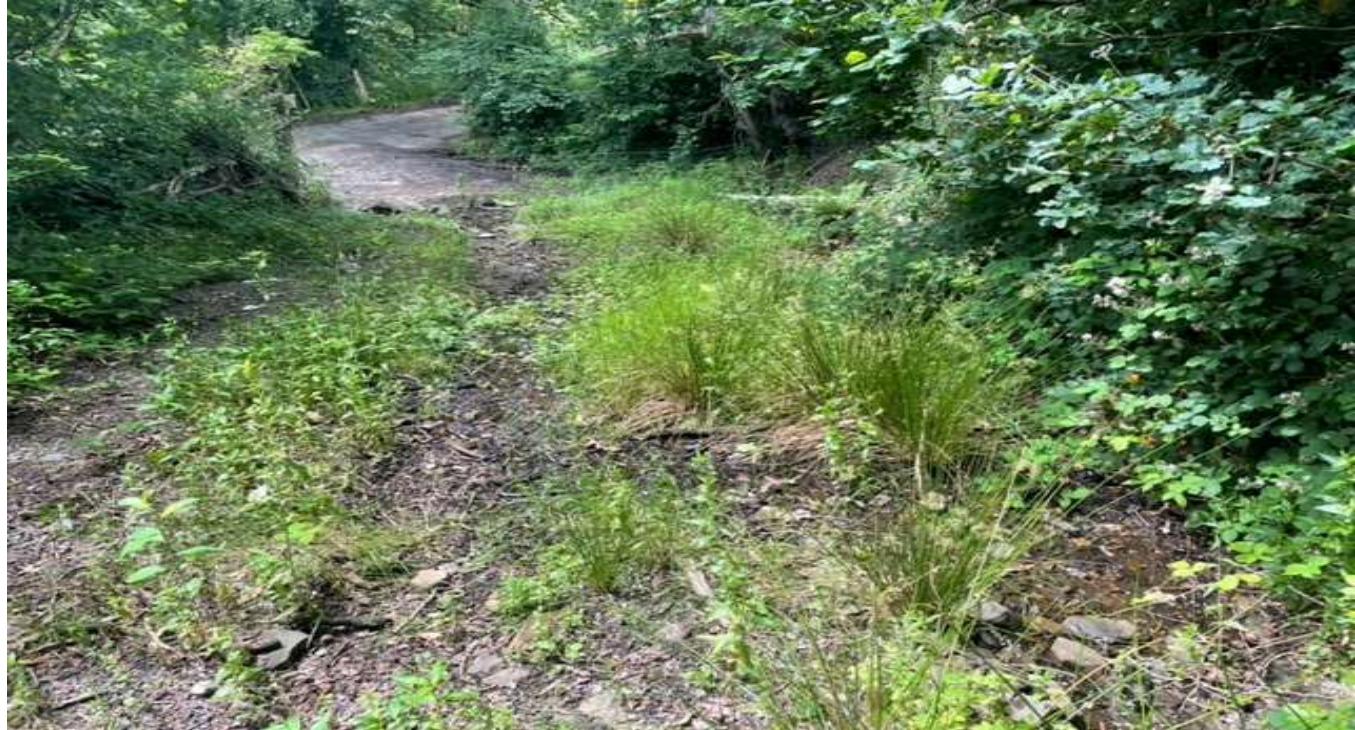
Photo No.	5	Comment	Dense vegetation partially obstructing the unlined channel which runs parallel to the access track, at the back of the tip. Associated saturated ground conditions. Channel ineffectively capturing flows, surface runoff migrating downslope.

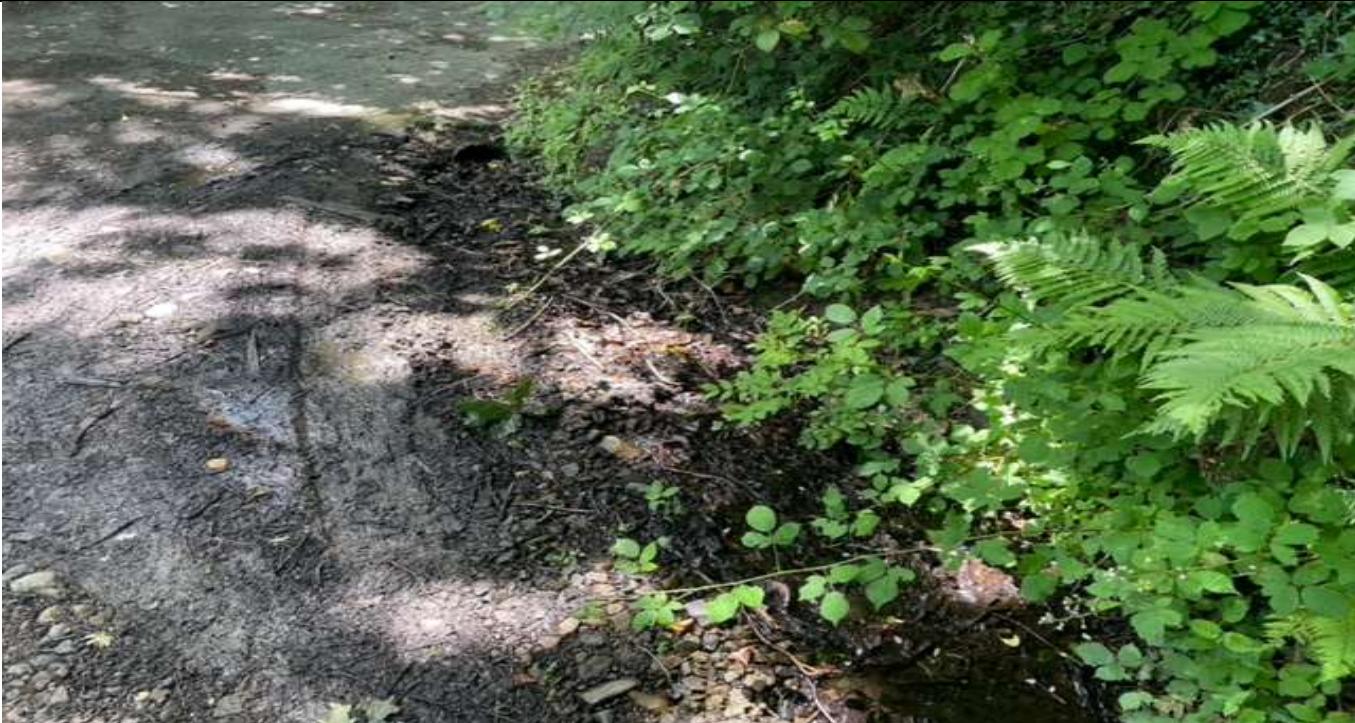
Photo No.	6	Comment	Silt and rock debris partially obstructing the cast iron culvert inlet, situated at the base of the unlined channel at the back of the tip.

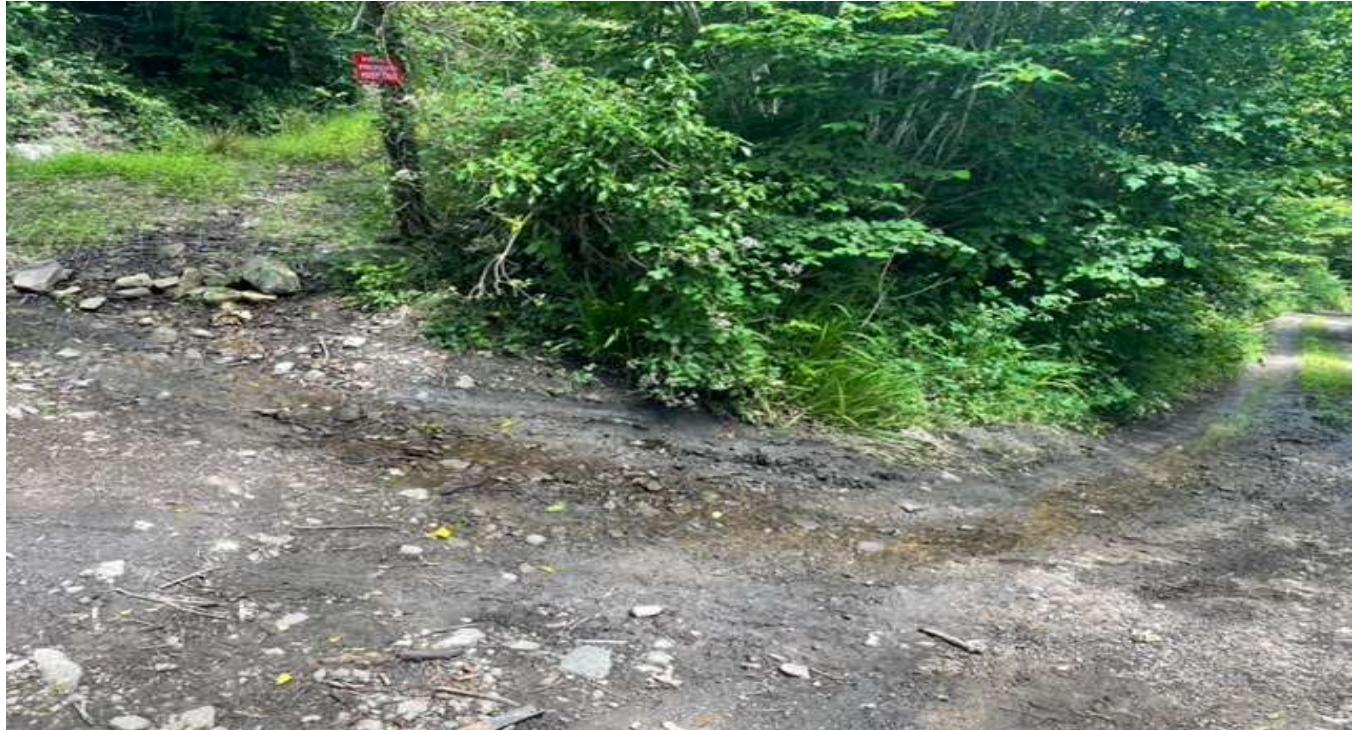
Photo No.	7	Comment	View looking north-east, surface run-off emanating from the back of the tip migrating down the access track.

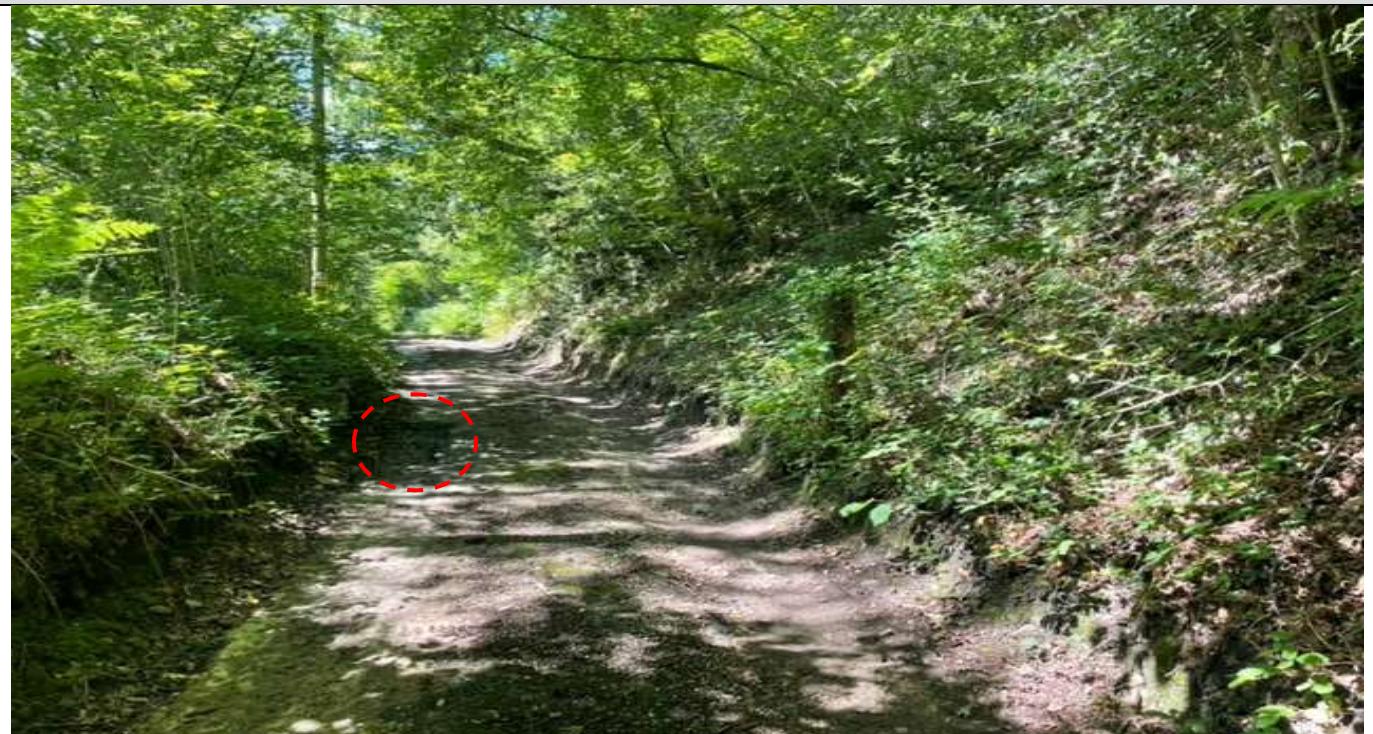
Photo No.	8	Comment	View looking south-west along the scoured access track (dashed red circle), situated adjacent to the toe. Steep, densely vegetated tip flank, OHP's situated in close proximity to the toe.

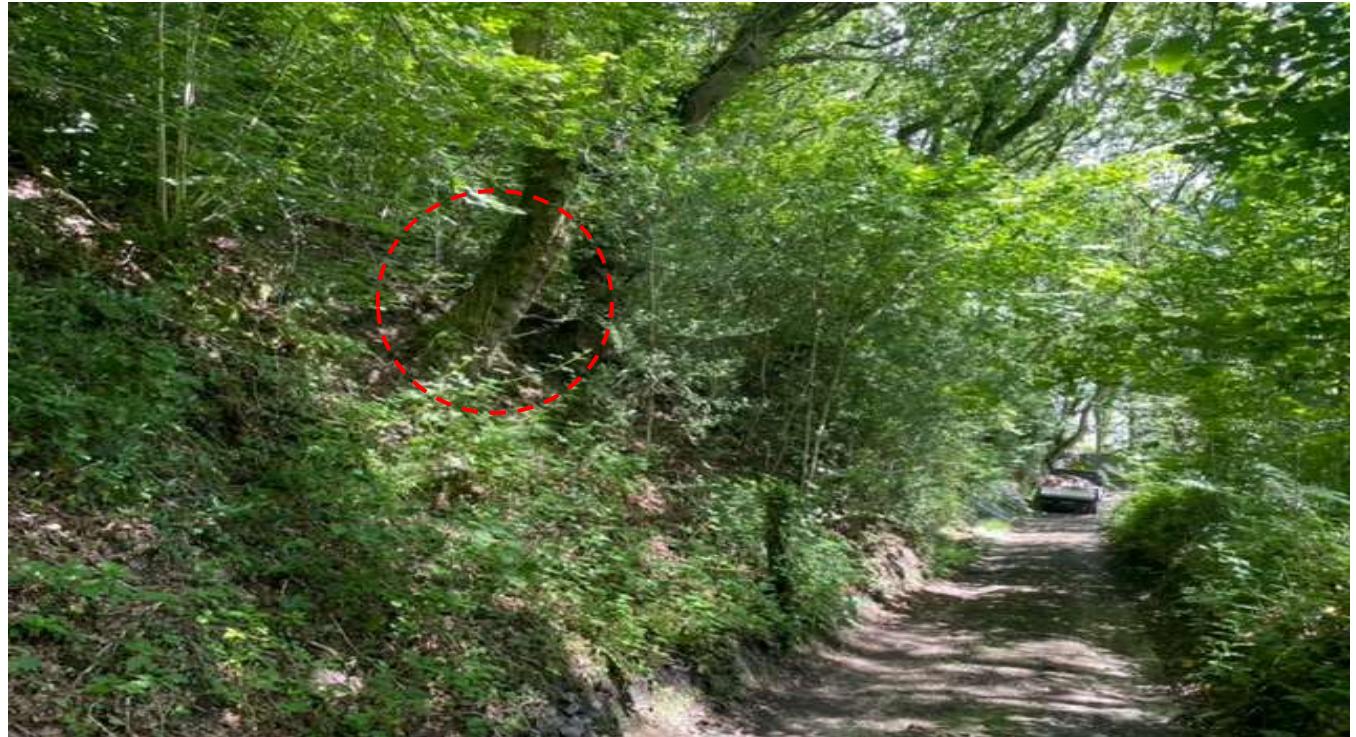
Photo No.	9	Comment	Distortion (curvature) of a mature tree (dashed red circle), situated along the steep, densely vegetated tip flank.

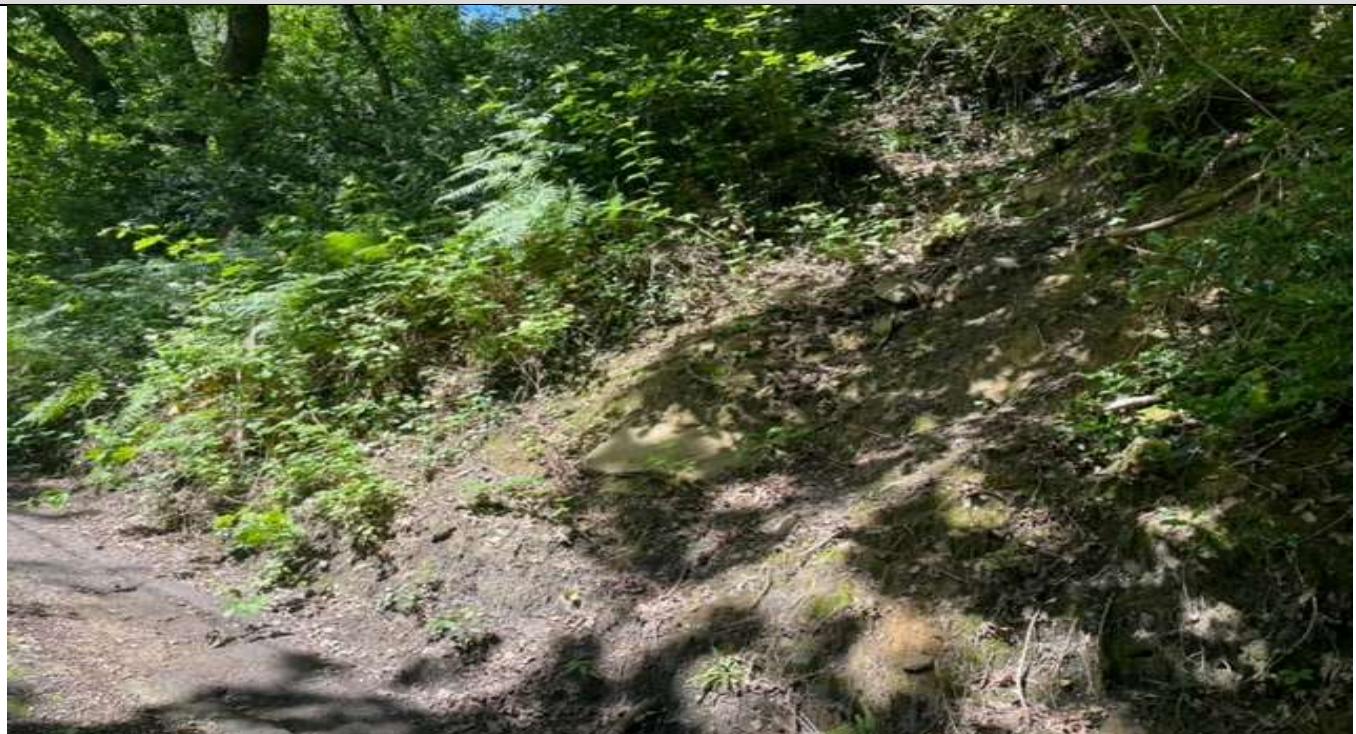
Photo No.	10	Comment	Minor slip situated along the toe, adjacent to the access track. Thin veneer of spoil material draped over natural ground.

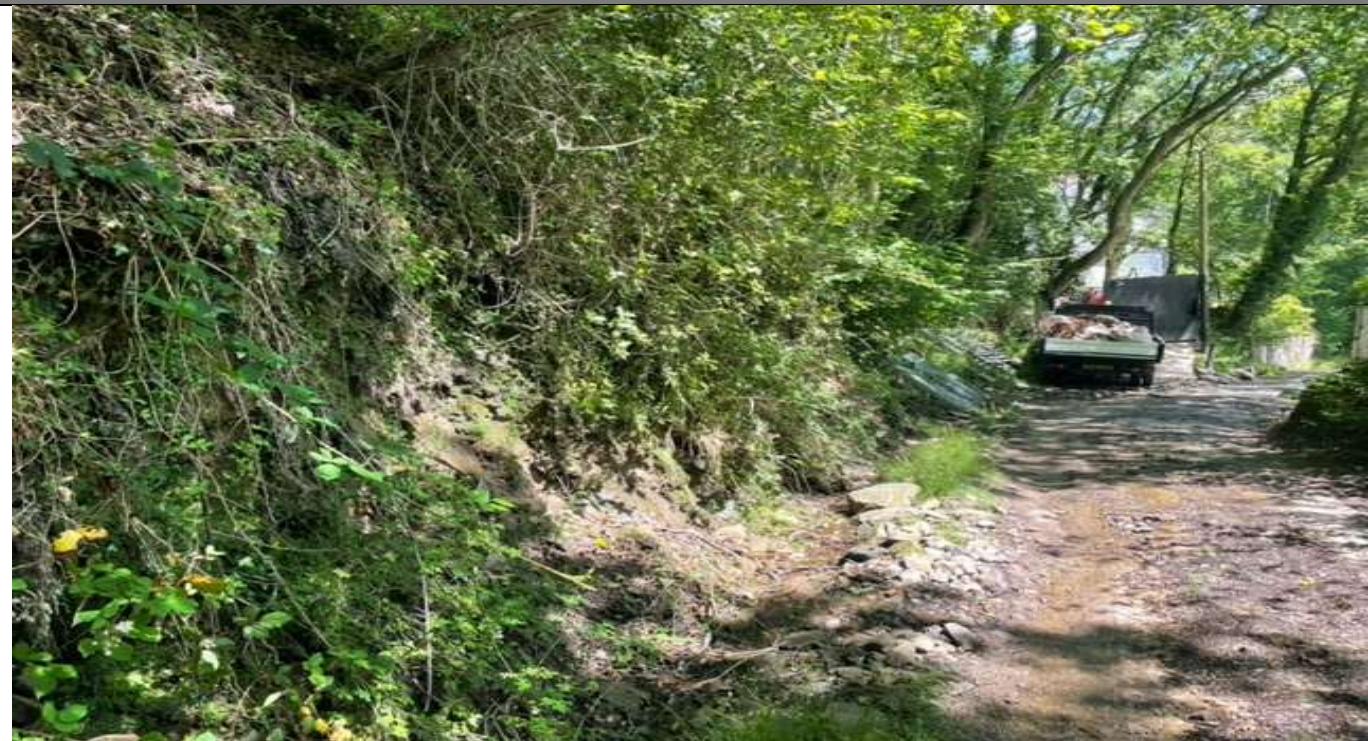
Photo No.	11	Comment	Seepage from the toe of the tip, run-off migrating down the access track. Flows conveying off-site, running adjacent to front drives/access tracks to residential houses situated off the main access track.
------------------	----	----------------	--

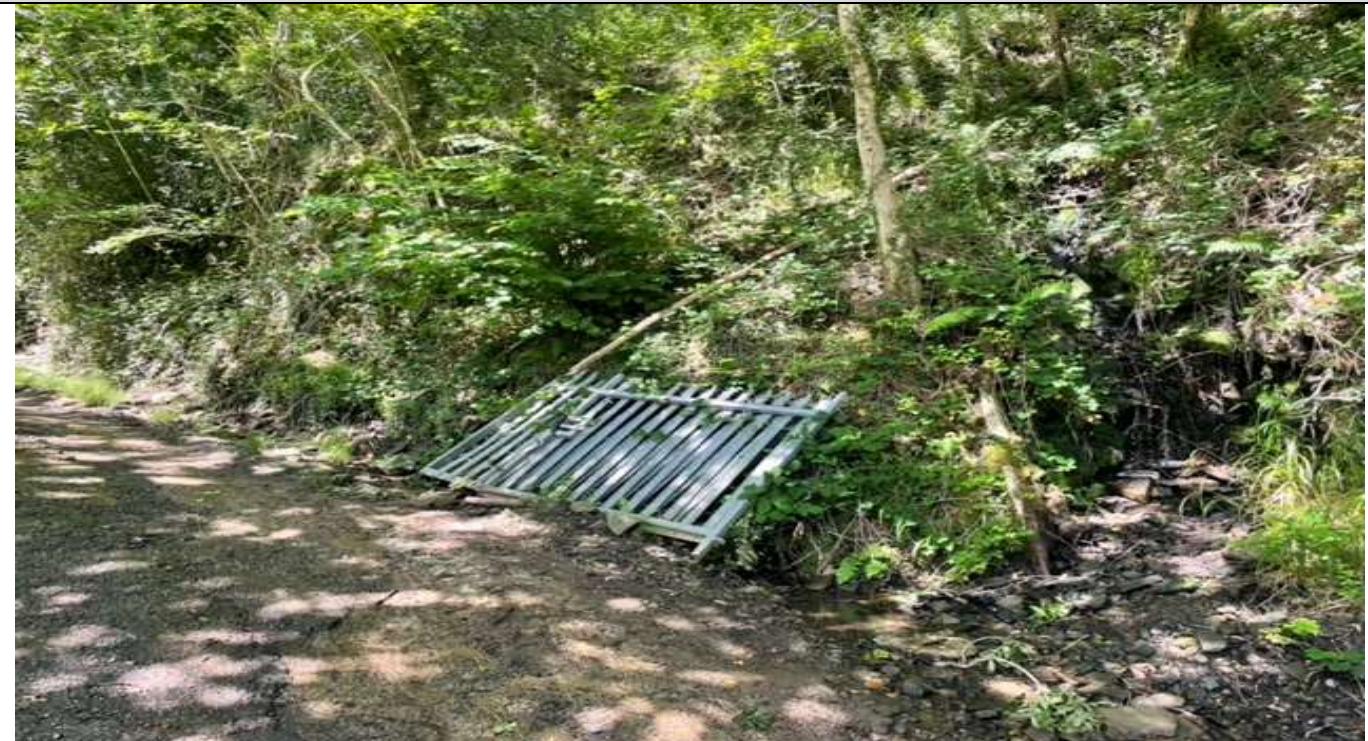
Photo No.	12	Comment	Scoured, undercut section of the toe, where the unnamed issue/watercourse cascades onto the access track.
------------------	----	----------------	---
