Coal Tip Name	Godre'r-Graig Higher / Pentwyn No. 3 Levels	Tip Ref Number	L044C	
		Ownership Status	Unknown	
Located In	Godre'r-Graig Higher, Neath-Port Talbot	Tip Category	D	
Inspection Led By		Date of Inspection	16/02/2023	Date of last Inspection
Weather	Overcast – Rain & Fog		Wet	Calm
General Remarks (e.g. access, limitations)	Access to the site was gained via an access track situated just off Graig Road, which leads to Pentwyn Farm. It should be noted that this inspection was conducted without the benefit of a detailed site plan. In certain areas, dense vegetation significantly limited accessibility and visual inspection. Therefore, instability within these areas could exist, but was not detectable at the time of the inspection. The location of the tip on privately owned land also limited the coverage of this inspection.			
Features Causing Concern		Description

Coal Tip Name	Godre'r-Graig Higher / Pentwyn No. 3 Levels	Tip Ref Number	L044C
Date of Inspection	16/02/2023	Tip Category	D
		Inspection led by

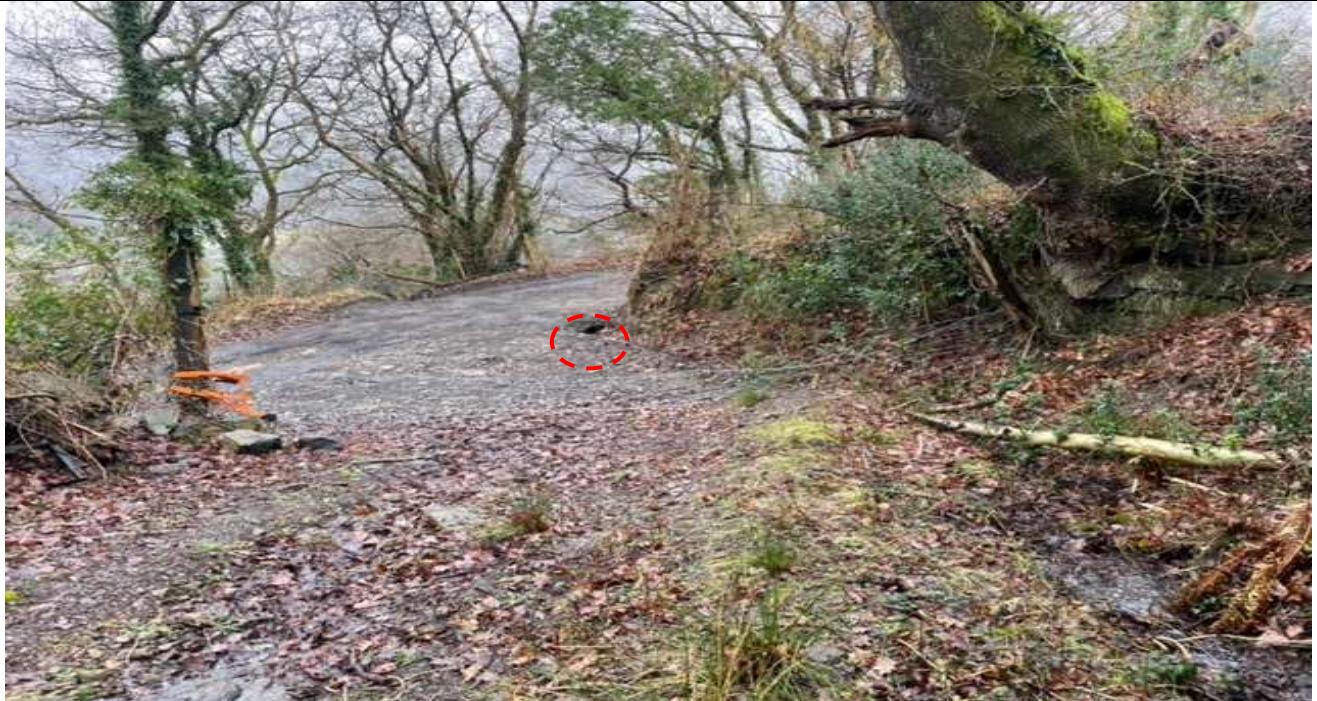
Photo No.	1	Comment	Vegetation and silt debris partially obstructing the shallow, unlined cut-off channel which runs parallel to the access track, located to the rear of the tip. Channel ineffectively capturing some flows (LHS), surface runoff migrating downslope, resulting in scouring of the access track. Some flows being conveyed towards the associated small diameter, cast iron culvert inlet (dashed red outline) as intended.

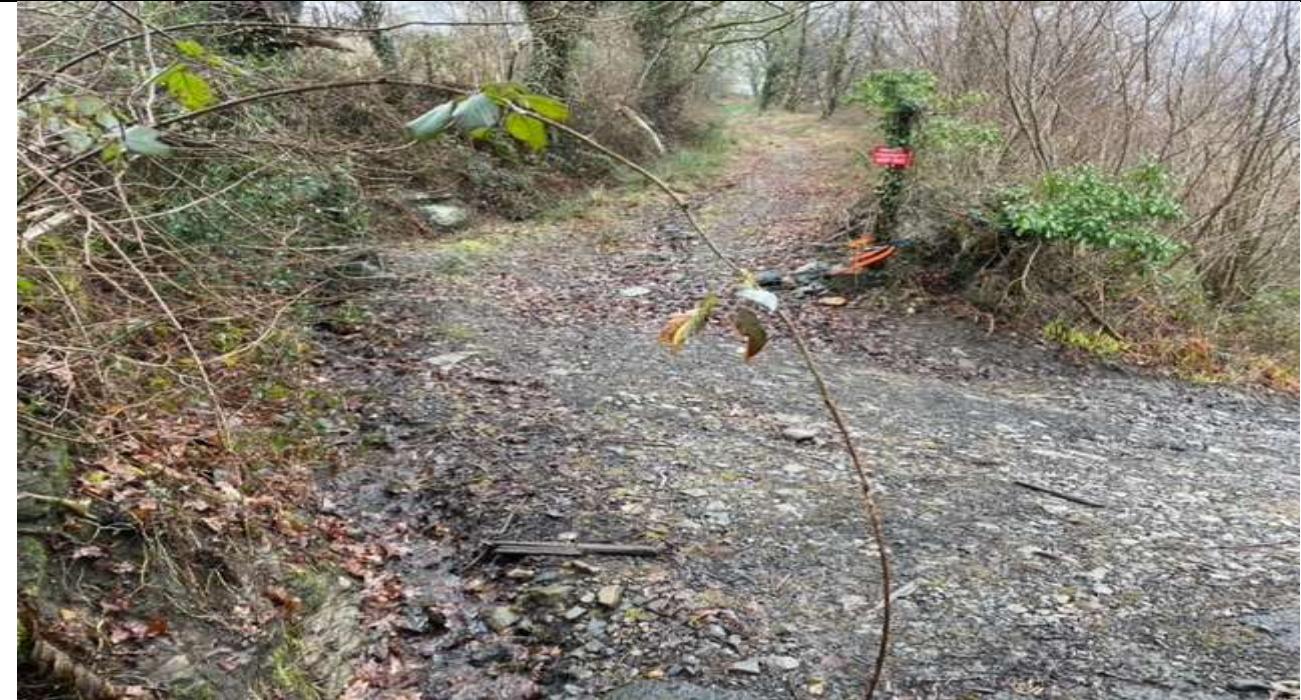
Photo No.	2	Comment	Vegetation and silt debris partially obstructing the shallow, unlined cut-off channel which runs parallel to the access track, located to the rear of the tip. Channel ineffectively capturing some flows, surface runoff migrating downslope, resulting in scouring of the access track. Private property signage present.

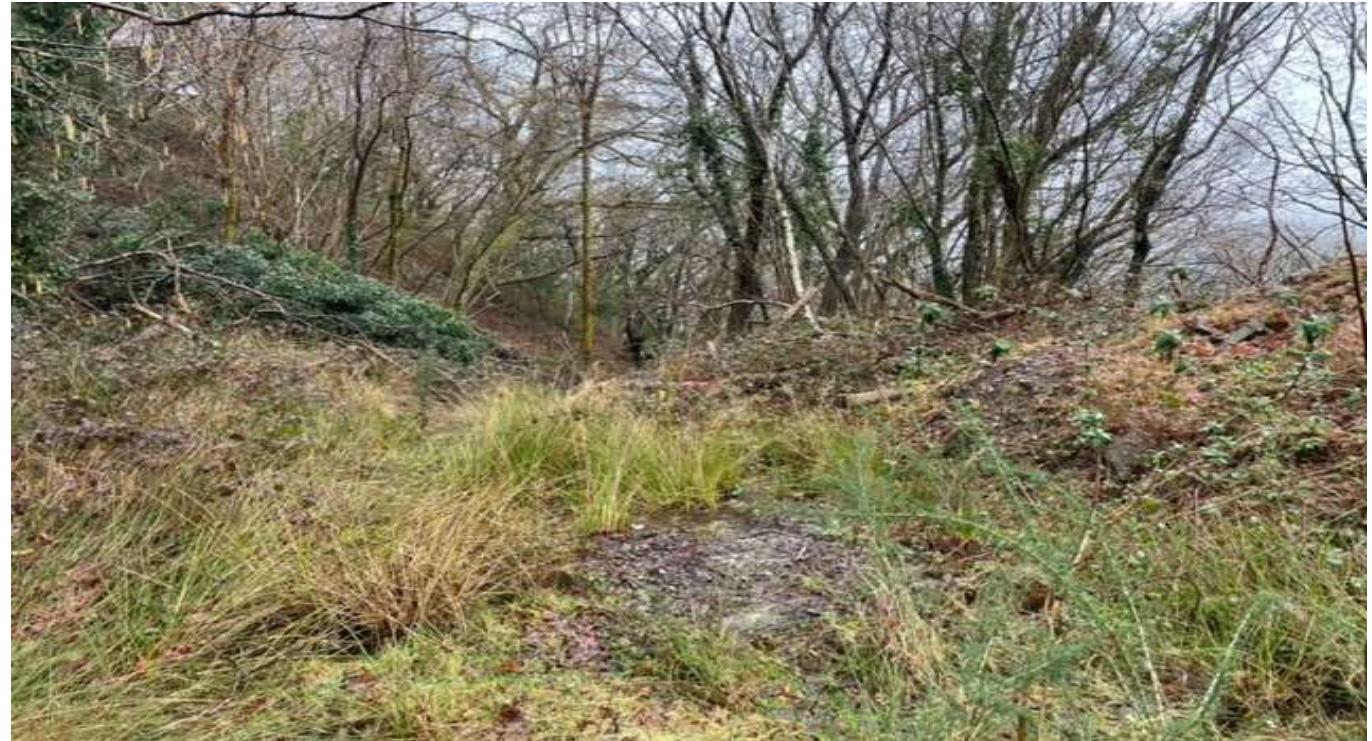
Photo No.	3	Comment	Multiple seepages situated on the north-eastern section of the tip plateau, associated saturated ground conditions. Sandstone quarry waste material deposited on the plateau (RHS).
------------------	---	----------------	---

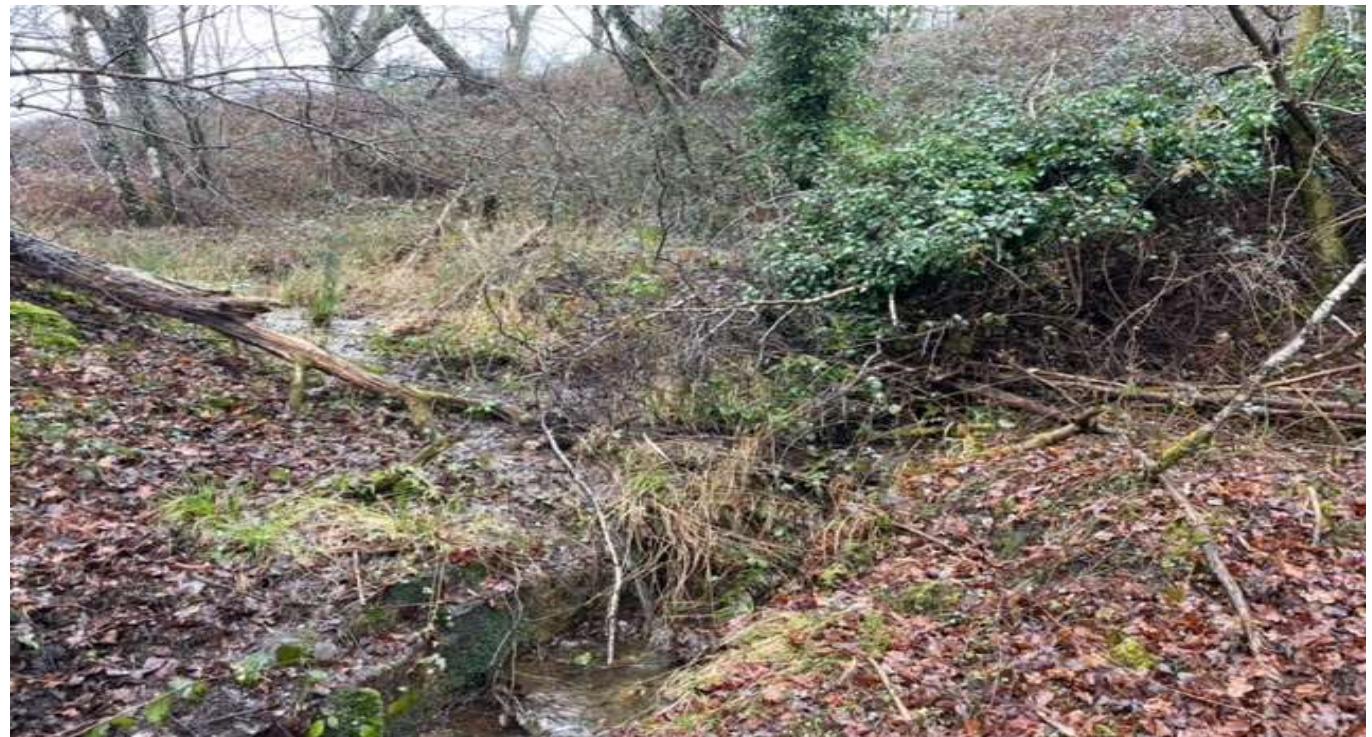
Photo No.	4	Comment	Seepages conveying from the north-eastern section of the plateau, towards the incised channel which skirts the eastern boundary.
------------------	---	----------------	--

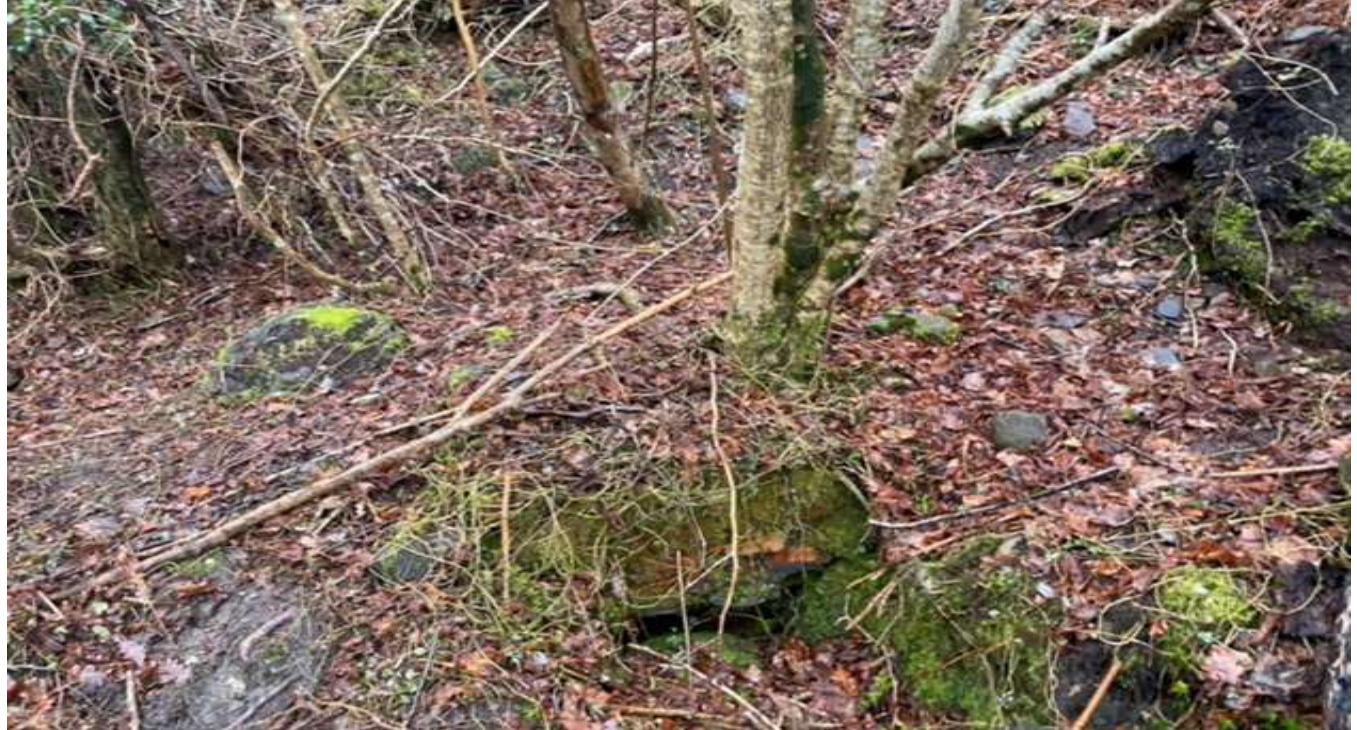
Photo No.	5	Comment	Seepage/flows emanating from an unknown brick structure, located directly adjacent to the incised channel which skirts the eastern perimeter.

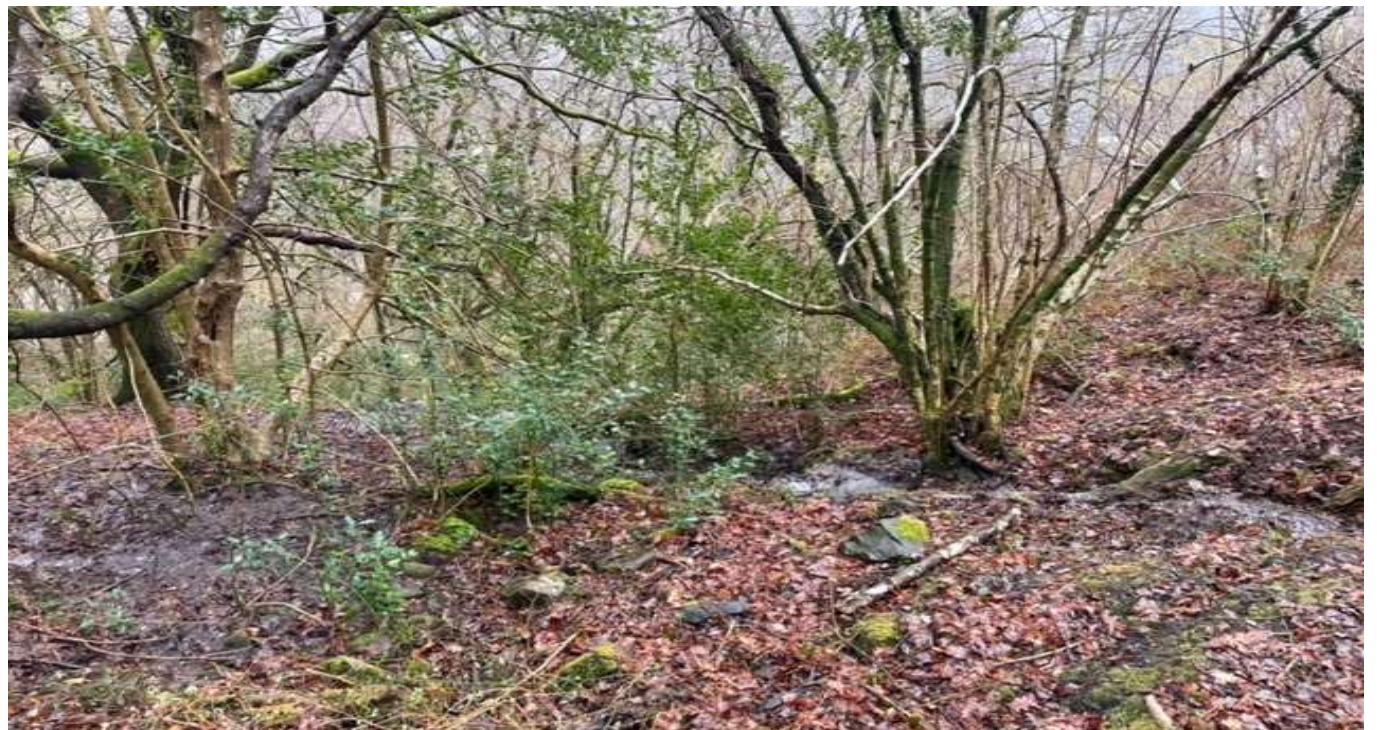
Photo No.	6	Comment	Strong flows associated with the unnamed issue/watercourse, conveying along the eastern boundary. Seepage/flows (LHS) emanating from an unknown brick structure, conveying towards the incised channel.

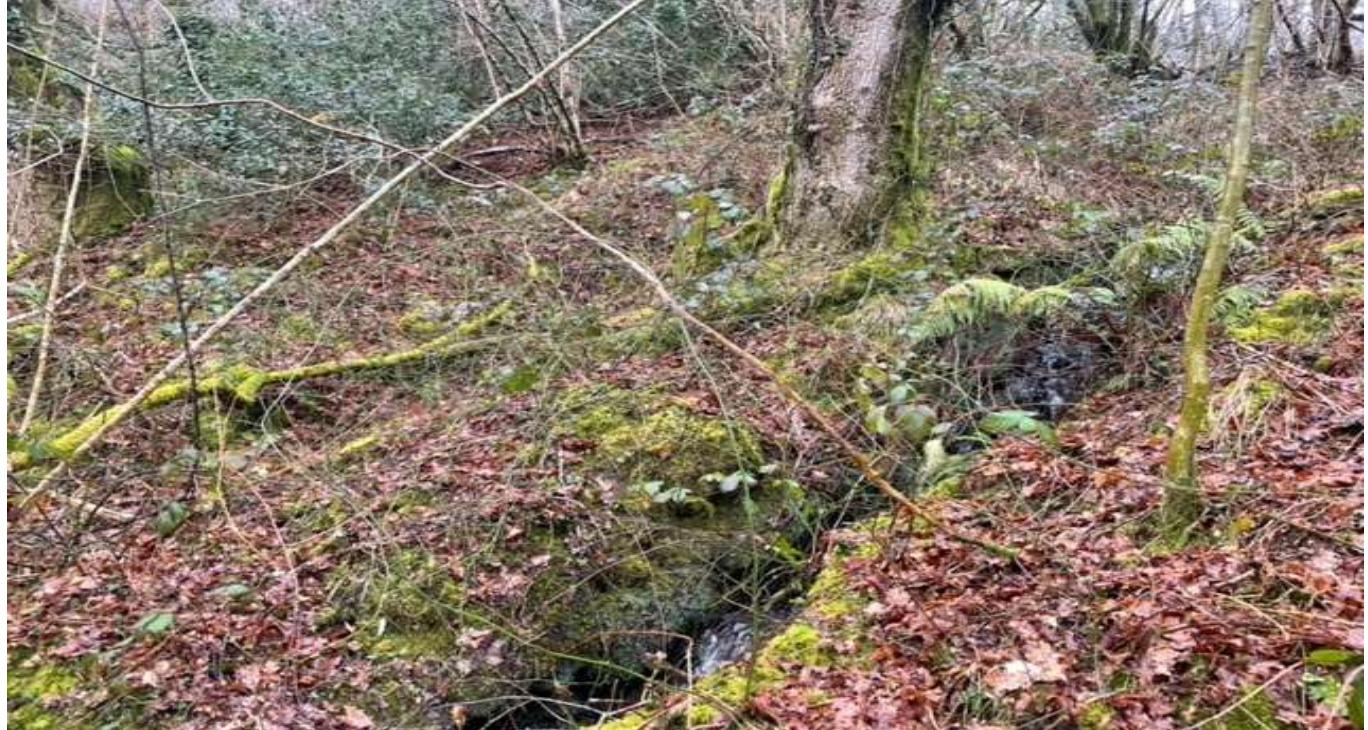
Photo No.	7	Comment	Incised scouring along the eastern boundary, induced by strong flows associated with the unnamed issue/watercourse.

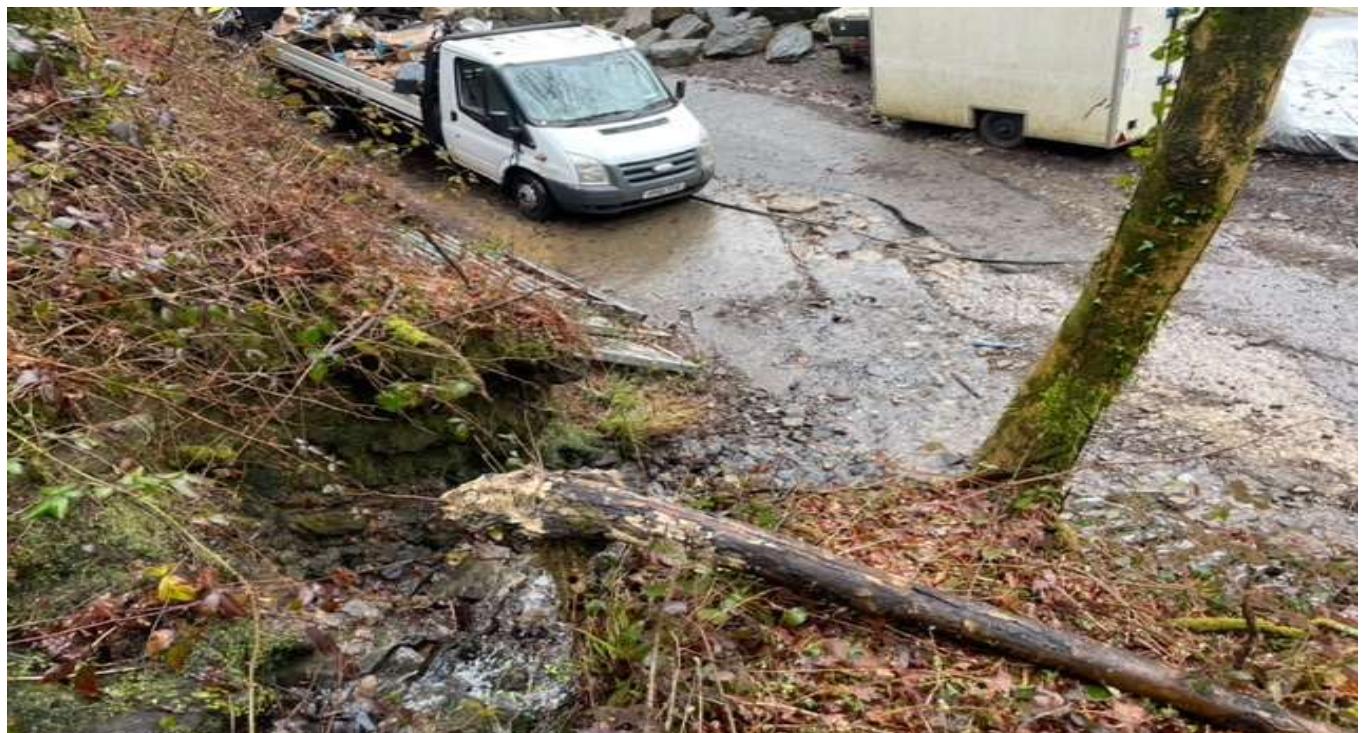
Photo No.	8	Comment	Incised scouring along the eastern boundary, where the flows associated with the unnamed issue/watercourse cascade onto the access track.

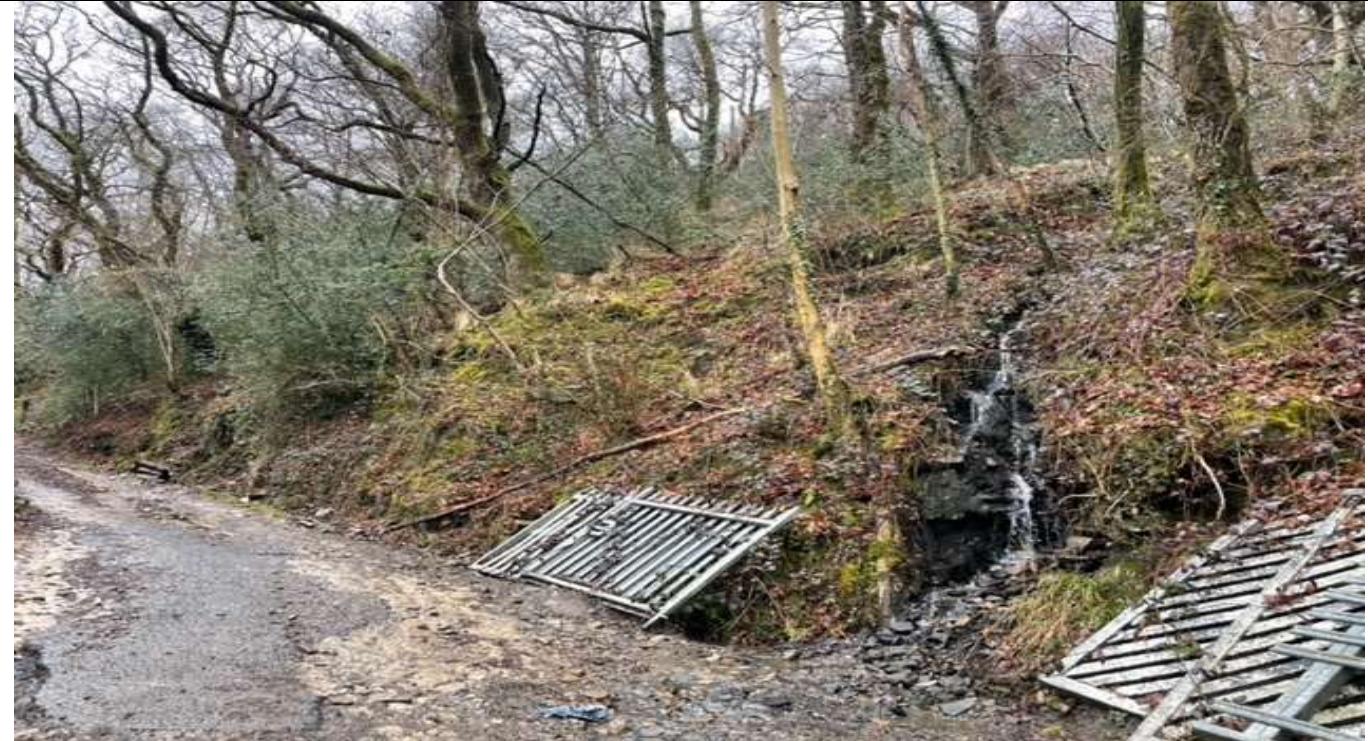
Photo No.	9	Comment	View looking north-west across the densely vegetated tip flank. Scoured, undercut section of the toe, where the unnamed issue/watercourse cascades onto the access track. Associated scouring of the adjacent access track, induced by the downslope migration of uncontrolled flows.

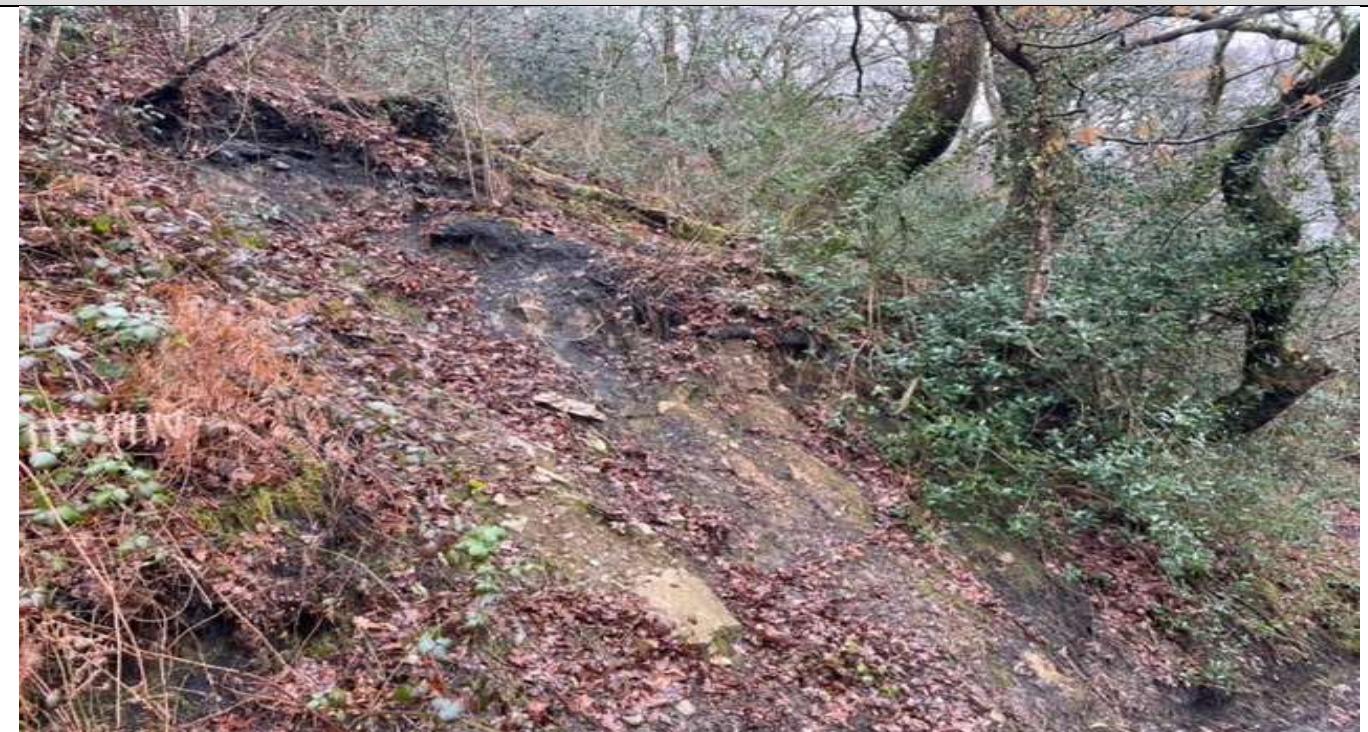
Photo No.	10	Comment	View looking across a minor, shallow surface slip situated along the toe, adjacent to the access track. Natural ground material has been exposed along the slip surface, with a thin veneer of overlying spoil material evident.
