Coal Tip Name	Godre'r-Graig Higher / Pentwyn No. 3 Levels	Tip Ref Number	L044C	
		Ownership Status	Unknown	
Located In	Godre'r-Graig Higher, Neath-Port Talbot	Tip Category	D	
Inspection Led By		Date of Inspection	05/07/2023	Date of last Inspection
Weather	Overcast, intervals of rain	Wet	Calm	
General Remarks (e.g. access, limitations)	Access to the site was gained via an access track situated just off Graig Road, which leads to Pentwyn Farm. It should be noted that this inspection was conducted without the benefit of a detailed site plan. In certain areas, dense vegetation significantly limited accessibility and visual inspection. Therefore, instability within these areas could exist, but was not detectable at the time of the inspection. The location of the tip on privately owned land also limited the coverage of this inspection.			
Features Causing Concern		Description

Coal Tip Name	Godre'r-Graig Higher / Pentwyn No. 3 Levels	Tip Ref Number	L044C
		Tip Category	D
Date of Inspection	05/07/2023	Inspection led by

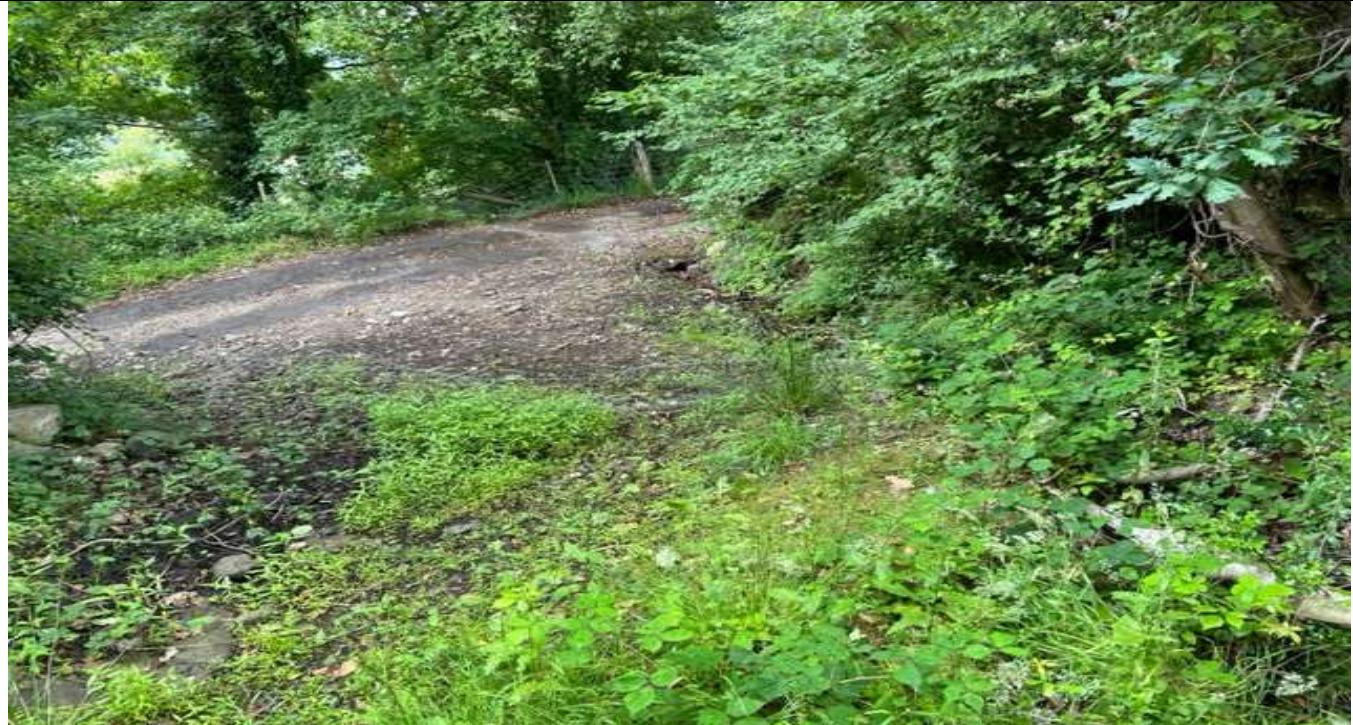
Photo No.	1	Comment	Vegetation and silt debris partially obstructing the shallow, unlined cut-off channel which runs parallel to the access track, located to the rear of the tip. Channel ineffectively capturing some flows, surface runoff migrating downslope, resulting in scouring of the access track. Some flows being conveyed towards the associated narrow diameter, cast iron culvert inlet as intended.

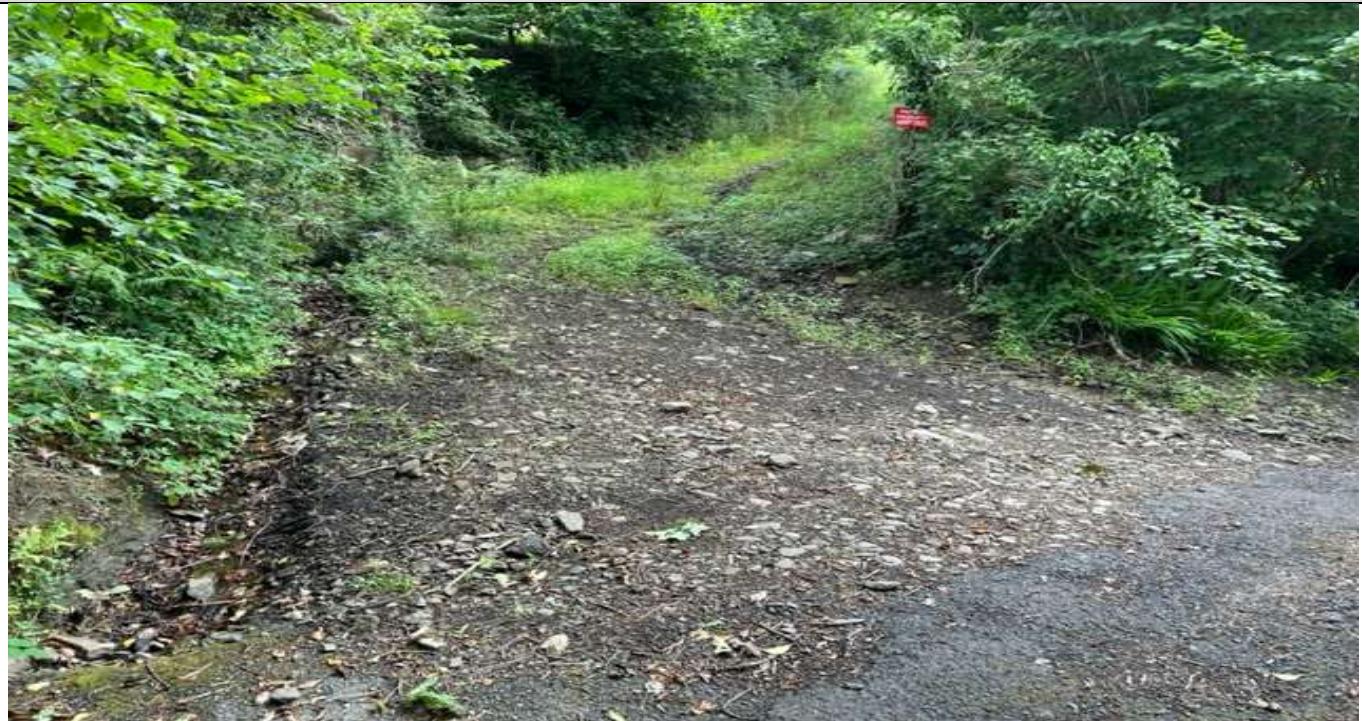
Photo No.	2	Comment	Vegetation and silt debris partially obstructing the shallow, unlined cut-off channel. Channel ineffectively capturing some flows, surface runoff migrating downslope, resulting in scouring of the access track. Private property signage present.

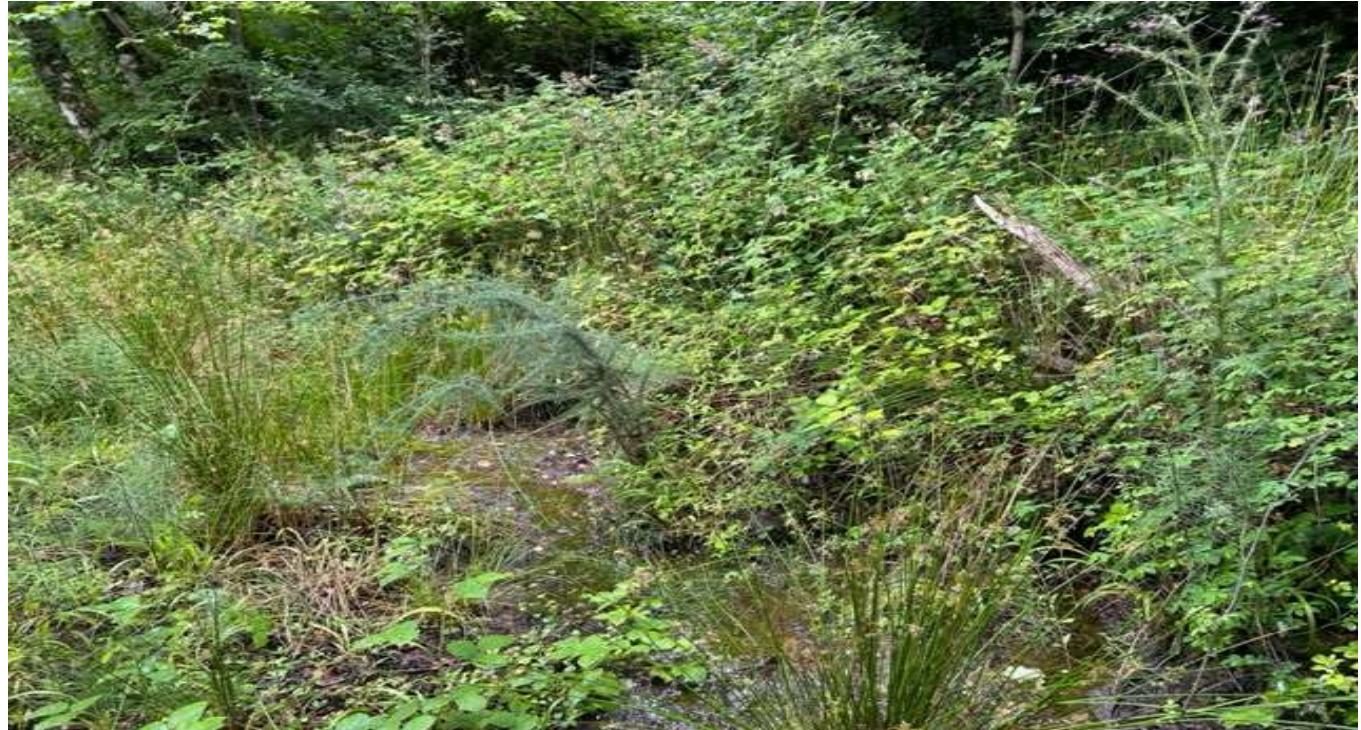
Photo No.	3	Comment	Multiple seepages situated on the north-eastern section of the tip plateau, associated saturated ground conditions.

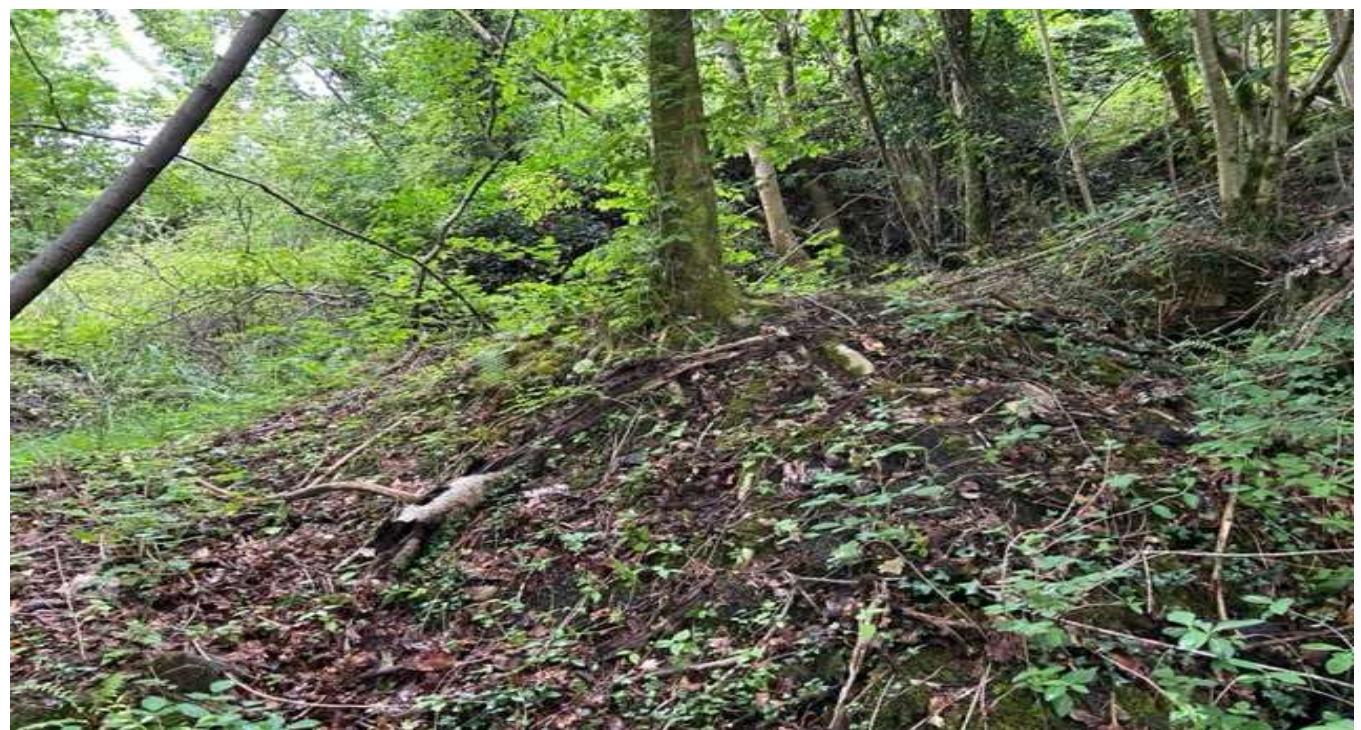
Photo No.	4	Comment	Seepage/flows emanating from an unknown brick structure, located directly adjacent to the incised watercourse which skirts the eastern perimeter.

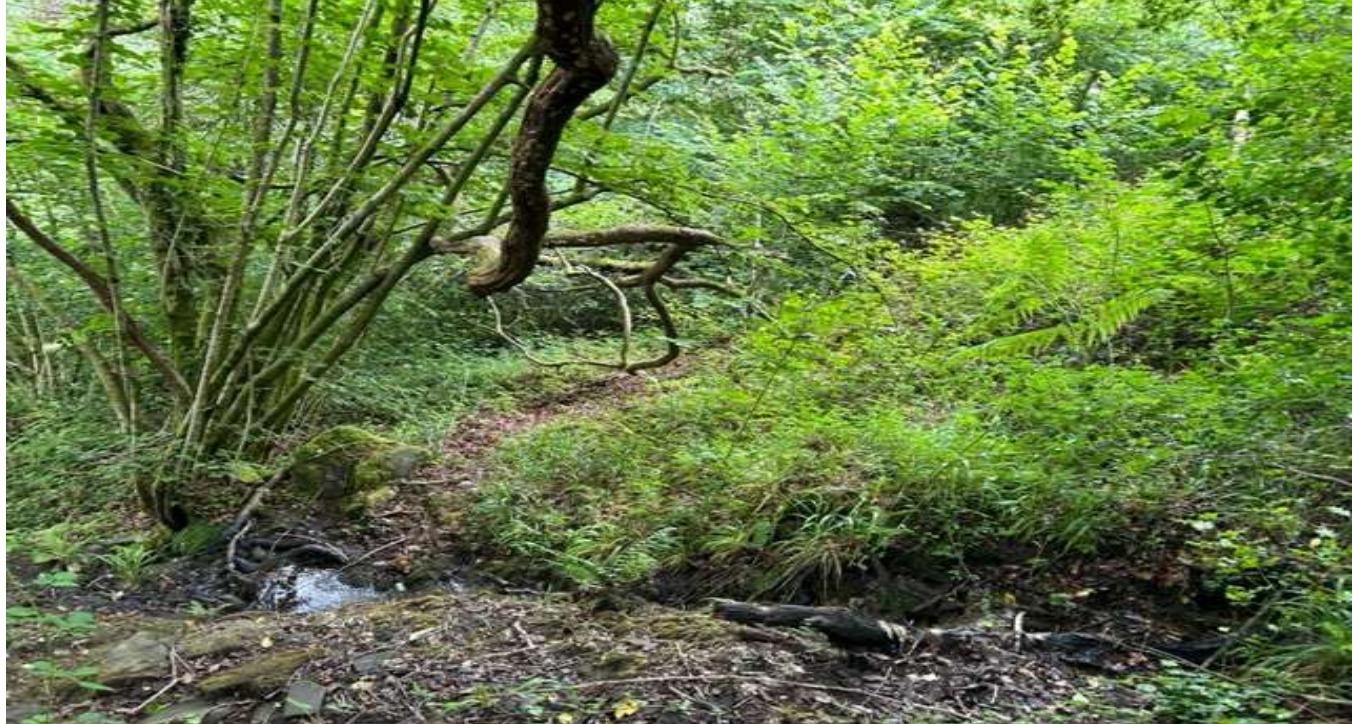
Photo No.	5	Comment	Incised scouring along the eastern boundary, induced by strong flows associated with the unnamed issue/watercourse.

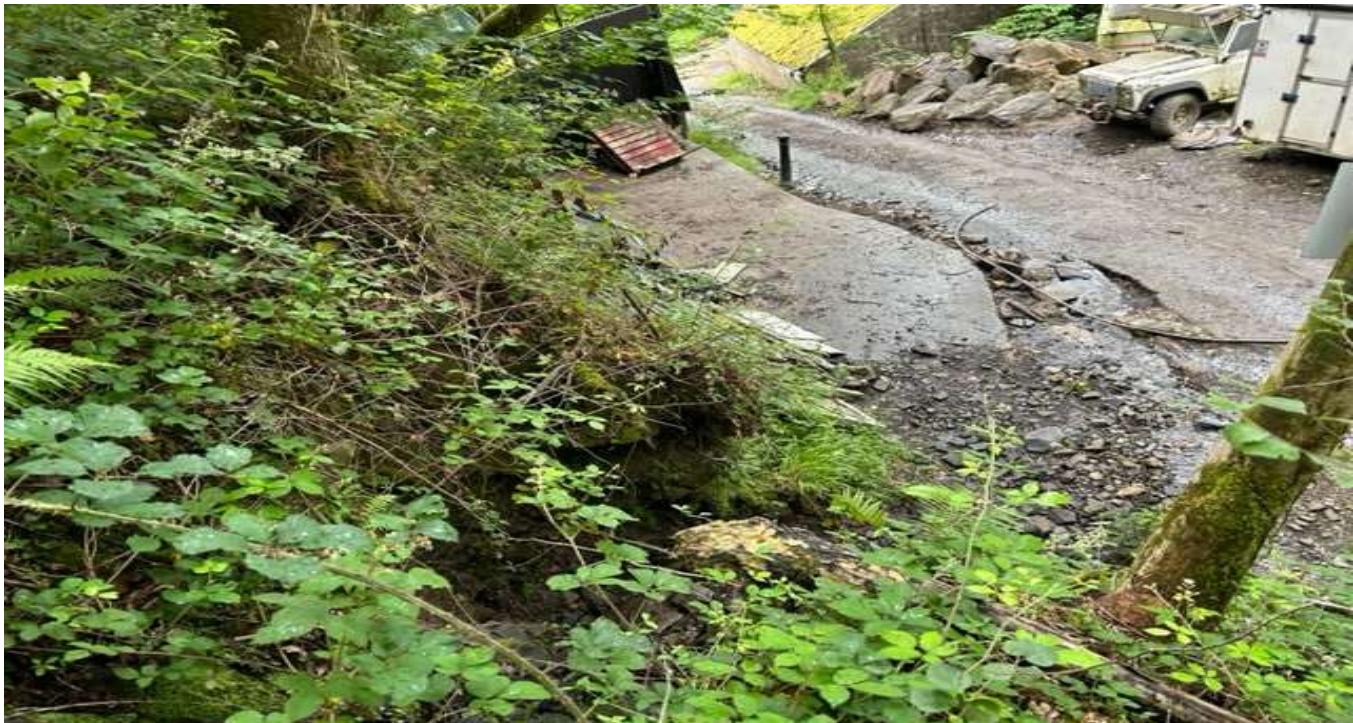
Photo No.	6	Comment	Incised scouring along the eastern boundary, where the flows associated with the unnamed issue/watercourse cascade onto the access track.

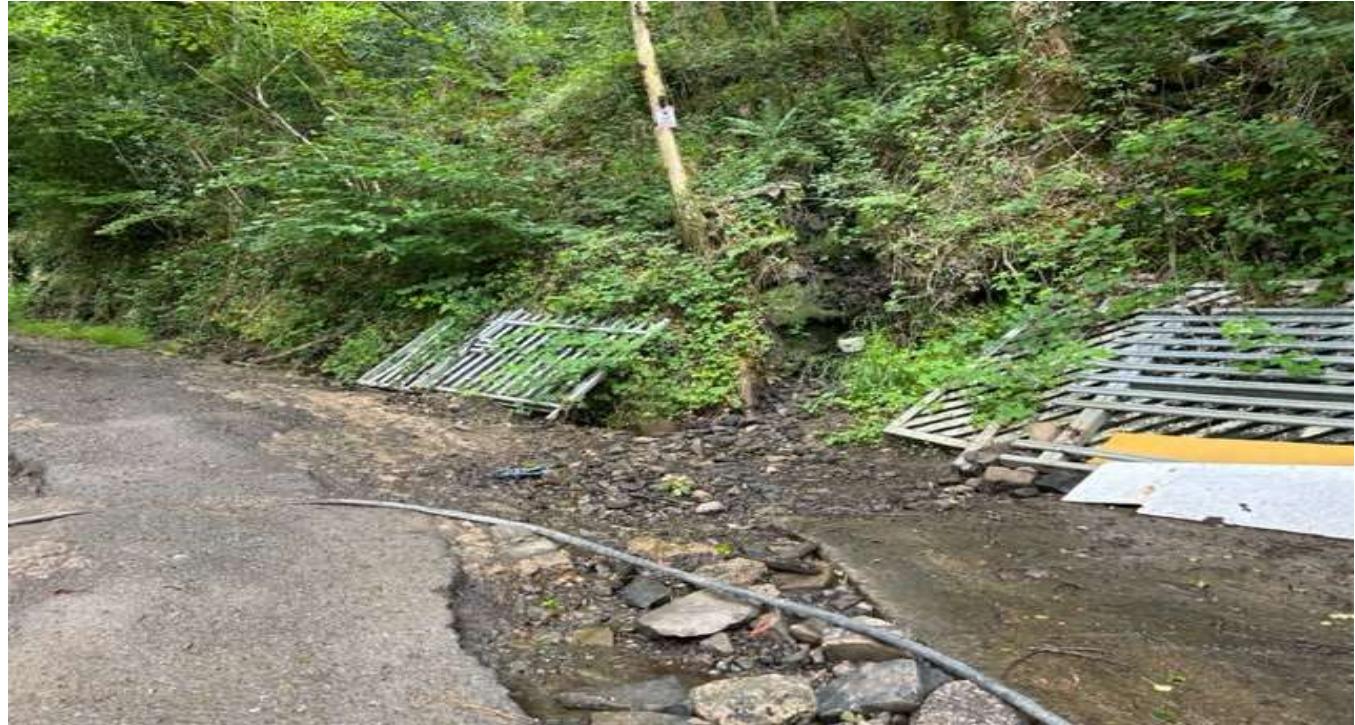
Photo No.	7	Comment	View looking north-west across the densely vegetated tip flank. Scoured, undercut section of the toe, where the unnamed issue/watercourse cascades onto the access track. Associated scouring of the adjacent access track, induced by the downslope migration of uncontrolled flows.

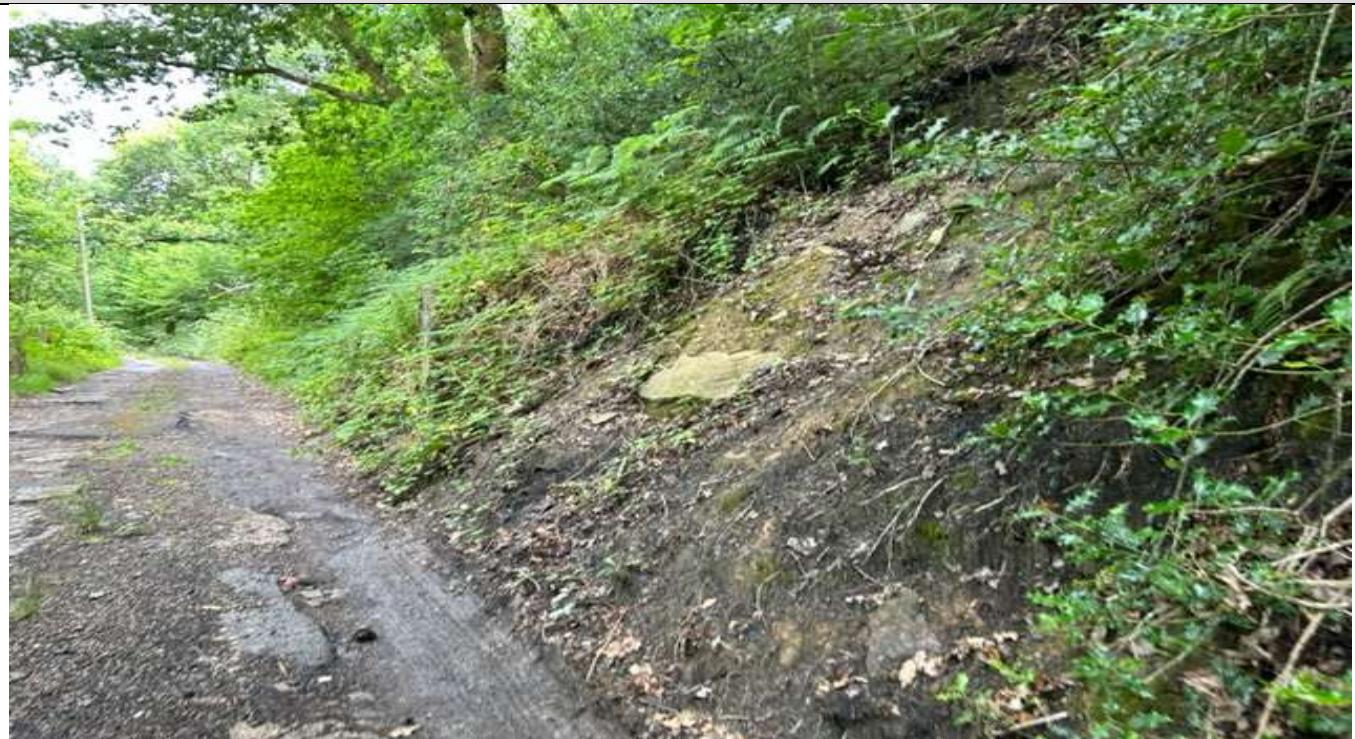
Photo No.	8	Comment	View looking across a minor, shallow surface slip situated along the toe, adjacent to the access track. Natural ground material has been exposed along the slip surface, with a thin veneer of overlying spoil material evident.
