Coal Tip Name	Godre'r-Graig Higher / Pentwyn No. 3 Levels	Tip Ref Number	L044C
		Ownership Status	Private
Located in	Godre'r-Graig, Neath-Port Talbot	Tip Category	D
Led by		Undertaken on behalf of	Welsh Government
Date	08/11/2023	Date of last Detailed Inspection	05/07/2023
Weather	Overcast	Damp	Calm
Comments on access and any limitations	Access to the site was gained via an access track situated just off Graig Road, which leads to Pentwyn Farm. It should be noted that this inspection was conducted without the benefit of a detailed site plan. Dense vegetation and the steep, slippery nature of the flank limited accessibility and visual inspection. Therefore, instability within these areas could exist, but was not detectable at the time of the inspection.		
RAG Status: Capital & Maintenance Works	<div style="display: flex; justify-content: space-between;"> <div style="flex: 1;"> <p>Description</p> <p>Consider clearing the vegetation and silt debris partially obstructing the shallow, unlined cut-off channel which runs parallel to the access track, located to the rear of the tip.</p> <p>Consider implementing appropriate drainage infrastructure to effectively capture the series of seepag

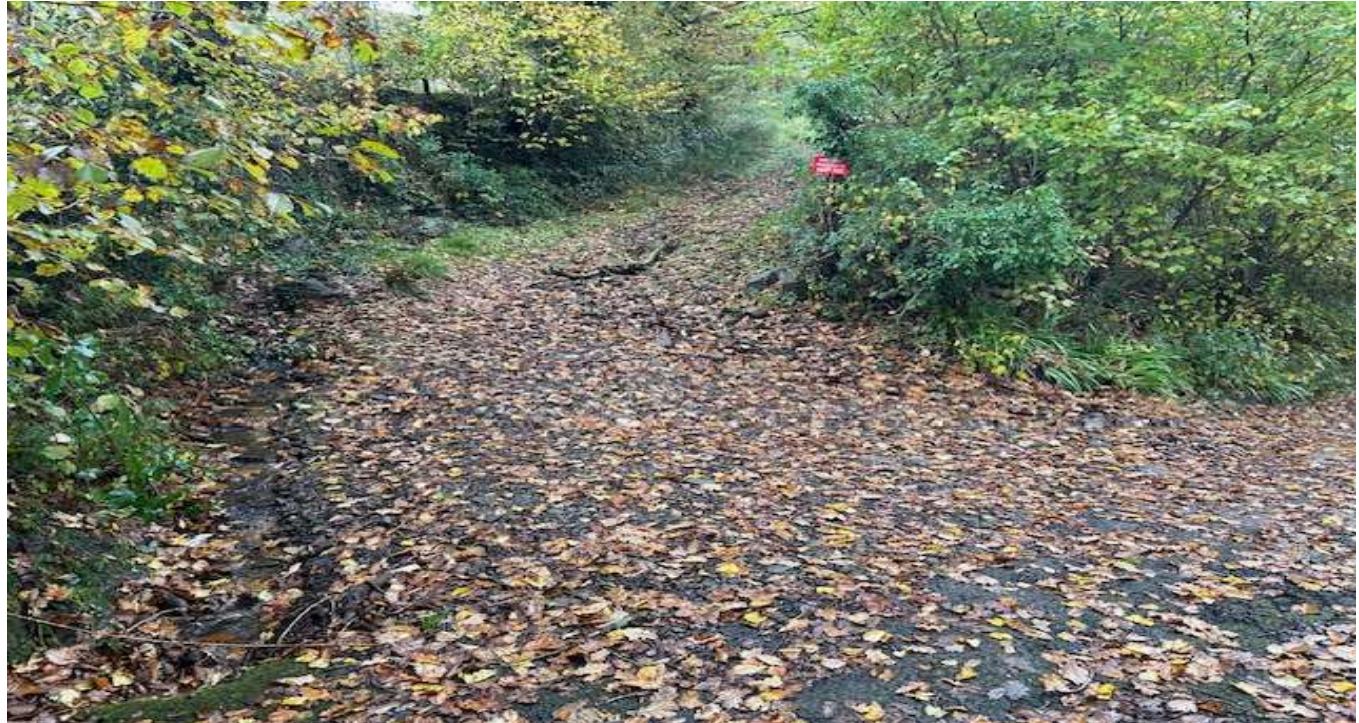
Photo No.	1	Comment	Vegetation and silt debris partially obstructing the shallow, unlined cut-off channel which runs parallel to the access track, located to the rear of the tip. Channel ineffectively capturing some flows, surface runoff migrating downslope, resulting in scouring of the access track.
Feature ID	23/D/01

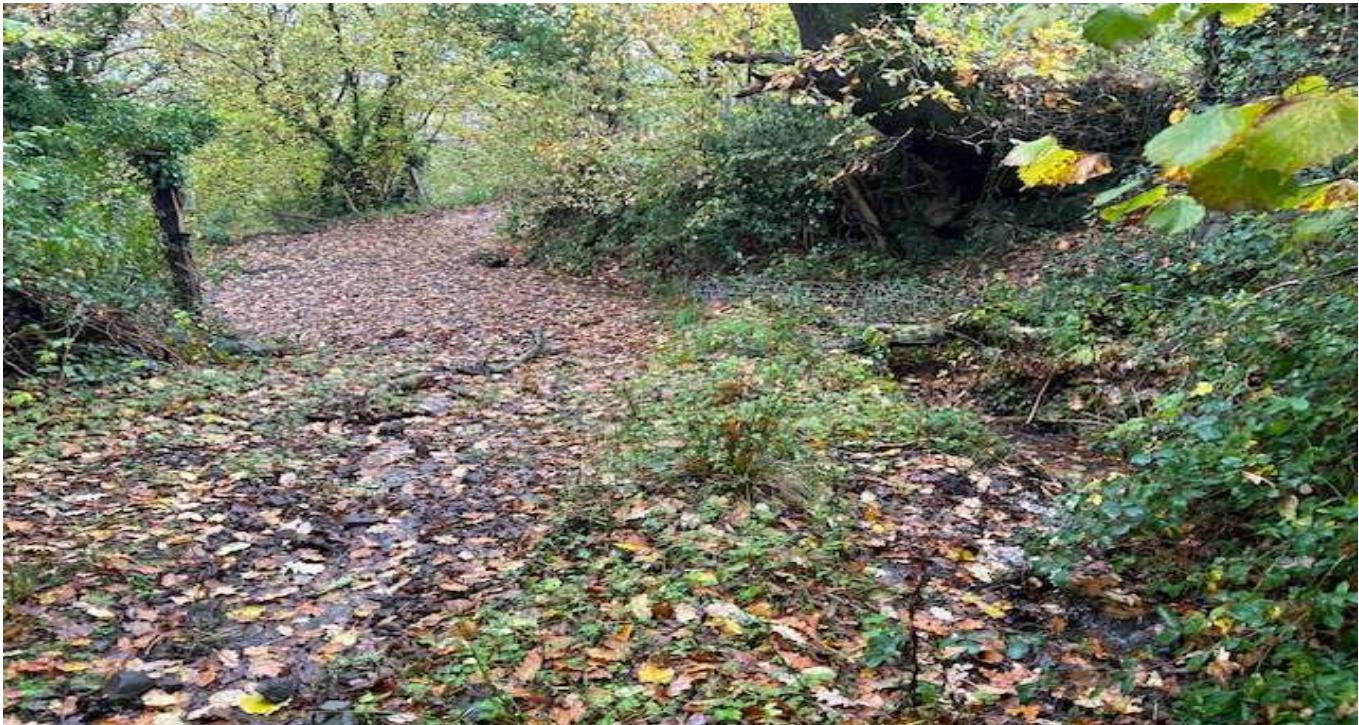
Photo No.	2	Comment	Vegetation and silt debris partially obstructing the shallow, unlined cut-off channel which runs parallel to the access track, located to the rear of the tip. Channel ineffectively capturing some flows, surface runoff migrating downslope, resulting in scouring of the access track.
Feature ID	23/D/01

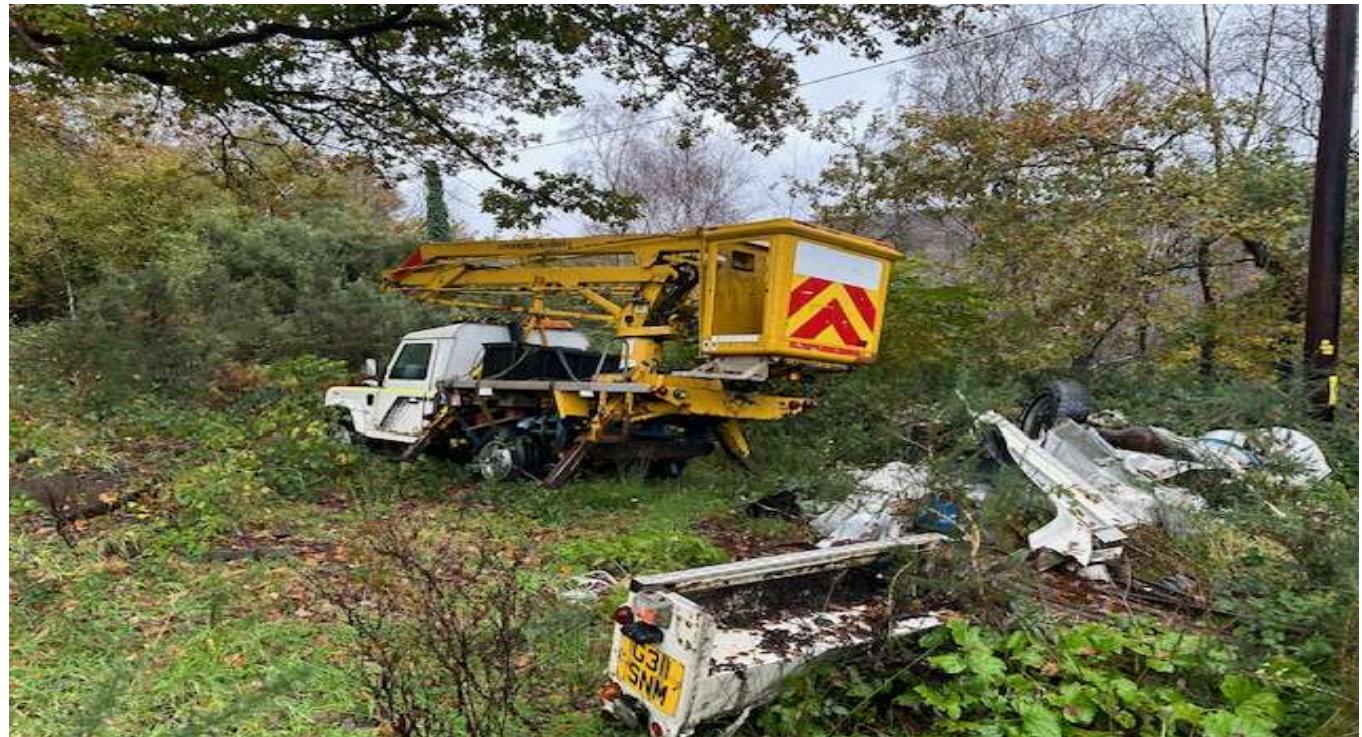
Photo No.	3	Comment	Vehicle and machinery situated on the north-eastern section of the tip plateau.
Feature ID	23/L/02

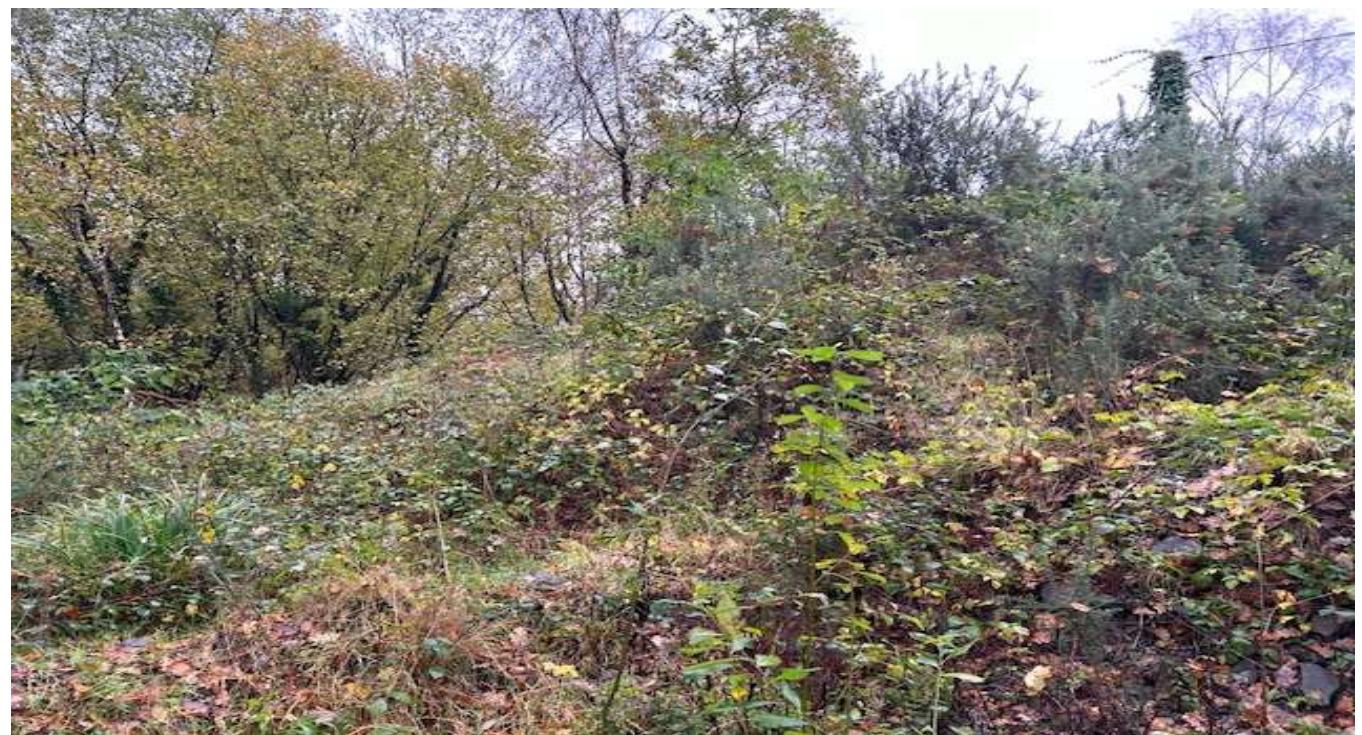
Photo No.	4	Comment	Sandstone quarry waste material, likely sourced from the nearby Cwar Pentwyn quarry deposited on the north-eastern section of the tip plateau.
Feature ID	23/L/02

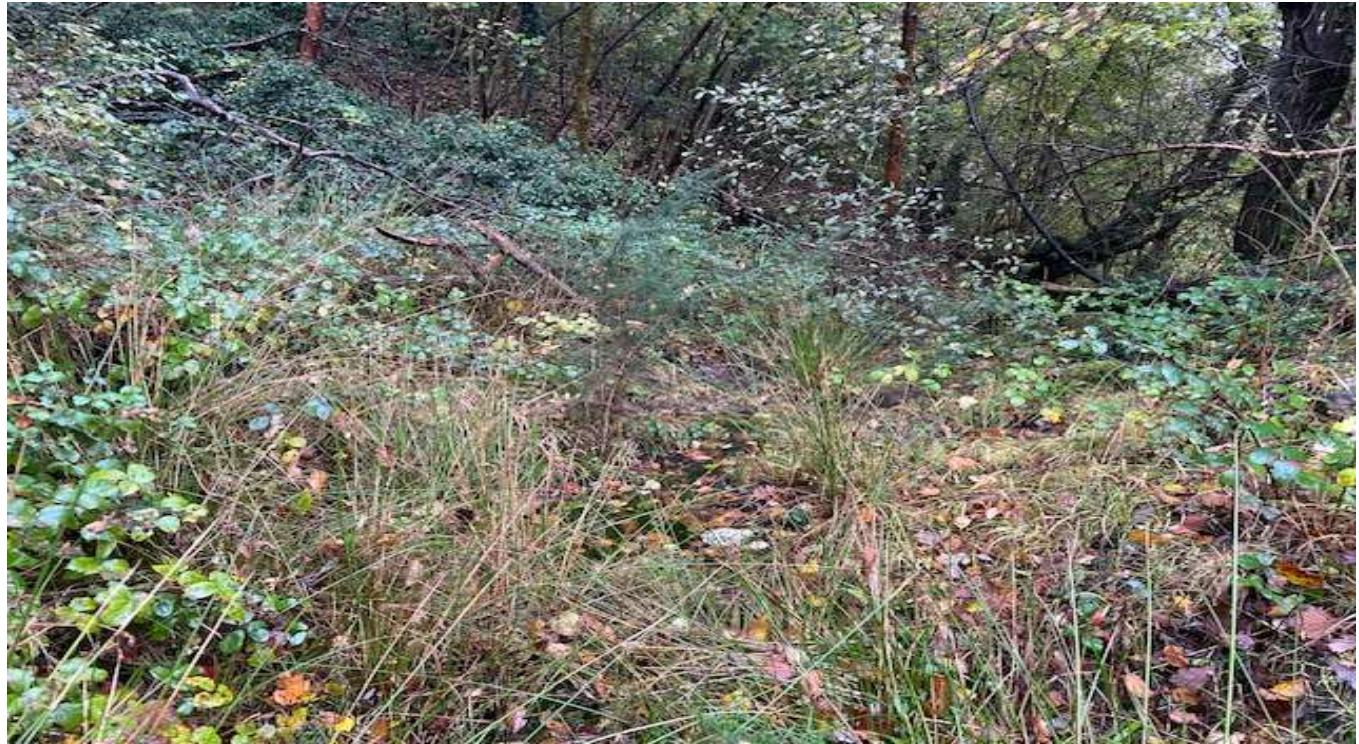
Photo No.	5	Comment	Multiple seepages situated on the north-eastern section of the tip plateau. Associated saturated ground conditions.
Feature ID	23/G/03 23/G/05

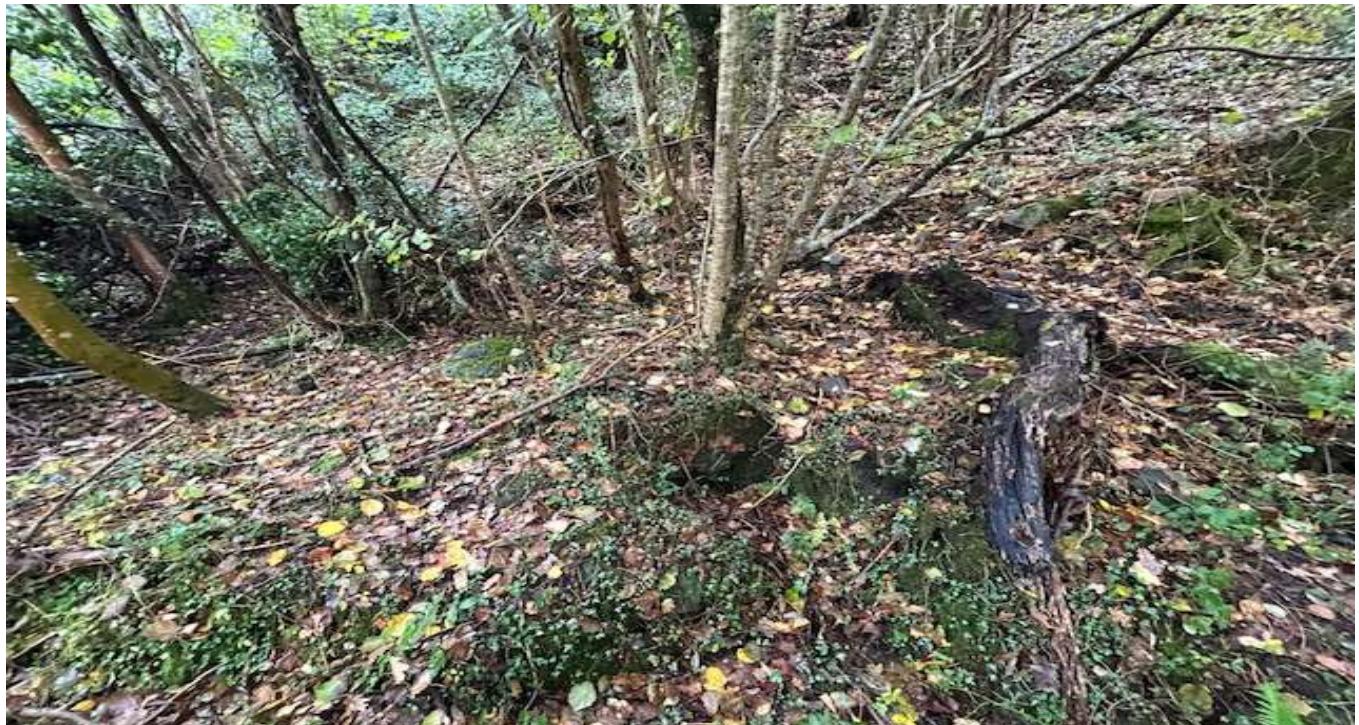
Photo No.	6	Comment	Flows emanating from an unknown brick structure, located directly adjacent to the incised watercourse which skirts the eastern perimeter.
Feature ID	23/G/03

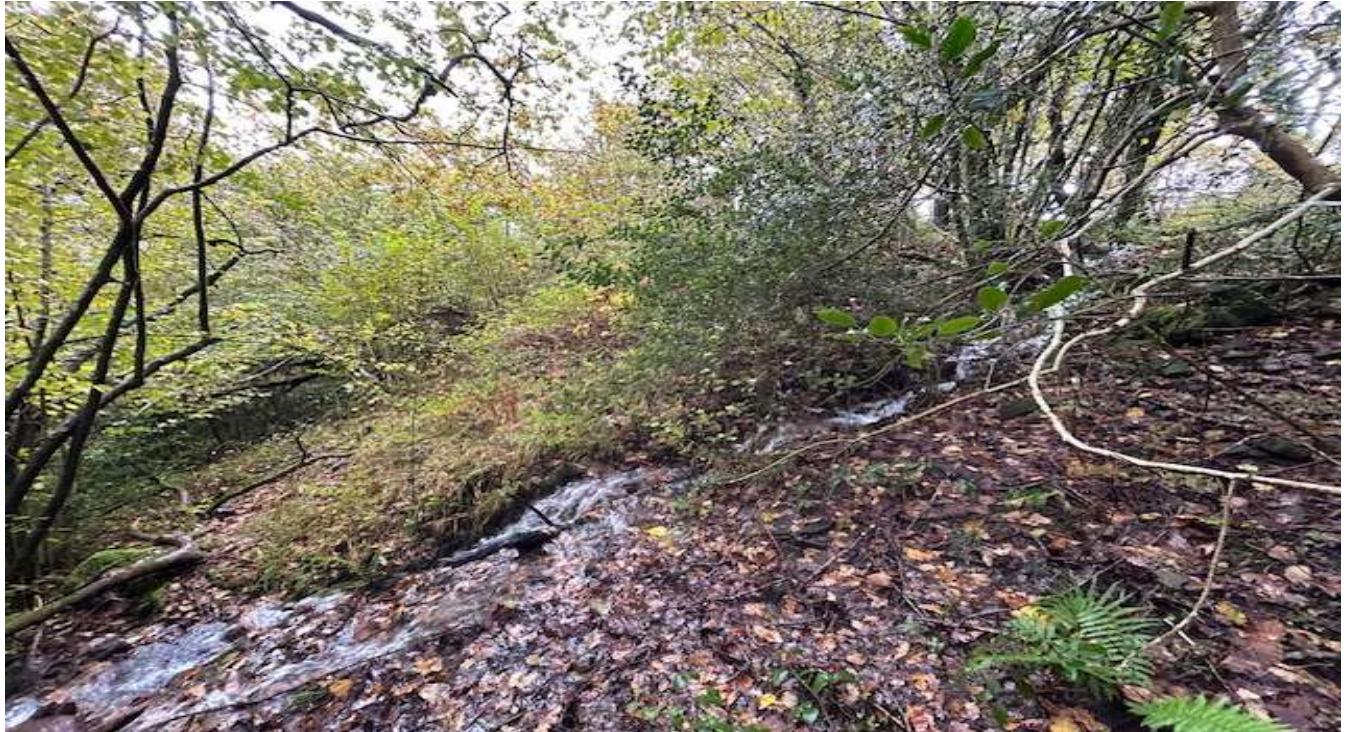
Photo No.	7	Comment	Incised scouring along the eastern boundary, induced by strong flows associated with the unnamed issue/watercourse.
Feature ID	23/G/07

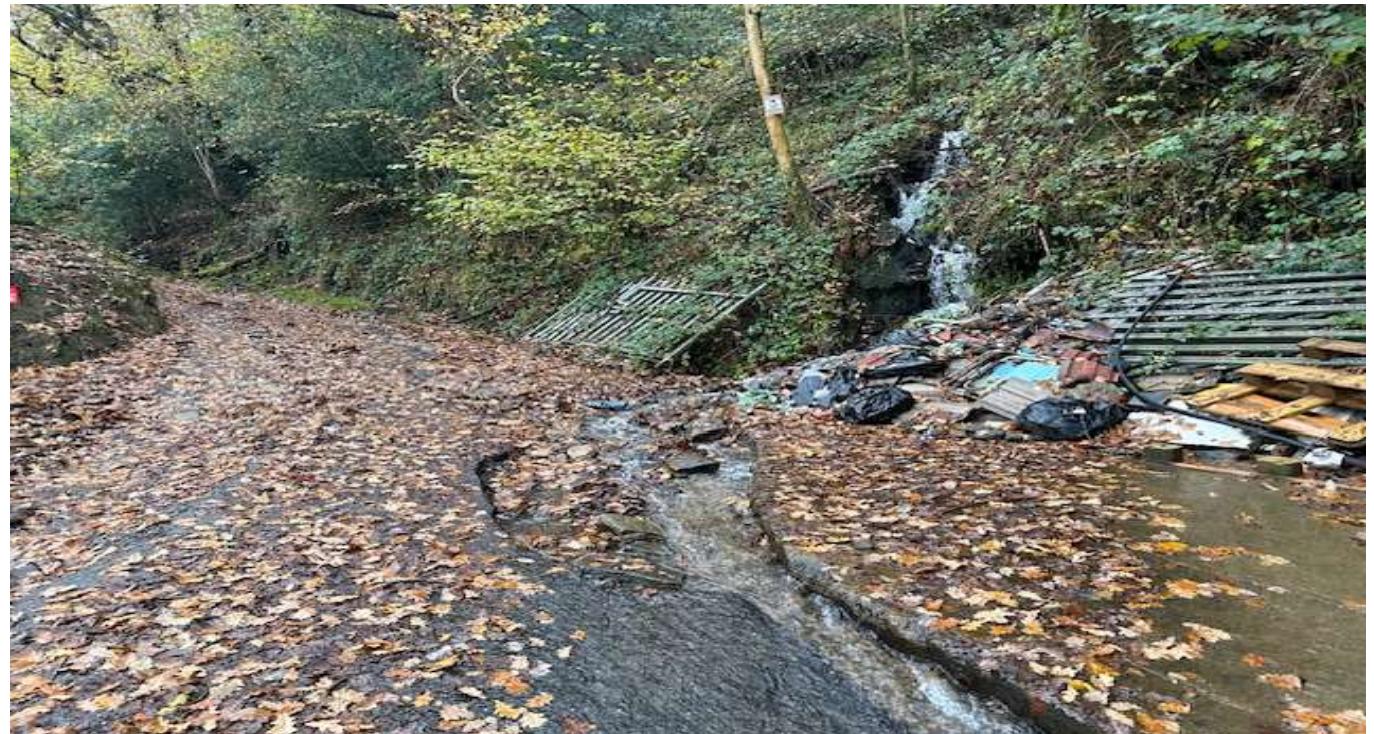
Photo No.	8	Comment	Scoured, undercut section of the toe, where the unnamed issue/watercourse cascades onto the access track. Associated scouring of the adjacent access track, induced by the downslope migration of uncontrolled flows. Fly-tipped material is evident.
Feature ID	23/G/06 23/G/08 23/L/04

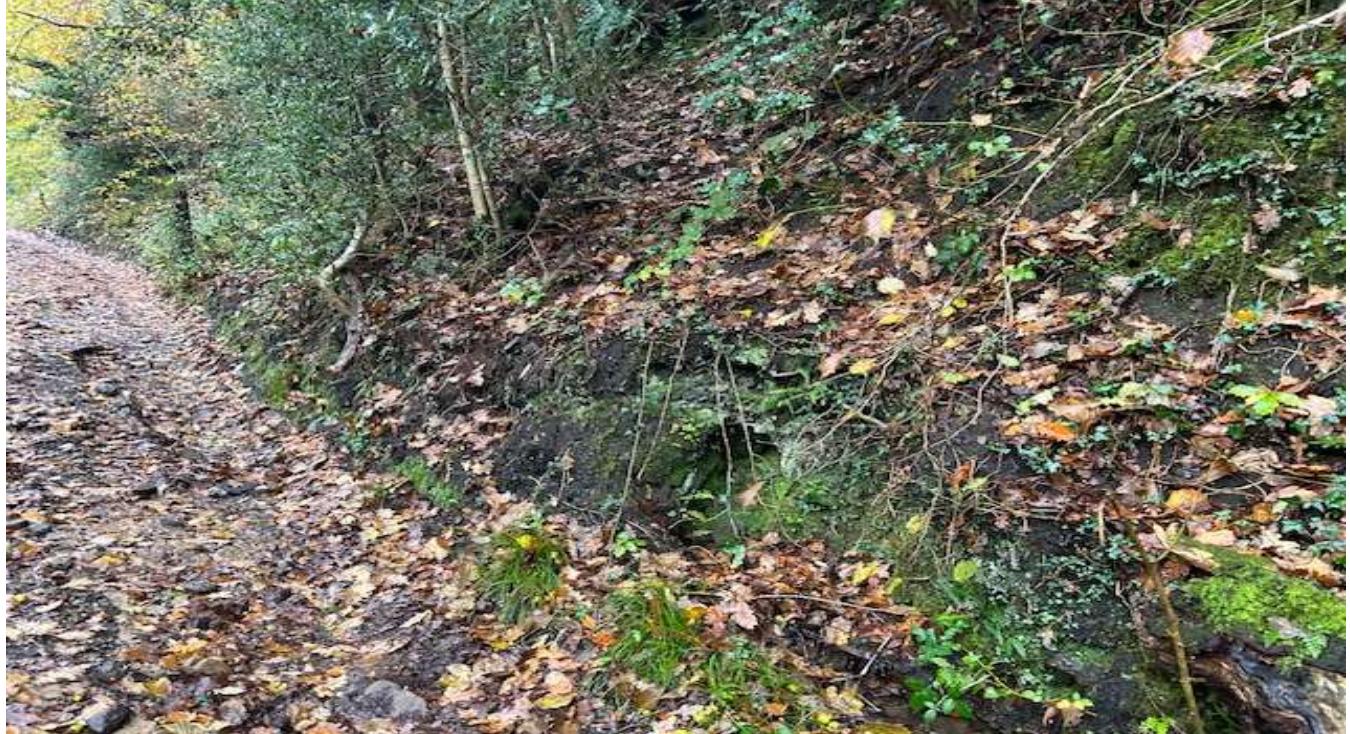
Photo No.	9	Comment	Seepages emanating from the base of the flank/toe, adjacent to the access track.
Feature ID	23/G/04

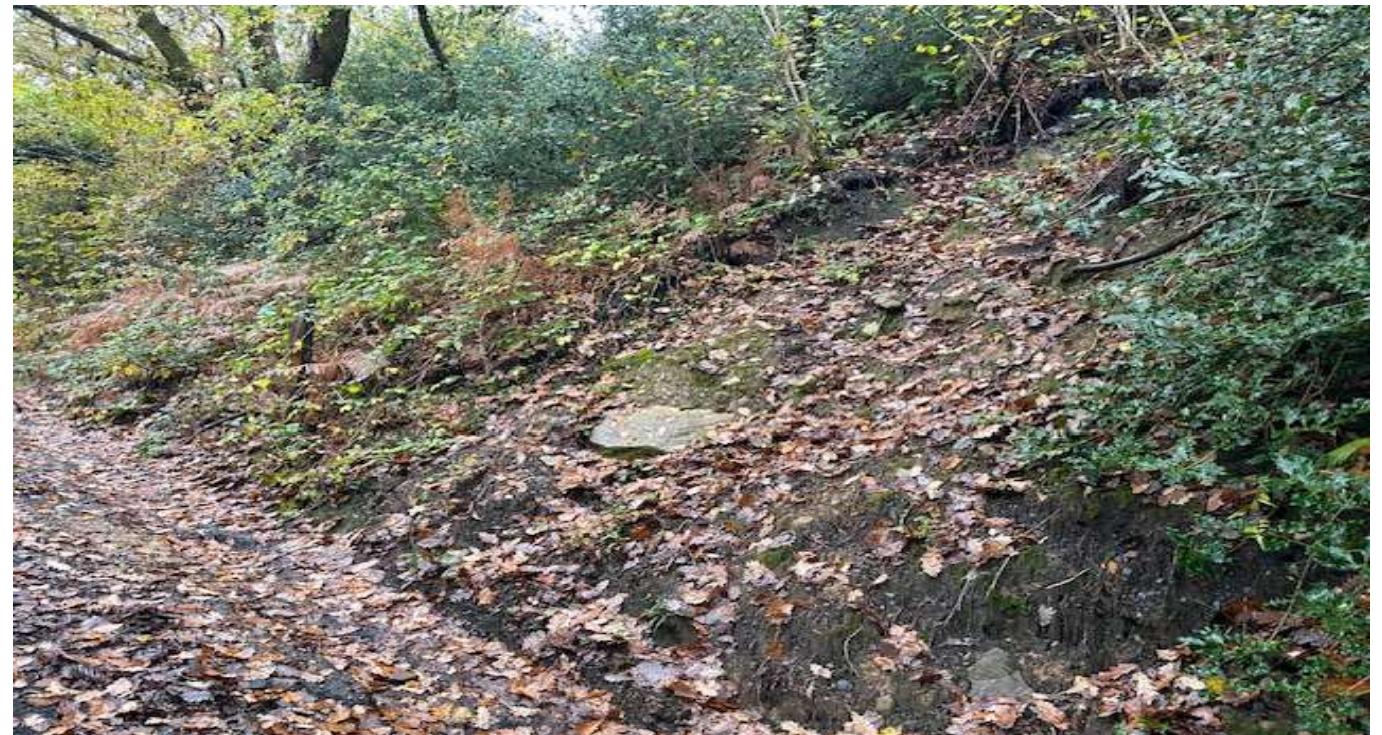
Photo No.	10	Comment	View looking across a minor, shallow surface slip situated along the toe, adjacent to the access track. Natural ground material has been exposed along the slip surface, with a thin veneer of overlying spoil material evident.
Feature ID	23/G/02
