Coal Tip Name	Godre'r Graig higher level and Pentwyn No. 2 and 3 - Tip A		Tip Ref Number	T13187	
Located In	Godre'r Graig, Neath-Port Talbot		Ownership Status	Private	
Inspection Led By		Date of Inspection	09/09/2024	Date of last Inspection	08/11/2023
Weather	Sun		Dry	Calm	
General Remarks (e.g. access, limitations)	<p>Access to the site is gained via Clos Cerrig access track, situated just off Graig Road, which leads to Patagonia Farm.</p> <p>It should be noted that this inspection was conducted without the benefit of a detailed site plan. Dense vegetation significantly limited accessibility and visual inspection; with access on to the tip body no longer possible. Therefore, instability within these areas could exist, but was not detectable at the time of the inspection.</p>				
Features Causing Concern		Description

Coal Tip Name	Godre'r Graig higher level and Pentwyn No. 2 and 3 - Tip A	Tip Ref Number	T13187
		Tip Category	D
Date of Inspection	09/09/2024	Inspection led by

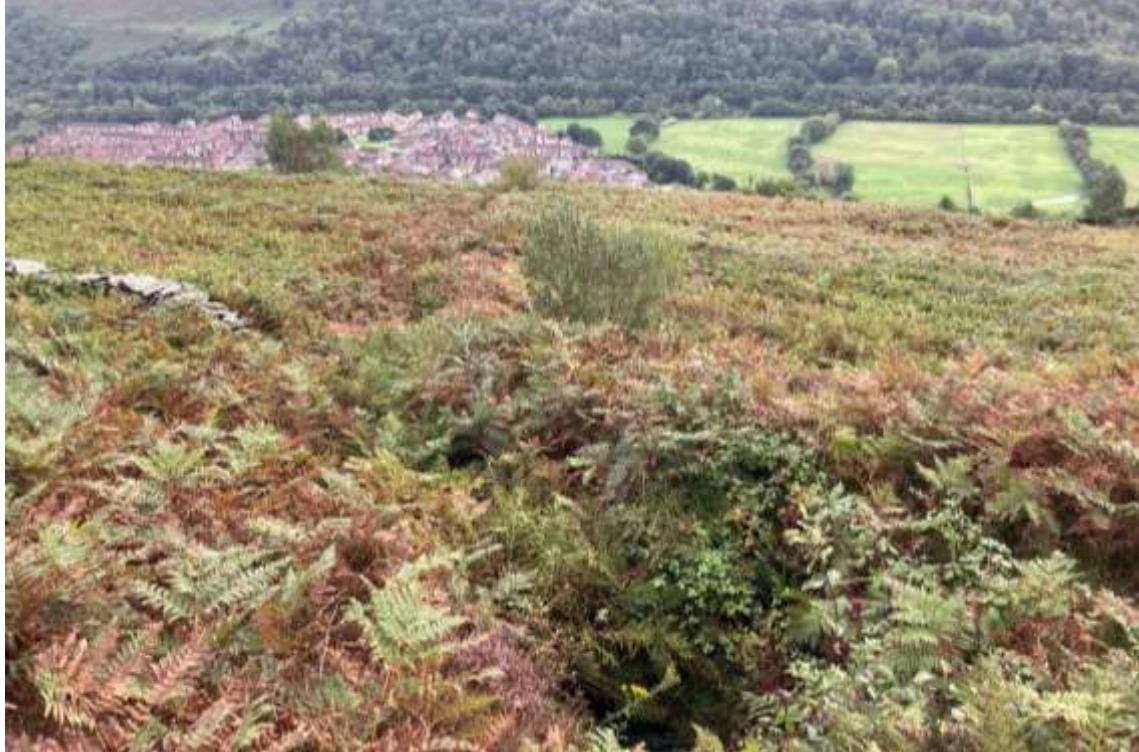
Photo No.	1	Comment	Strong flows associated with T62866 Tip (up-slope) conveying downslope towards the north-eastern section of the site.
------------------	---	----------------	---

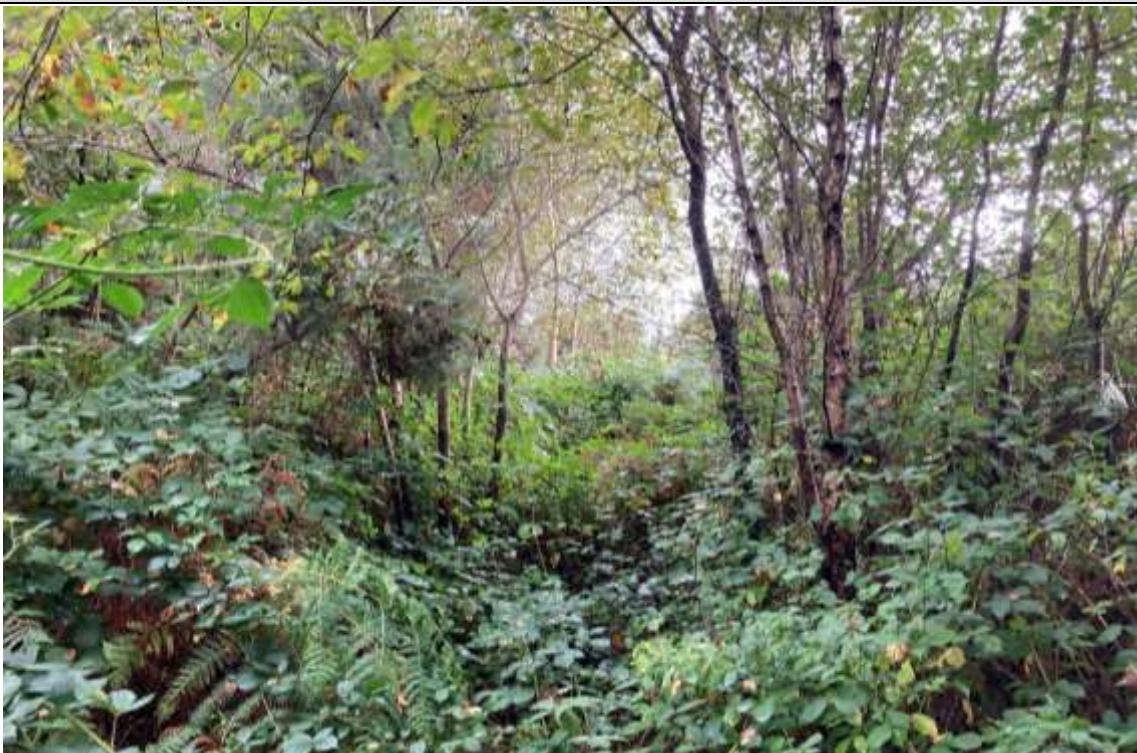
Photo No.	2	Comment	Dense vegetation along the access path, preventing access onto the tip body.
------------------	---	----------------	--

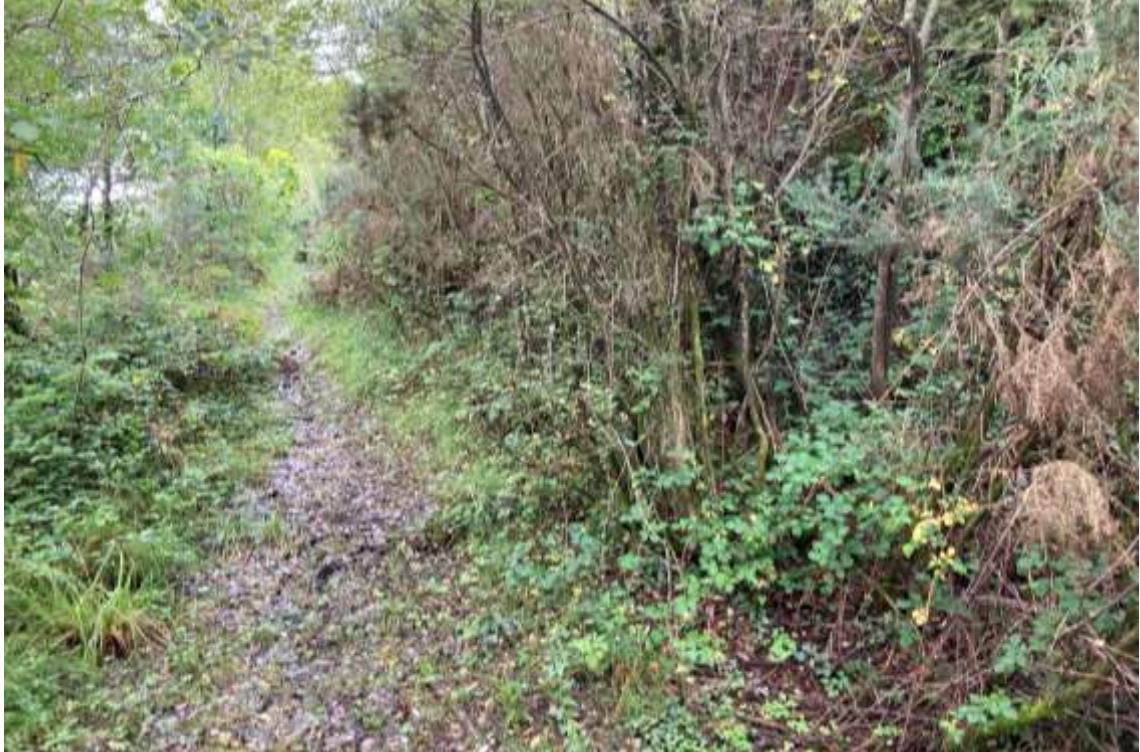
Photo No.	3	Comment	Vegetation partially obstructing the shallow, unlined ditch present along the southern boundary, adjacent to the access track.
------------------	---	----------------	--

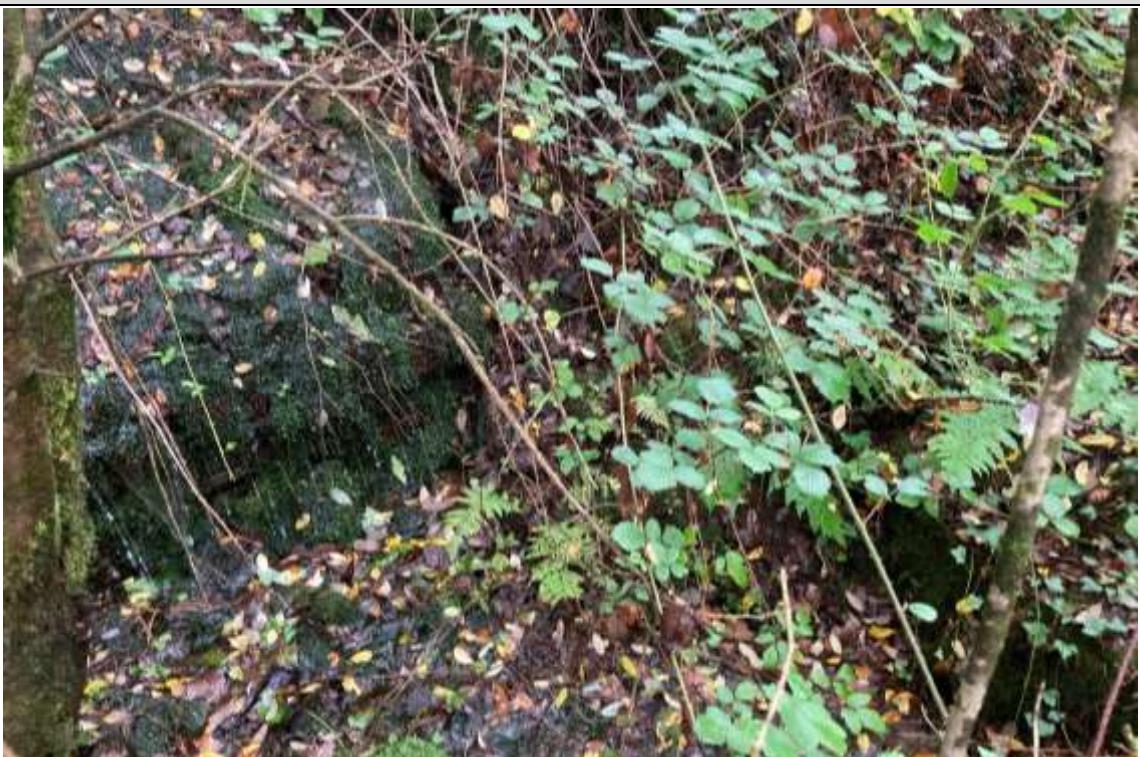
Photo No.	4	Comment	Seepage conveying towards the Armco pipe, situated within the shallow ditch present along sections of the southern boundary, adjacent to the access track.
------------------	---	----------------	--
