| Coal Tip Name | | Cwar Pentwyn Quarry / Cilmaengwyn | | UID | | T11695 | | | | |
| Located in | | Godre'r Graig, Neath-Port Talbot | | Tip Category | | | | | | |
| Inspection Led by | | | Date of Inspection | | 12/02/2025 | | Date of last Inspection | | 09/09/2024 | |

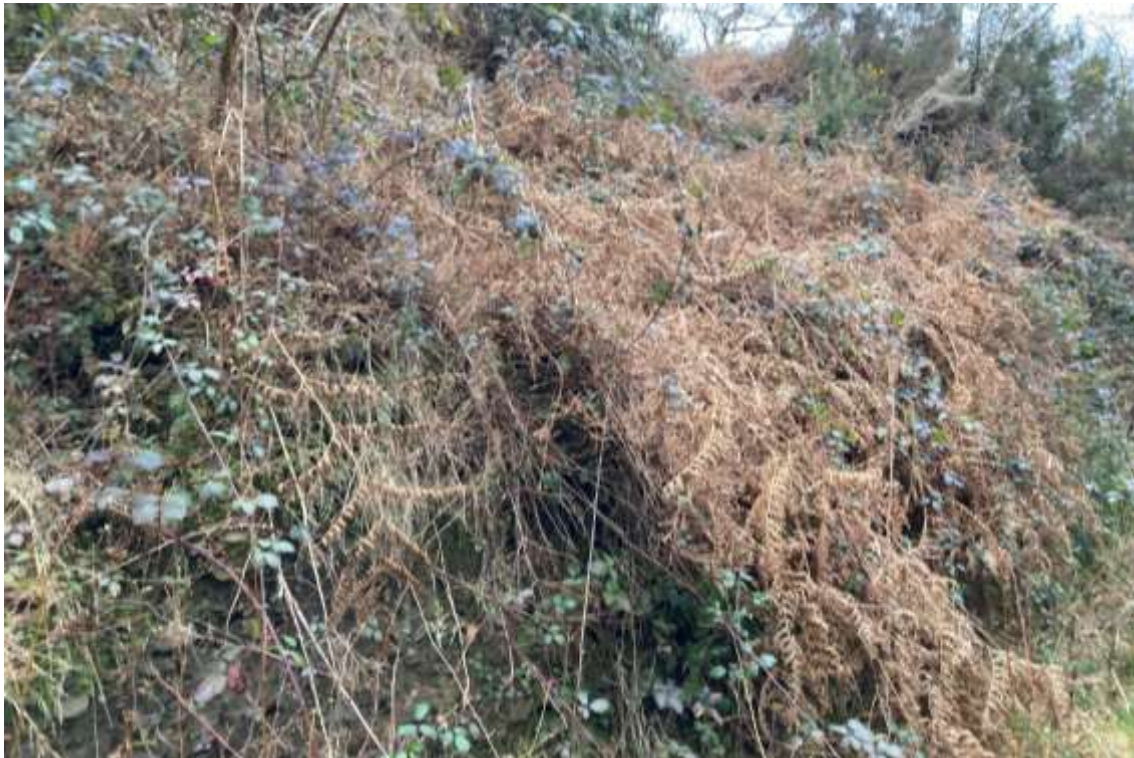
| <b>Photo No.</b> | 1 | <b>Comment</b> | View looking towards a small exposure of sandstones, shales and clays; situated within the densely vegetated western extent of the site. |

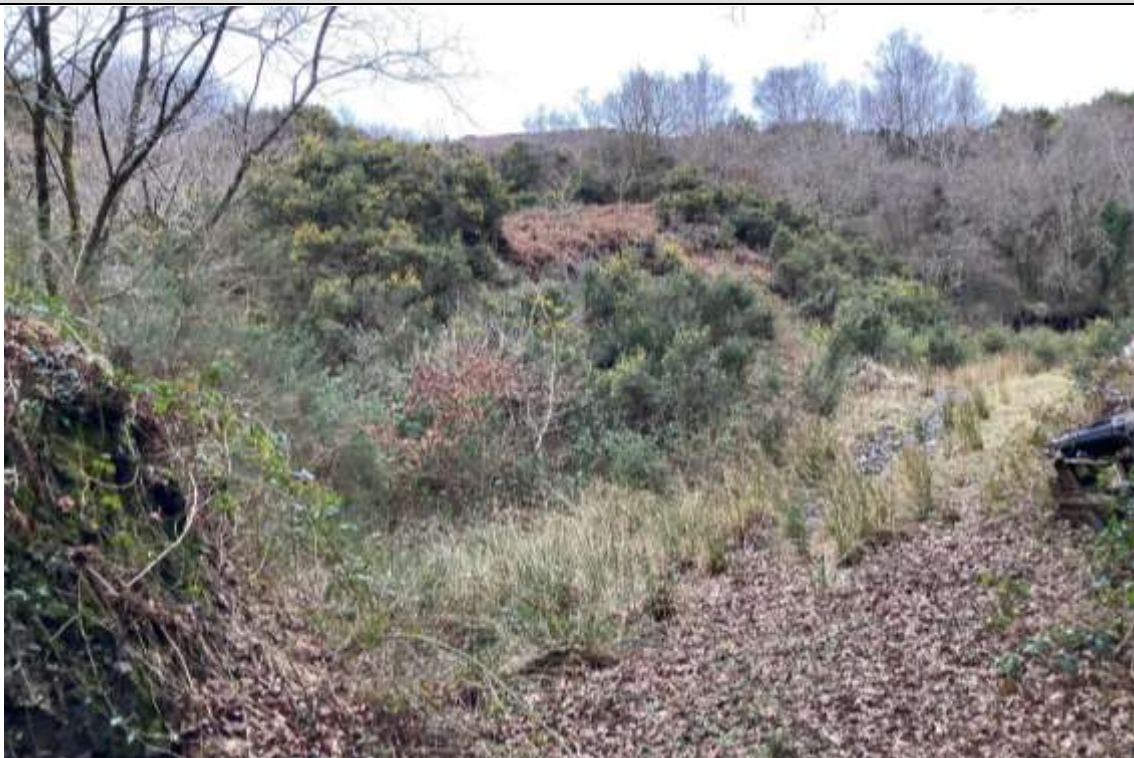
| OBSERVATIONS | | | | |
|---|---|---|---|---|
| 25/G/01 | Ponding | | Issues convey over an excavated face to the North of the site boundary. Flows convey towards the flat-lying ground/quarry floor, adjacent to the northern perimeter of the western section of the site. Resultant minor ponding and associated saturated ground conditions present. | None |

| <b>Photo No.</b> | 2 | <b>Comment</b> | Flows convey towards the flat-lying ground/quarry floor, adjacent to the northern perimeter of the western section of the site. |

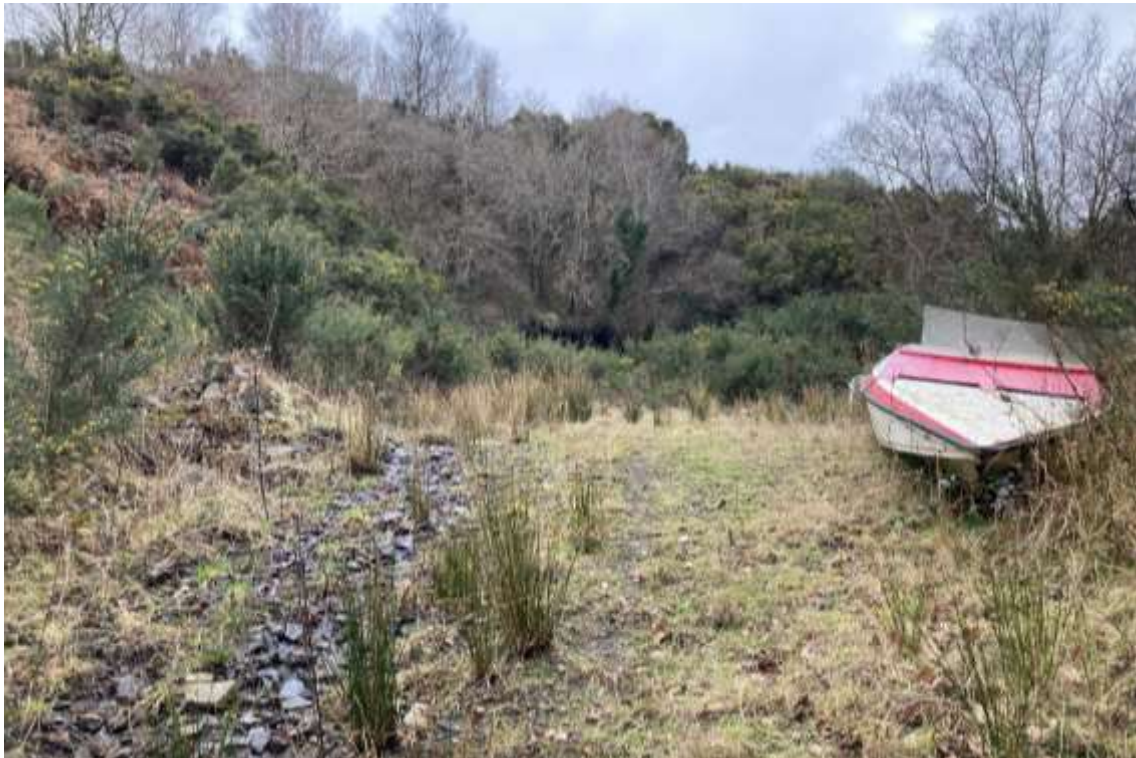
| 25/L/04 | Land Use | | Evidence of human activity within the Quarry floor, with the presence of machinery, chairs, a boat and electricity extension cables leading downslope (previously recorded as extending downslope towards the properties named 'Glander' and 'Darren View'). | None |

| <b>Photo No.</b> | 3 | <b>Comment</b> | Flows convey towards the flat-lying ground/quarry floor, adjacent to the northern perimeter of the western section of the site. Evidence of human activity within the Quarry floor; abandoned boat. |

| Recommendations | | | - Investigate ownership of the site and establish what measures, if any, have been taken with regard to placing recent materials over historic spoil.<br>- Investigate activity within Cwar Pentwyn to establish if planning or quarry regulations have been breached. | |

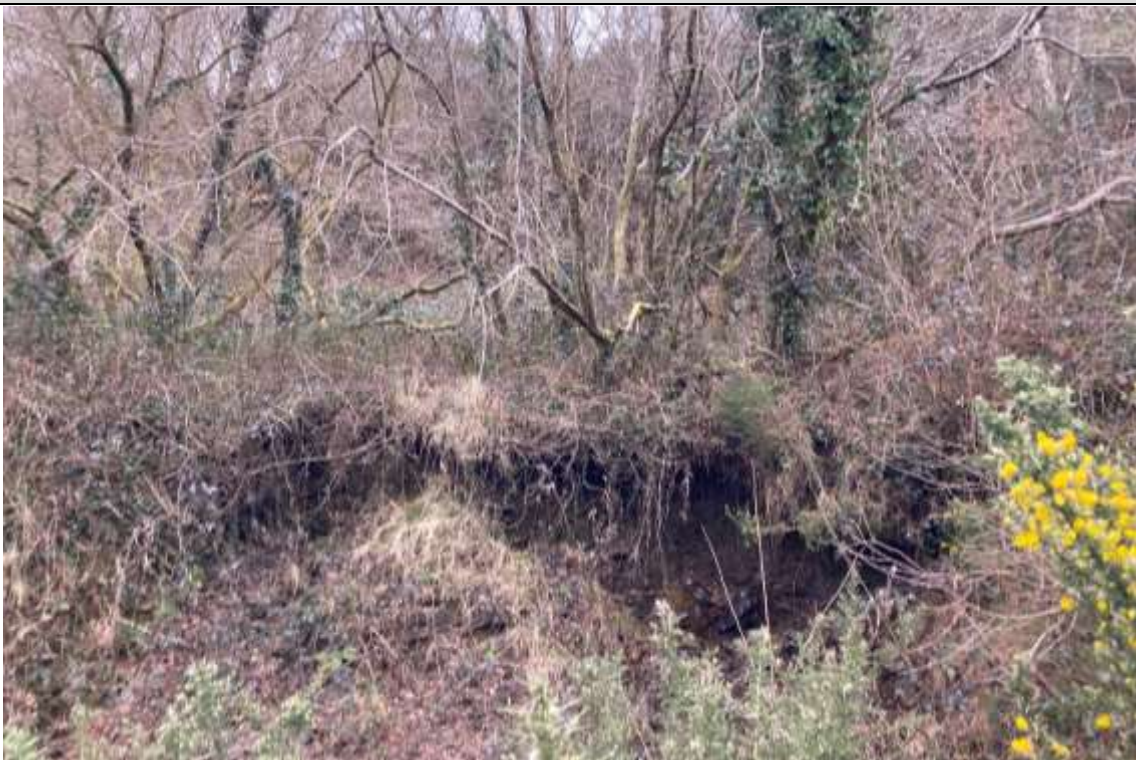
| <b>Photo No.</b> | 4 | <b>Comment</b> | Issues convey over an excavated face to the North of the site boundary. |
