| <b>Coal Tip Name</b> | | Godre'r-Graig Higher / Pentwyn No. 3 Levels | | <b>UID</b> | | T42668 | |
| <b>Located in</b> | | Godre'r Graig, Neath Port Talbot | | <b>Tip Category</b> | | D | |
| <b>Inspection Led by</b> | | C.Gibbons | | <b>Date of Inspection</b> | | 18/07/2025 | |

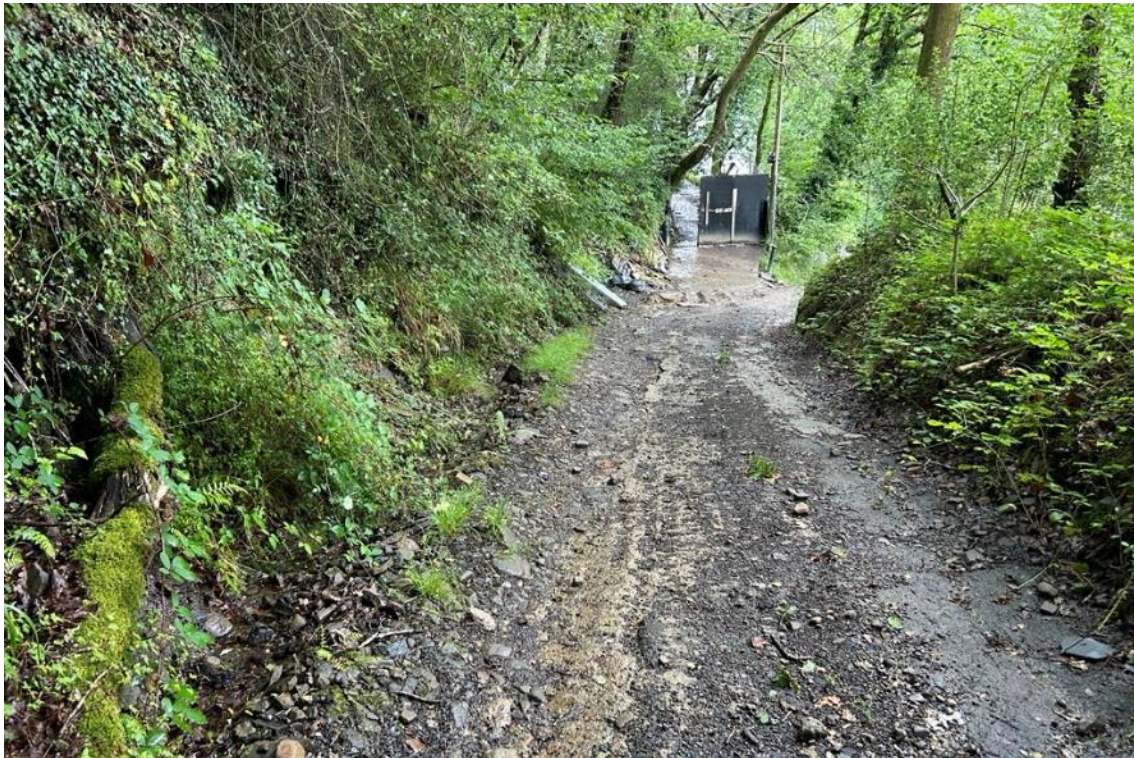
| <b>Feature ID</b> | 25/D/01 | | |

| OBSERVATIONS | | | | |
|---|---|---|---|---|
| 25/D/01 | Channel | E-274919, N-206774 | An unlined trackside channel spans the upper section of the access track leading to Pentwyn Farm. This access track is | None |

| | | | significantly scoured in places, indicating that flows escape the trackside channel during heavy rainfall (Photo 1). | |

| <b>Photo No.</b> | 01 | <b>Comment</b> | Scoured access track leading to Pentwyn Farm. Flows visible on LHS of image, conveying along an unlined, trackside channel at the toe of the tip. |

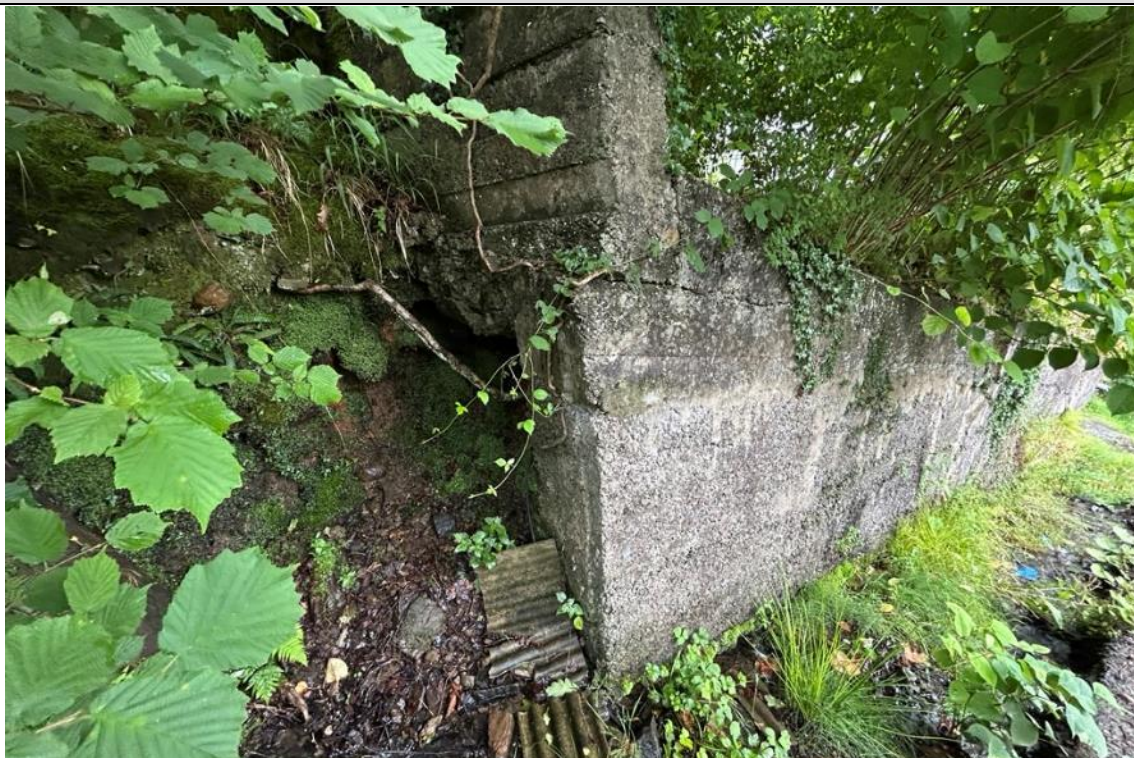
| <b>Feature ID</b> | 25/E/01 | | |

| 25/E/01 | Retaining Wall | E-274907, N-206777 | The retaining wall located along the property of Glanderri (located just east of the site) is in poor condition, with multiple minor seepages emanating from cracks/voids within the structure. Flows conveying along the base of this structure and enter an unlined, trackside channel. This has resulted in minor saturation along the base of the retaining wall (Photo 2). | None |

| <b>Photo No.</b> | 02 | <b>Comment</b> | Minor seepages and saturated ground conditions observed adjacent to the retaining wall situated along the residential property of Glanderri, located just East of the site. This structure is in poor condition. |

| Recommendations | | | Continue to monitor the condition of the retaining wall structure associated with the residential property of Glanderri for a deterioration (25/E/01). | |

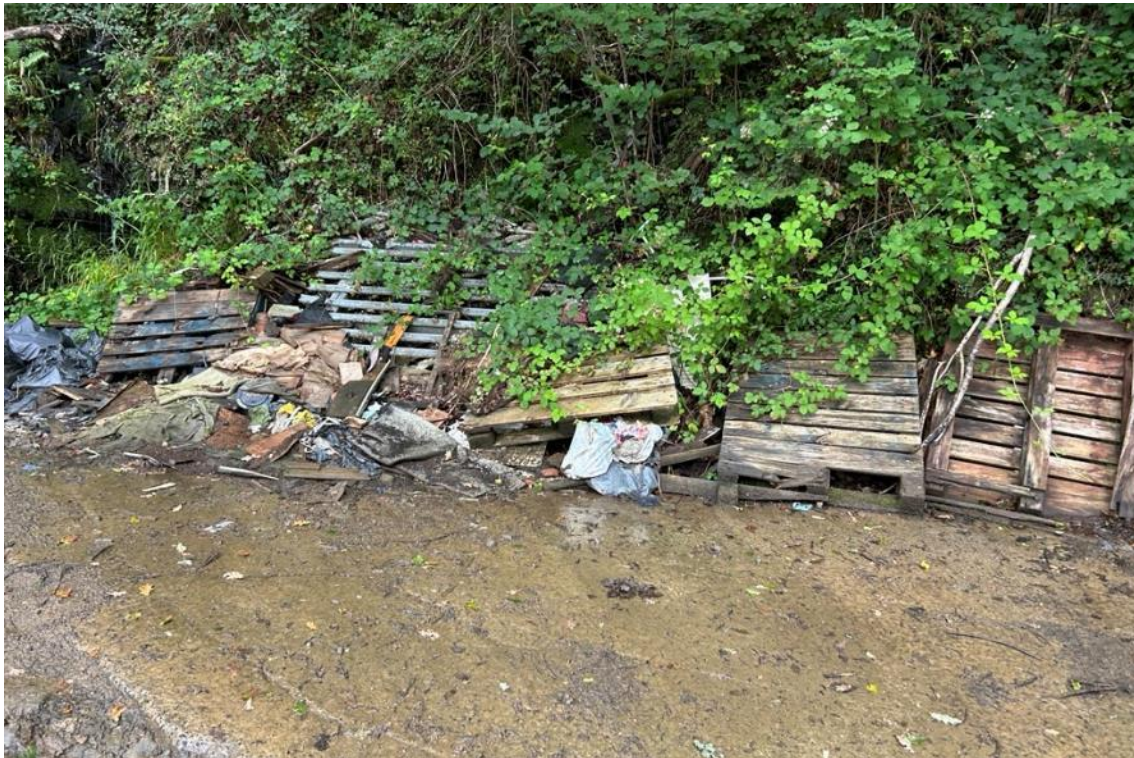
| <b>Feature ID</b> | 25/L/01 | | |

| 25/L/01 | Deposition | E-274890, N-206779 | Pallets and other miscellaneous materials discarded below the outfall of flow path of issues which skirts the Eastern perimeter of the tip body. Material deposited on the driveway of the residential property Glanderri (Photo 3). | None |

| <b>Photo No.</b> | 03 | <b>Comment</b> | Pallets and other miscellaneous materials discarded below the outfall of flow path of issues which skirts the Eastern perimeter of the tip body. Material deposited on the driveway of the residential property Glanderri. |

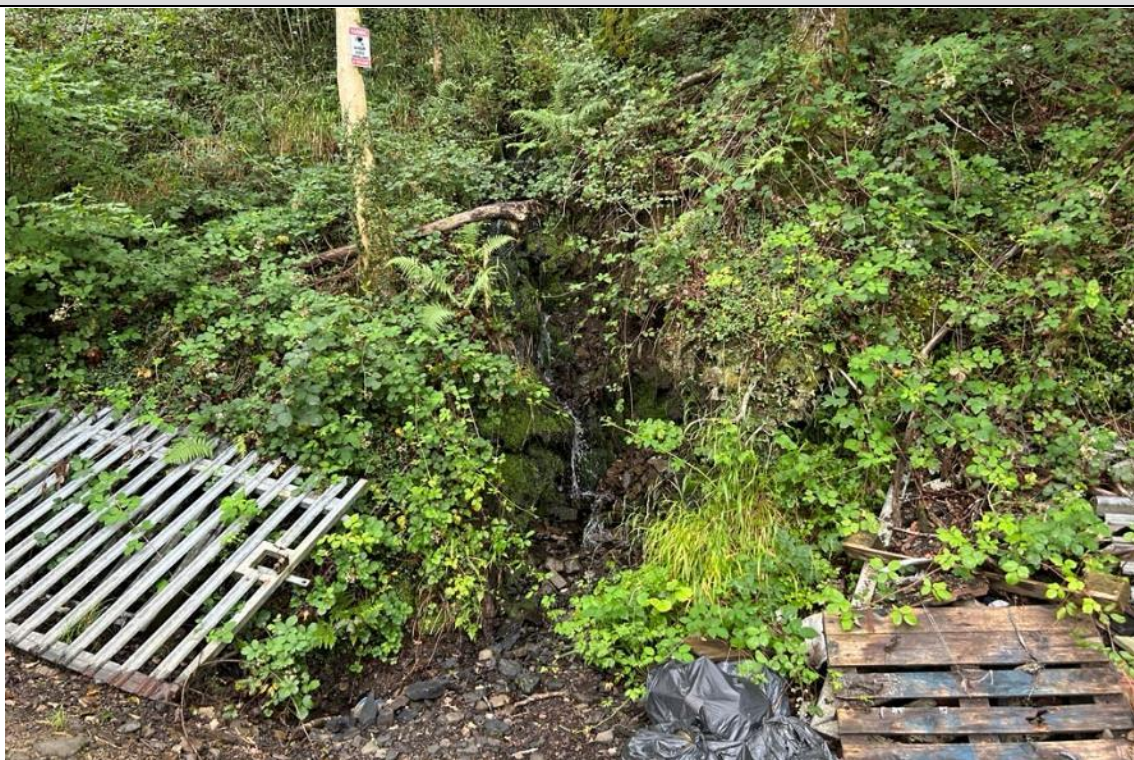
| <b>Feature ID</b> | 25/G/01 | | |

| OBSERVATIONS | | | | |
|---|---|---|---|---|
| 25/G/01 | Erosion | E-274886, N-206778 | Minor erosion of natural ground noted at the outfall of the flow pathway of issues which skirt the Eastern perimeter of the tip body (Photo 4). | None |

| <b>Photo No.</b> | 04 | <b>Comment</b> | View looking towards the outfall of the flow path of issues which skirt the Eastern perimeter of the tip body located further upslope. A small amount of natural ground material has been eroded adjacent to the outfall. |

| OBSERVATIONS | | | | |
|---|---|---|---|---|
| Recommendations | | | Consider implementing appropriate drainage infrastructure to effectively capture the uncontrolled flows associated with the outfall of issues. Consider formalising/lining the flow pathway of the issues, to prevent further scouring (25/G/01/06). | |

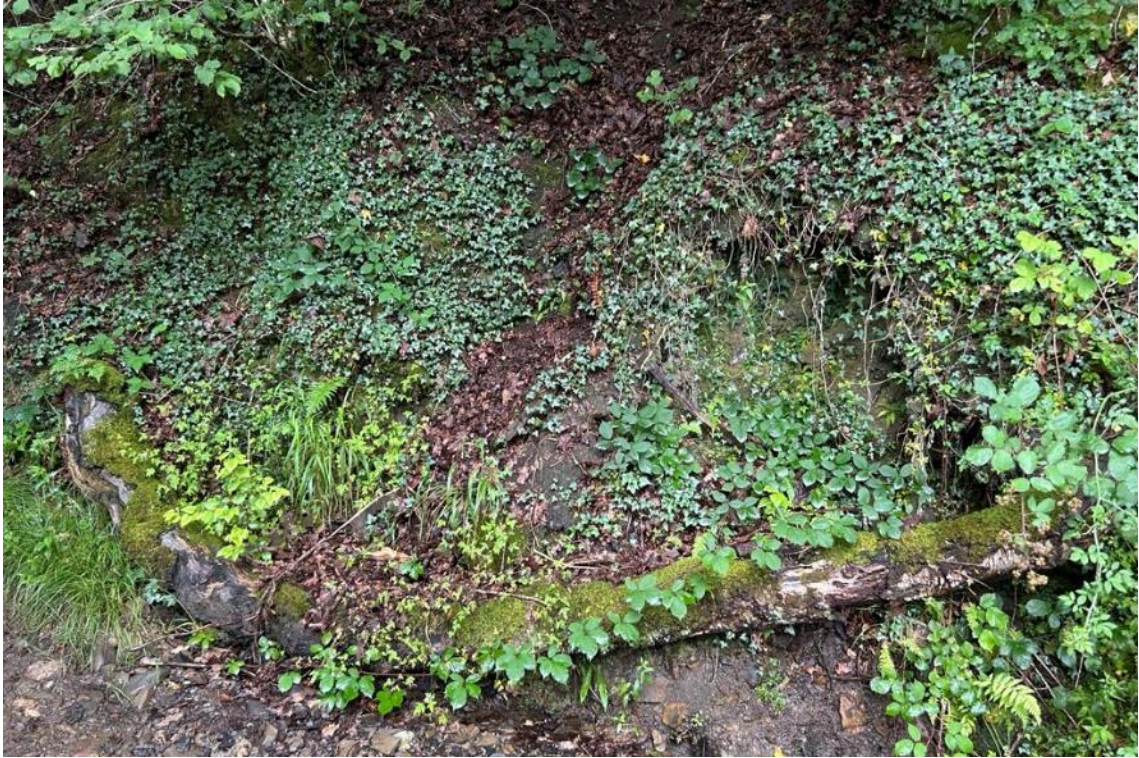
| <b>Feature ID</b> | 25/G/02 | | |

| OBSERVATIONS | | | | |
|---|---|---|---|---|
| 25/G/02 | Slumping | E-274847, N-206774 | A very small section of the toe of the tip has been subject to minor slumping, relating to a fallen, uprooted tree displacing a small amount of spoil material (Photo 5). | None |

| <b>Photo No.</b> | 05 | <b>Comment</b> | View from the access track which spans the toe, looking towards the small section of slumped material, likely associated with the uprooted tree visible at the base. |

| OBSERVATIONS | | | | |
|---|---|---|---|---|
| | | | Consider the feasibility of implementing a retaining structure along the base of flank/toe of the tip, as it directly abuts an access track (25/G/02-03). | |

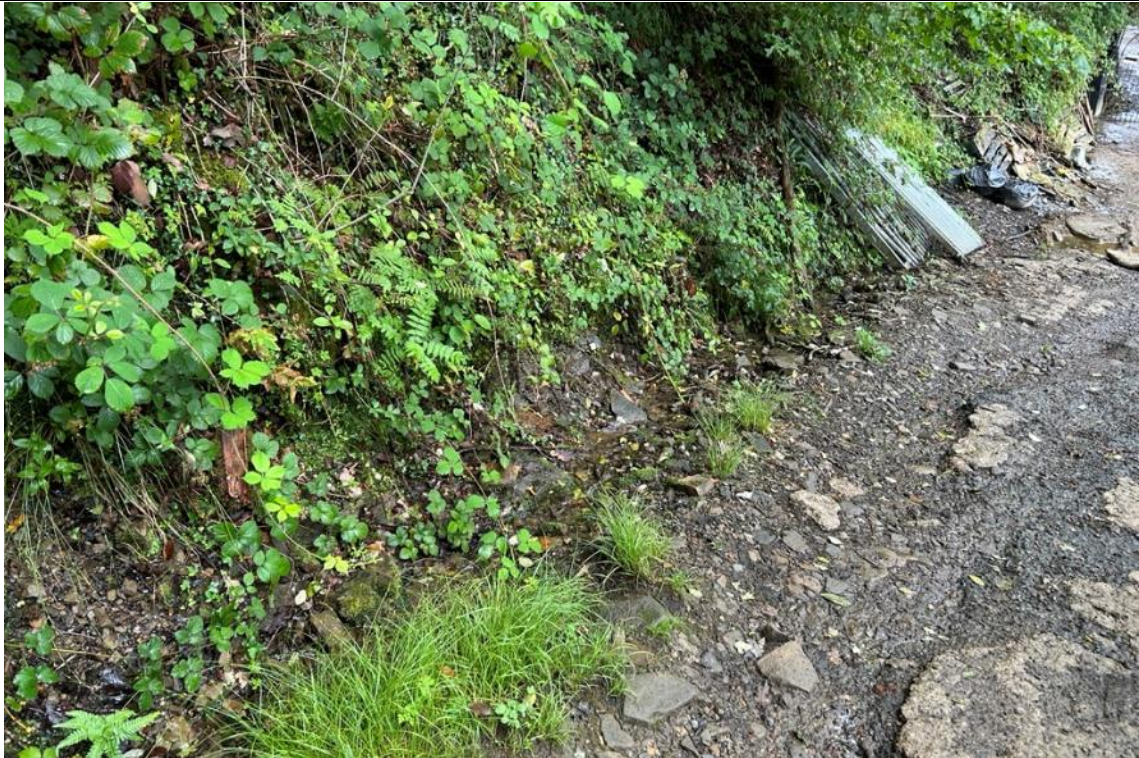
| <b>Feature ID</b> | 25/G/03 | | |

| OBSERVATIONS | | | | |
|---|---|---|---|---|
| 25/G/03 | Minor Seepage | Toe of the Tip | Previously reported multiple, minor seepages emanating from the toe of the tip and conveying along the adjacent access track. At the time of inspection, no seepages were identified but it is assumed that they wax and wane depending on weather conditions. Very minor seepages present at time of inspection (Photo 6). | None |

| <b>Photo No.</b> | 06 | <b>Comment</b> | View from the access track, looking across the steep lower section and toe of the tip flank. Previously, multiple minor seepages have been identified along the toe, which wax and wane depending on weather conditions. |

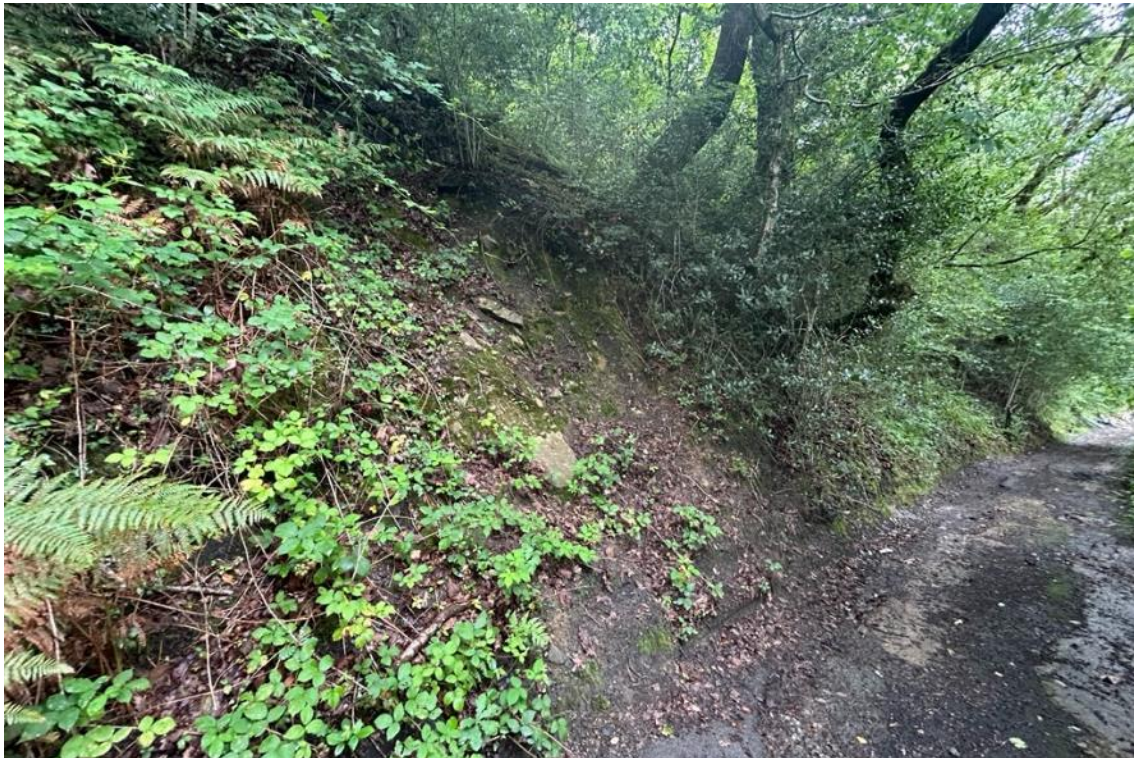
| <b>Feature ID</b> | 25/G/04 | | |

| OBSERVATIONS | | | | |
|---|---|---|---|---|
| 25/G/04 | Backscarp | E-274813, N-206763 | Minor, arcuate backscarp approximately 5m in width located along the Western section of the toe of the tip, indicating the presence of a historical, superficial surface slip (Photo 7). | None |

| <b>Photo No.</b> | 07 | <b>Comment</b> | View from the toe, looking towards the minor, arcuate backscarp approximately 5m in width indicating the presence of a historical, superficial surface slip. |

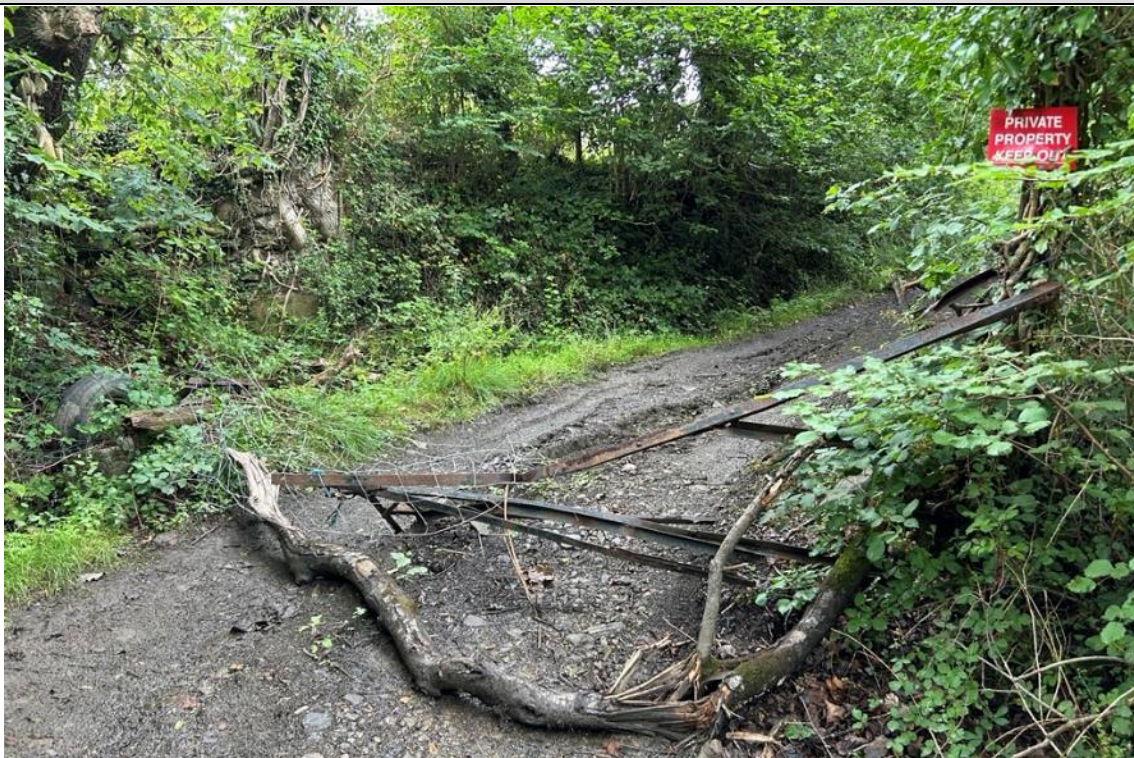
| <b>Feature ID</b> | 25/L/02 | | |

| 25/L/02 | Fencing | E-274780, N-206745 | The temporary fencing at the entrance to the access track which climbs the Western site perimeter has been re-erected (Photo 8). | New |

| <b>Photo No.</b> | 08 | <b>Comment</b> | The temporary fencing at the entrance to the access track which climbs the Western site perimeter has been re-erected. |

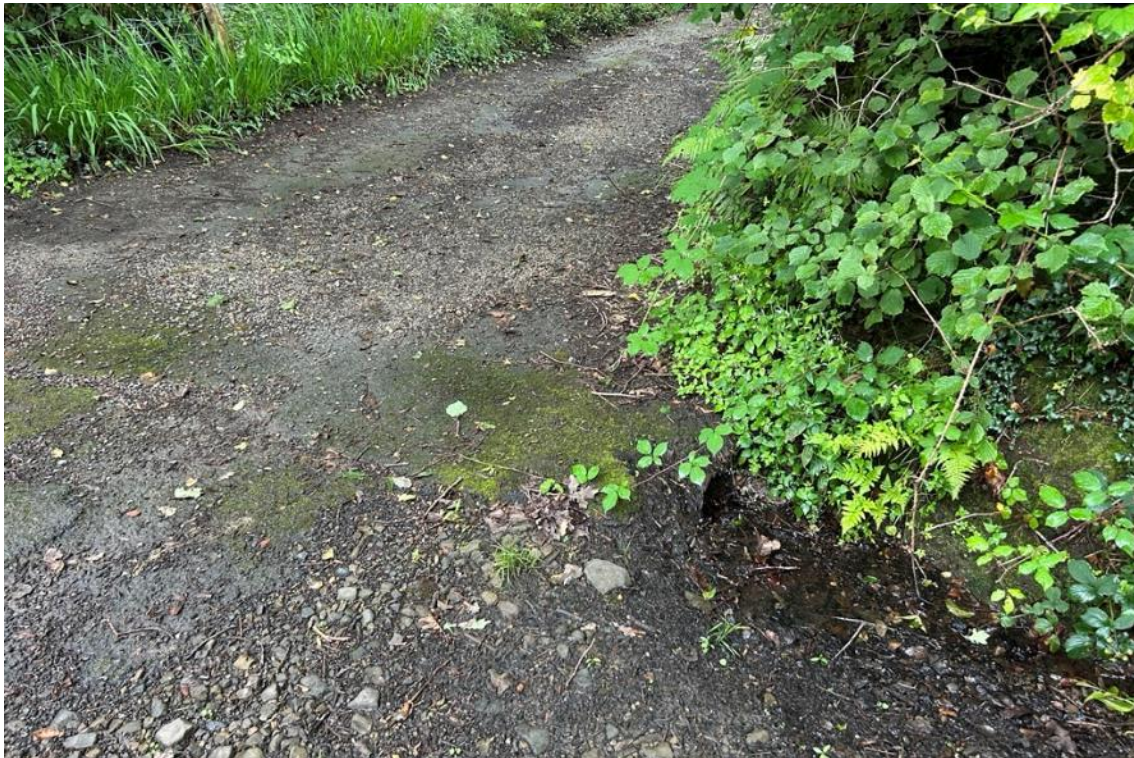
| <b>Feature ID</b> | 25/D/02 | | |

| 25/D/02 | Culvert | E-274776, N-206736 | Previously reported leaf litter obstructing flows from entering the trackside drain, located adjacent to the access track which spans just off the Western site perimeter. Leaf litter has since been removed (Photo 9). | N/A |

| <b>Photo No.</b> | 09 | <b>Comment</b> | Trackside drain, located adjacent to the access track which spans just off the Western site perimeter is no longer obstructed by leaf matter. |

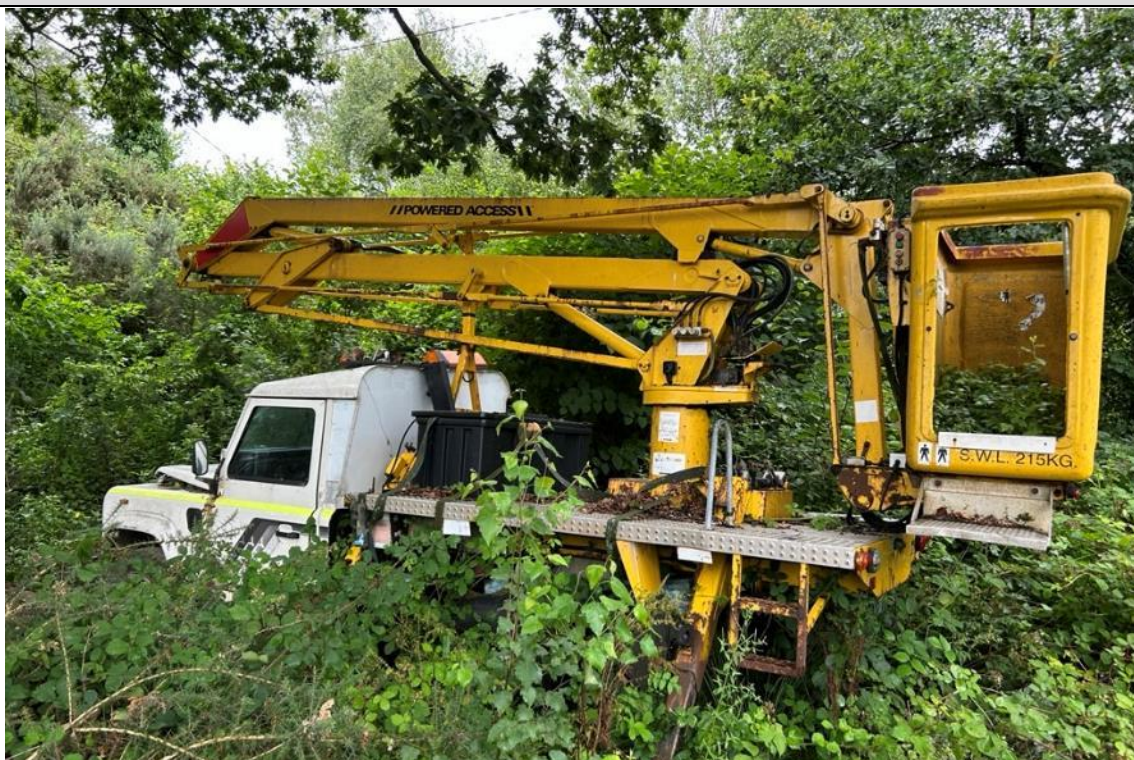
| <b>Feature ID</b> | 25/L/03 | | |

| 25/L/03 | Deposition | E-274821, N-206794 | Disused plant vehicle and associated equipment discarded on the north-western section of the tip plateau (Photo 10). | None |

| <b>Photo No.</b> | 10 | <b>Comment</b> | Disused plant vehicle and associated equipment discarded on the north-western section of the tip plateau. |

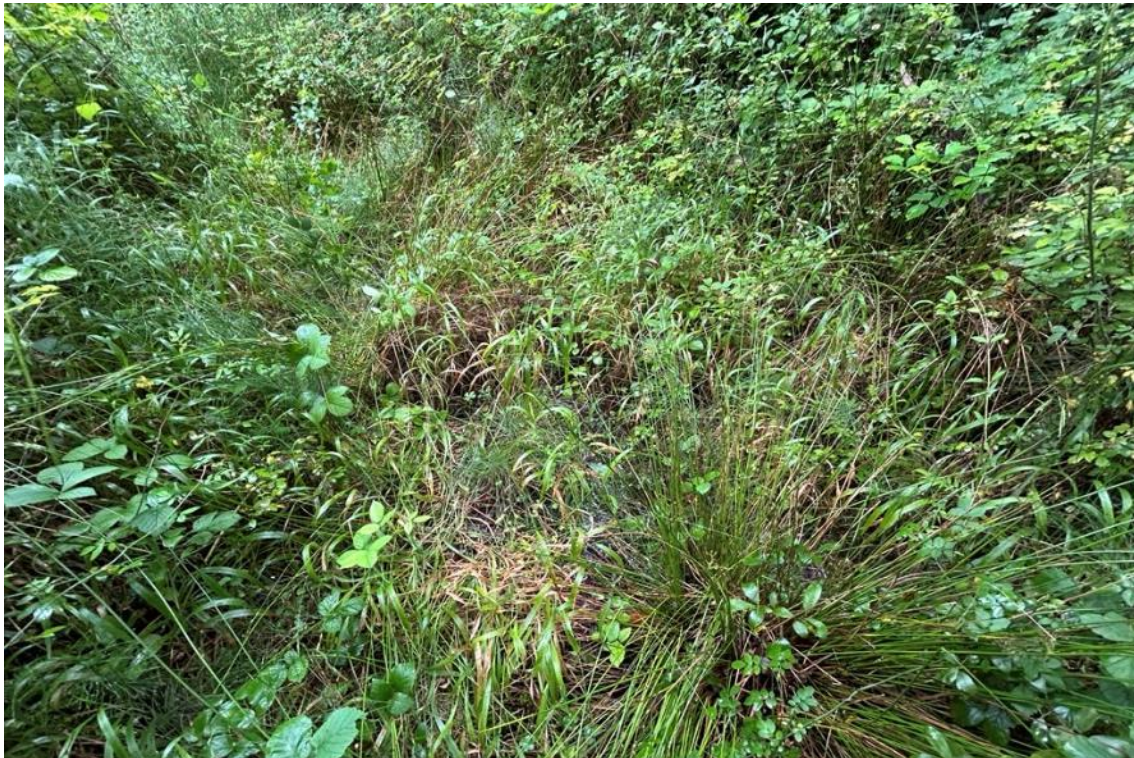
| <b>Feature ID</b> | 25/G/05 | | |

| OBSERVATIONS | | | | |
|---|---|---|---|---|
| 25/G/05 | Saturated Ground | E-274845, N-206825 | Saturated ground conditions marked by reed growth and minor ponding observed along the upper, north-eastern section of the tip body. This is a longstanding feature of the site (Photo 11). | None |

| <b>Photo No.</b> | 11 | <b>Comment</b> | Saturated ground conditions marked by reed growth and minor ponding observed along the upper, north-eastern section of the tip body. |

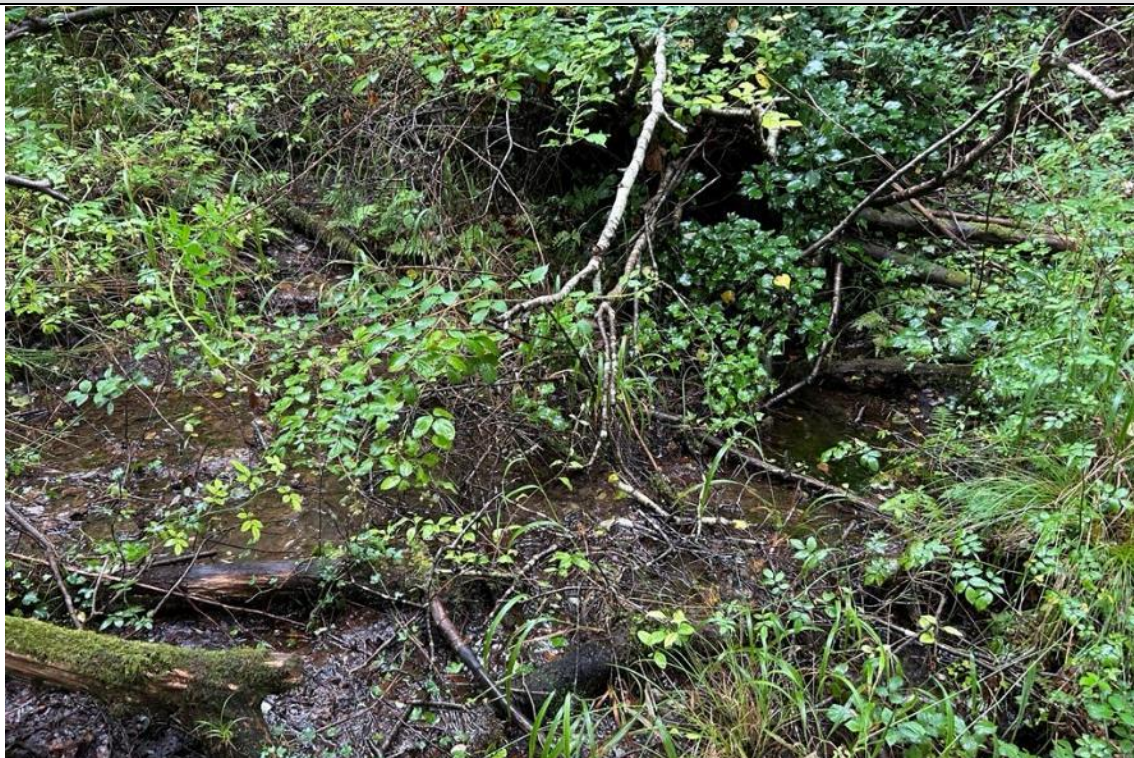
| <b>Feature ID</b> | 25/G/06 | | |

| OBSERVATIONS | | | | |
|---|---|---|---|---|
| 25/G/06 | Erosion | E-274853, N-206816 | Minor erosion of the tip body by the flow pathway of issues which skirt a small section of the Eastern site perimeter. Flows emanate from the natural ground hillside to the rear, which presumably contains historic mine entries. Flows outfall from this pathway adjacent to the residential property of Glander, as displayed in image 4 (Photo 12-13). | None |

| <b>Photo No.</b> | 12 | <b>Comment</b> | A moderate levels flows emanating from the hillside to the rear of the upper, north-eastern section of the site and potential historic mine entries convey along a partial length of the Eastern site perimeter, before conveying further downslope. |

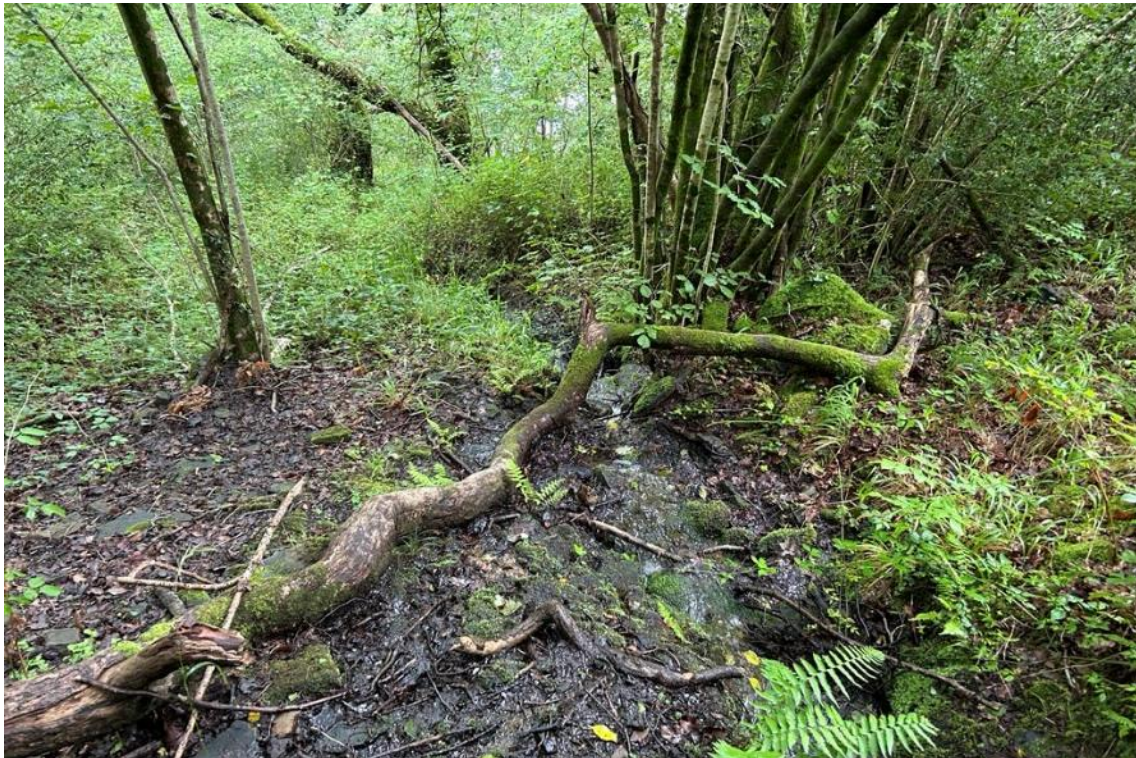
| <b>Feature ID</b> | 25/G/06 | | |

| <b>Photo No.</b> | 13 | <b>Comment</b> | Flow pathway of issues which skirt a small section of the Eastern site perimeter, resulting in minor erosional scour. |

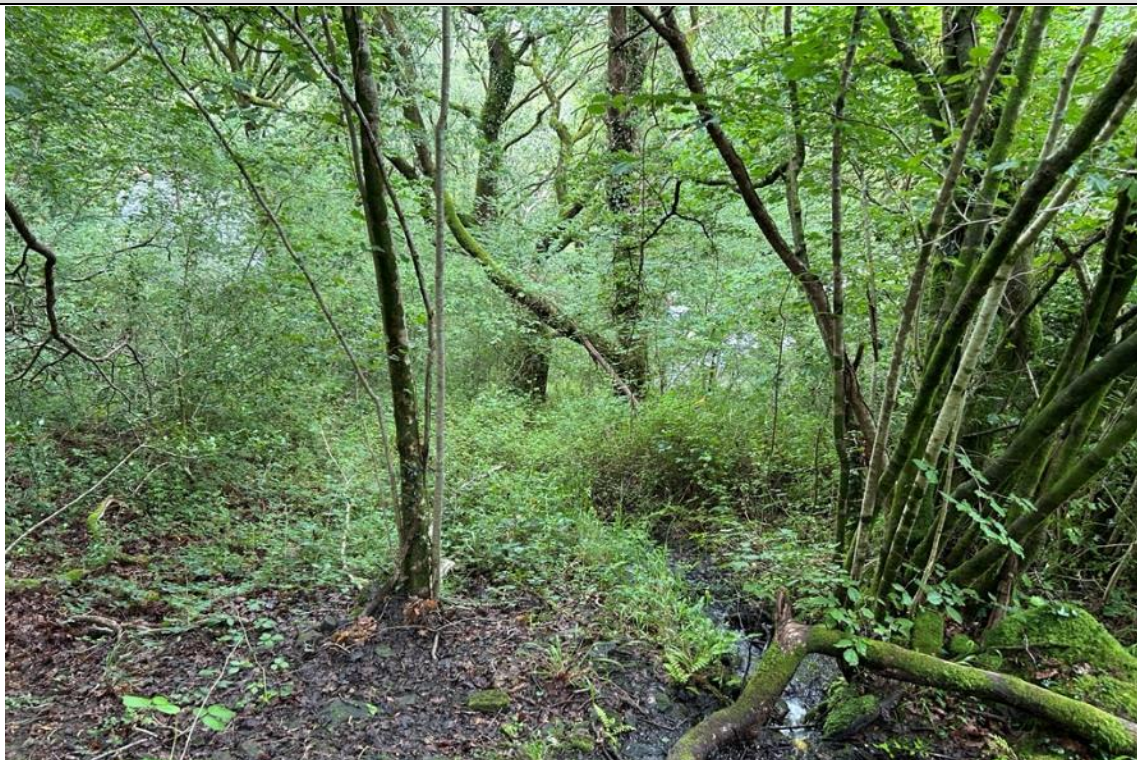
| <b>Feature ID</b> | 25/L/04 | | |

| 25/L/04 | Vegetation Cover | Tip Body | The tip body is located within a woodland, as such is densely vegetated with a thick undergrowth of bramble and shrub, alongside many semi-mature and mature trees. The entry point to the upper section of the site is overgrown, which may result in future accessibility issues (Photo 14 & 17). | Worse |

| <b>Photo No.</b> | 14 | <b>Comment</b> | View from the upper slope, looking across the well-wooded tip body. |

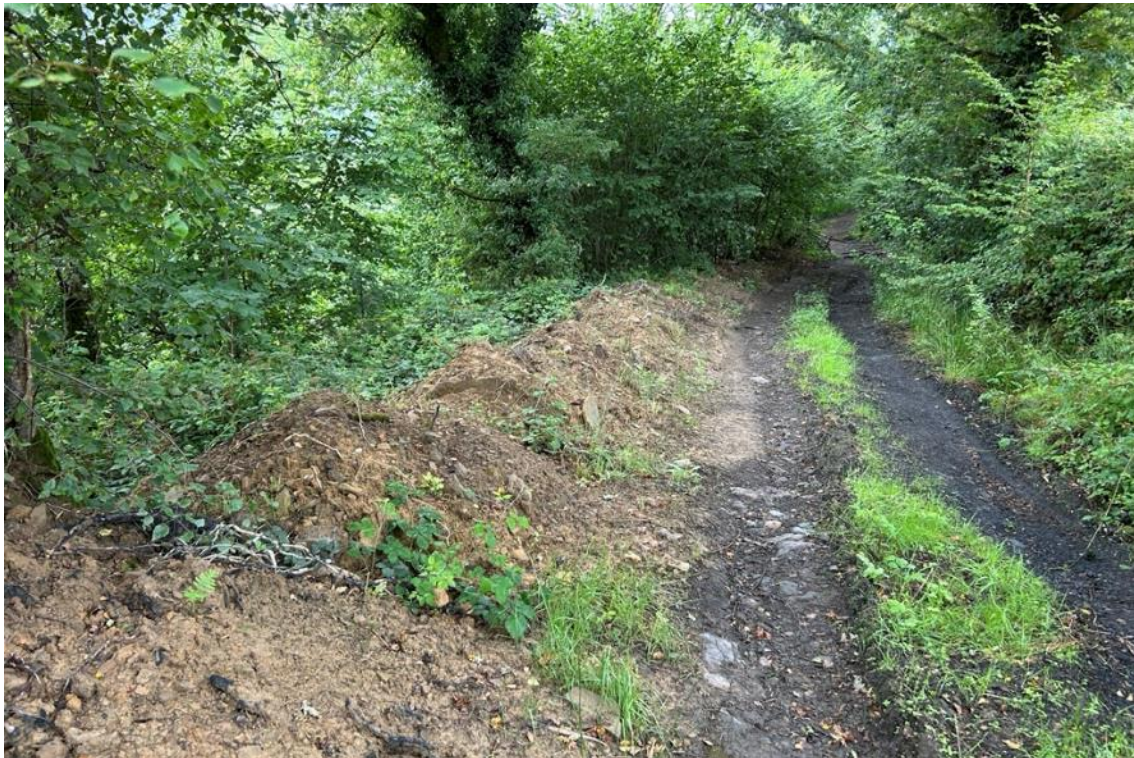
| <b>Feature ID</b> | 25/L/05 | | |

| 25/L/05 | Deposition | E-274824, N-206804 | Bund of natural ground material deposited along the tip crest at the NW section of the site, adjacent to the access track which skirts the rear of the site. A larger quantity of natural ground material has been deposited further along the access track. The origin of this material is unknown but does not appear to have been removed from within the site boundaries (Photo 15-16). | New |

| <b>Photo No.</b> | 15 | <b>Comment</b> | New observation. Shallow bund of natural ground material deposited along the NW section of tip crest, adjacent to the access track which spans to the rear of the site. |

| Recommendations | | | Desist from depositing natural ground material along the tip crest, as continued tipping has the potential to lead to structural instability across the slope below (25/L/05). | |

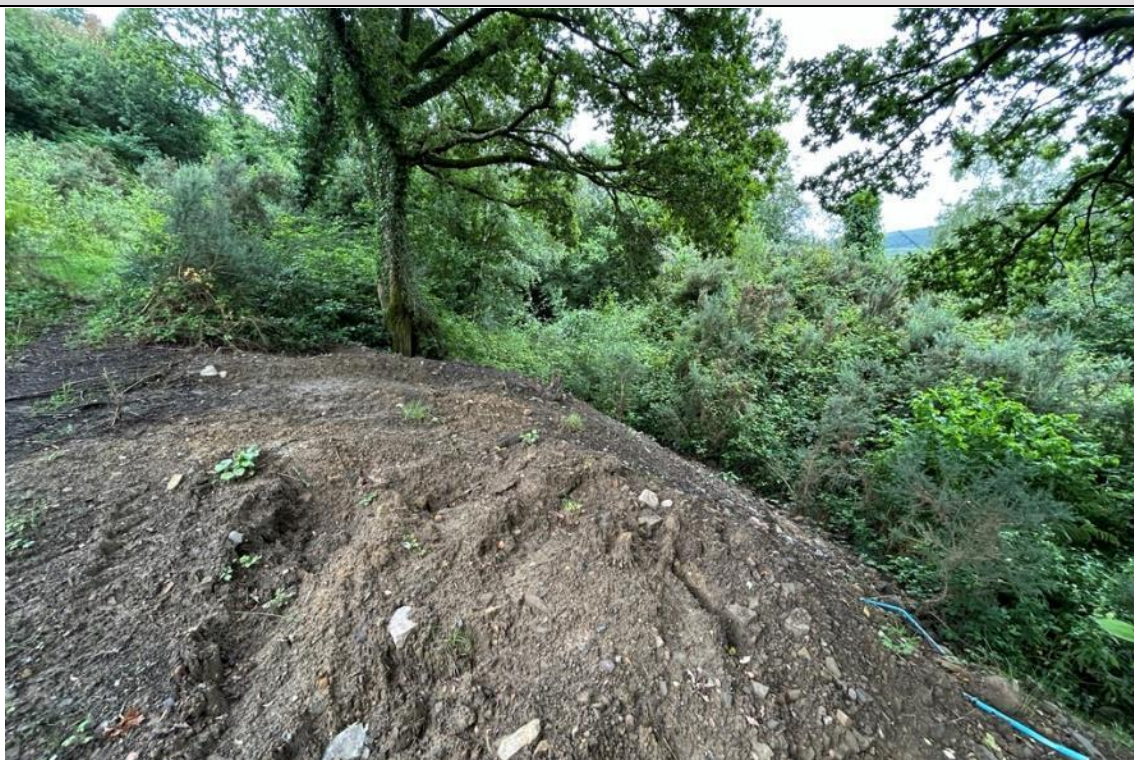
| <b>Feature ID</b> | 25/L/05 | | |

| <b>Photo No.</b> | 16 | <b>Comment</b> | Larger quantity of natural ground material tipped to the rear of the tip crest, adjacent to the access track which spans to the rear of the site. |

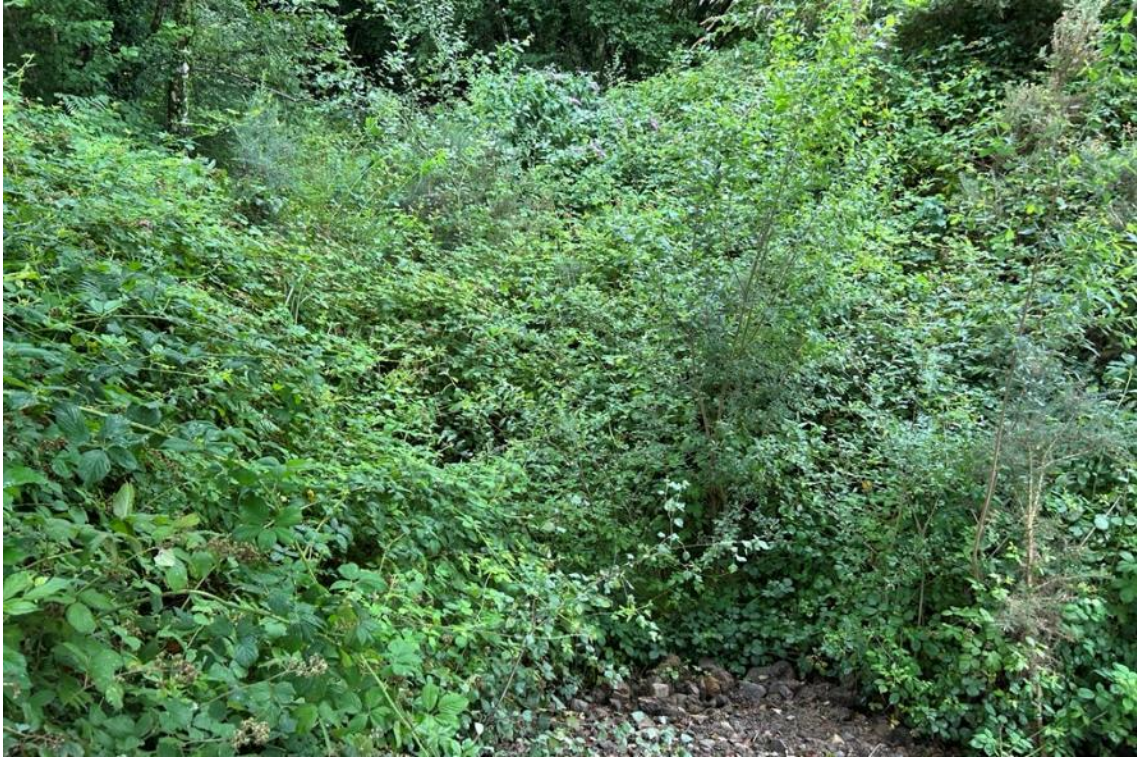
| <b>Feature ID</b> | 25/L/04 | | |

| <b>Photo No.</b> | 17 | <b>Comment</b> | Access point to the upper section of the site is overgrown, which may pose future accessibility issues. |
