**The Coal  
Authority**

## **Site Inspection Report**

### **L44 – Godre’r Graig Tips**

**Date: July 2019**

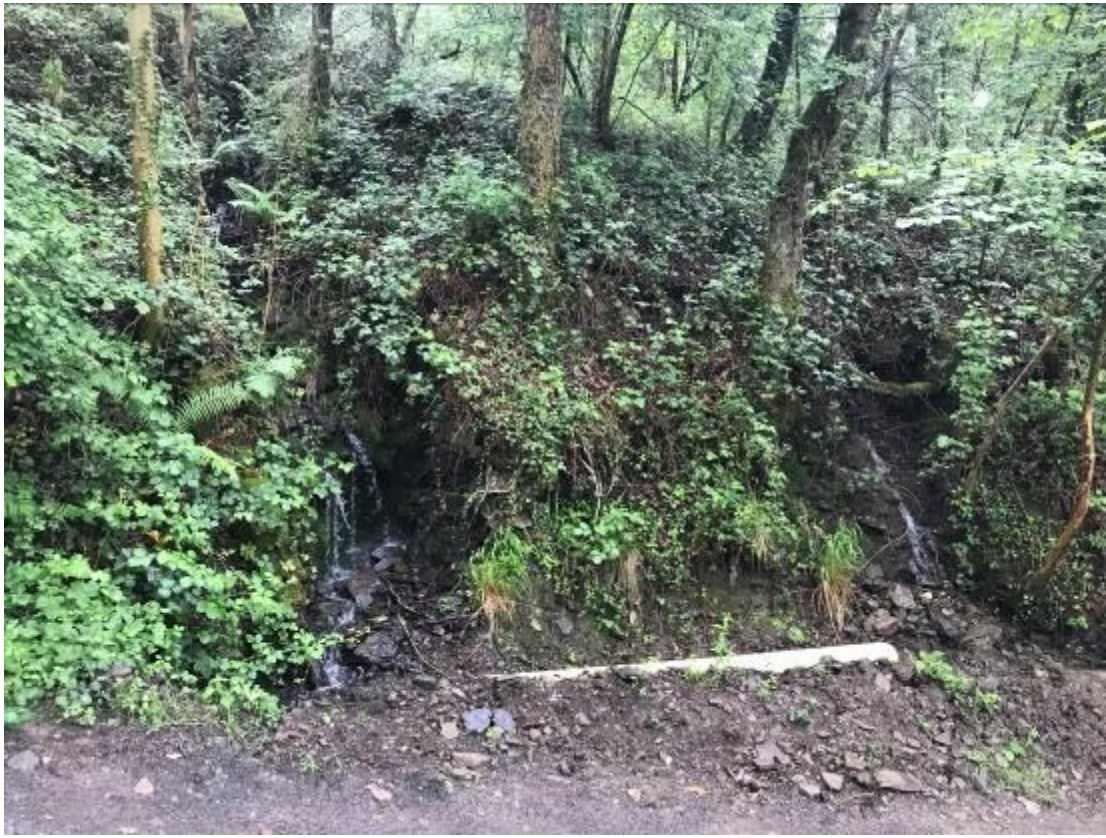
Inspection on the 13<sup>th</sup> June 2019 began at the south-western extremity of Site 1, at the access track leading to Pentwyn Farm and the entrance to Cwar Pentwyn (photographs 1 and 2). It was noted that flows from the mine adits above were entering the roadside drainage channel along the Pentwyn Farm access road (photograph 3). The quarry access track was well used and mounds of what appeared to be quarried material were present over the location of the mine adits and the colliery spoil tip to the south of the track (photographs 4, 5 and 9).

**Photograph 3 – Flows from adit positions to Pentwyn Farm access track**

- Investigate activity within Cwar Pentwyn to establish if planning or quarry regulations have been breached.
- Ensure drainage system from adit positions at Cwar Pentwyn is maintained.

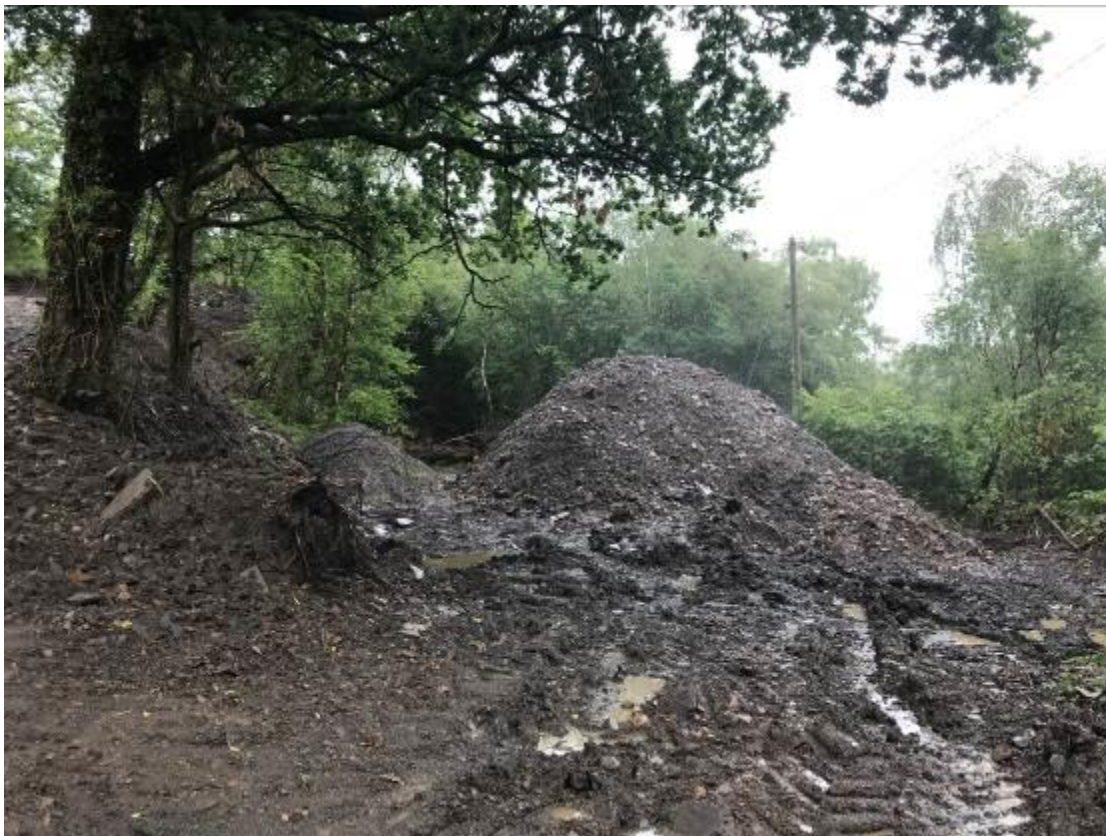
Spoil material associated with quarry working and historic coal extraction from three adits was observed to be present along the southern section of the site. Recent tipping of quarry waste has taken place over previous colliery spoil tipping areas and partially over one of the three adits.

**Photograph 4 – Recent tipping of material at Site 1**

- Investigate ownership of Site 1 and establish what measures, if any, have been taken with regard to placing recent materials over historic spoil materials.

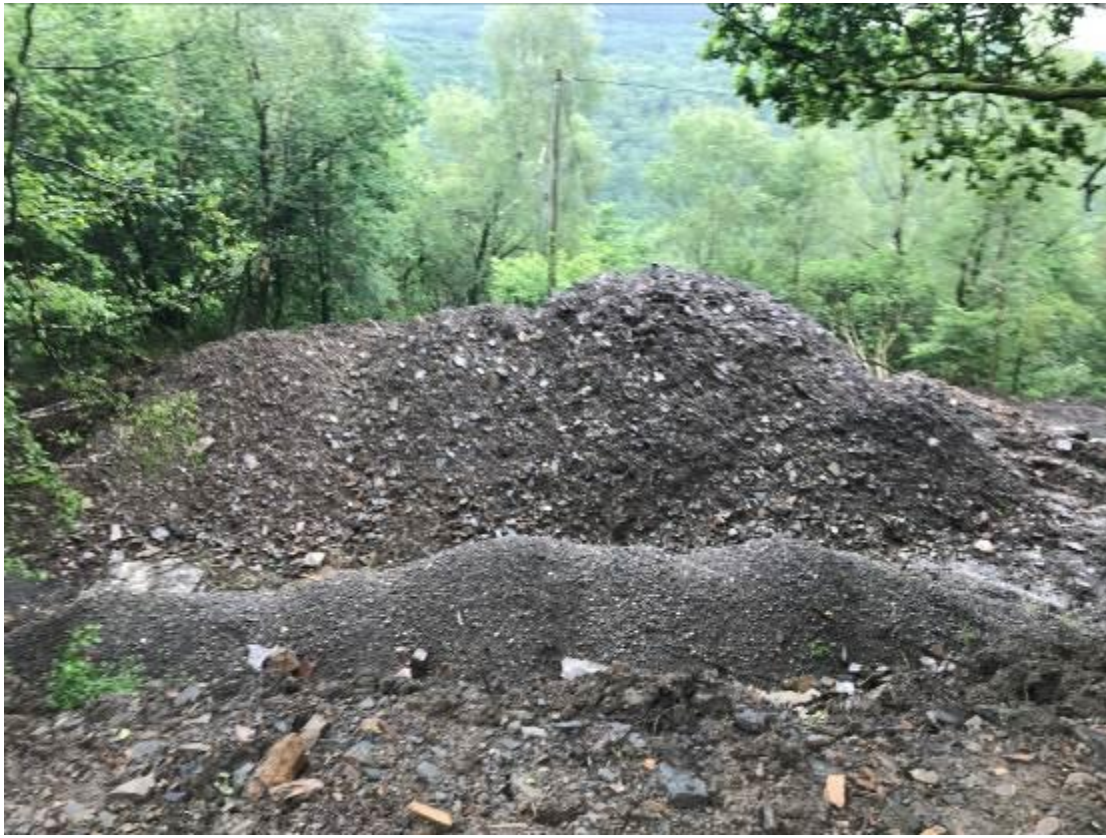
**Photograph 5 – Recent tipping of material at Site 1**

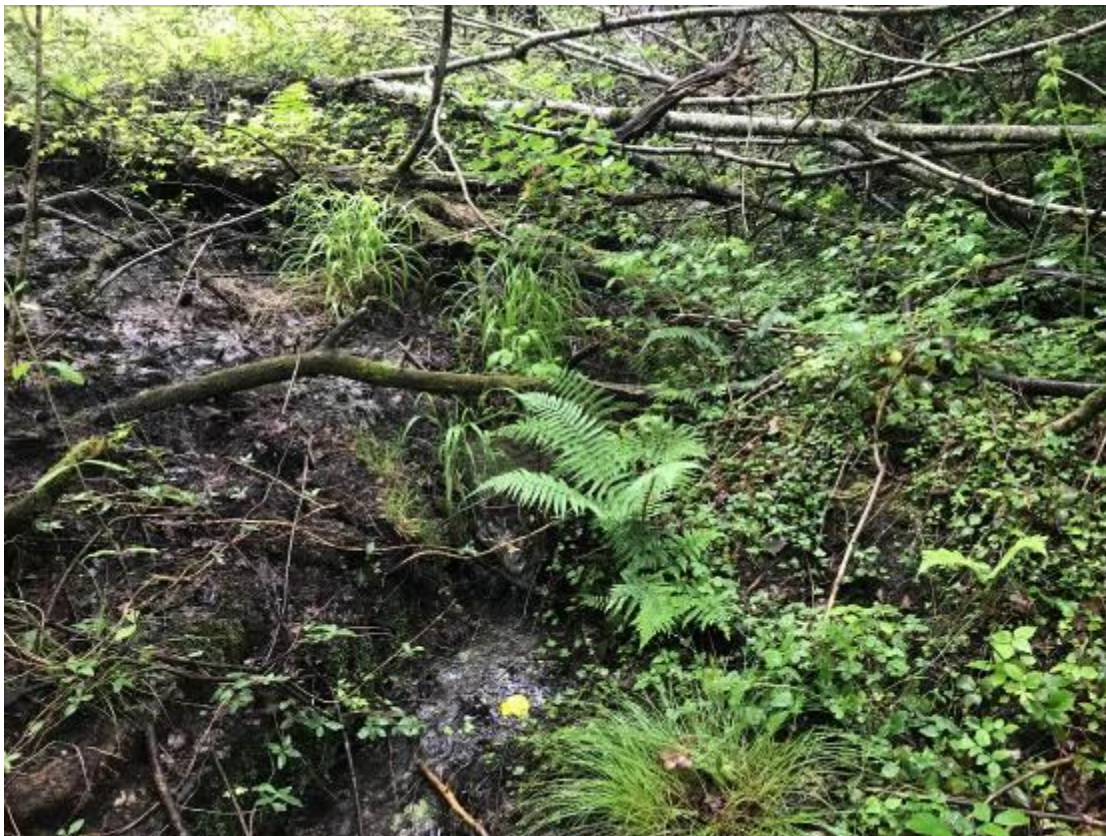
The recorded adit positions in this area were evidenced by flows entering a partially lined channel, conveying water to the roadside channel along Pentwyn Farm access road (photographs 6 and 7).

**Photograph 6 – Discharge from adit positions at Site 1**

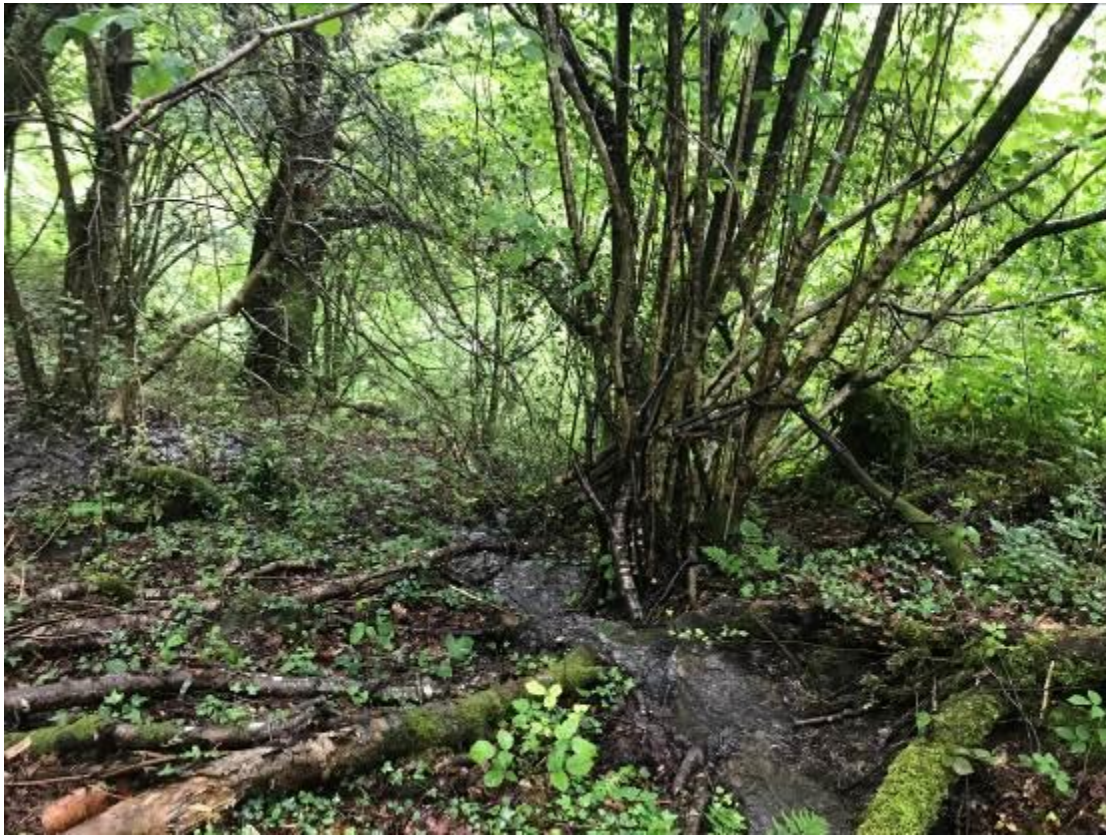
**Photograph 7 – Discharge from adit positions at Site 1**

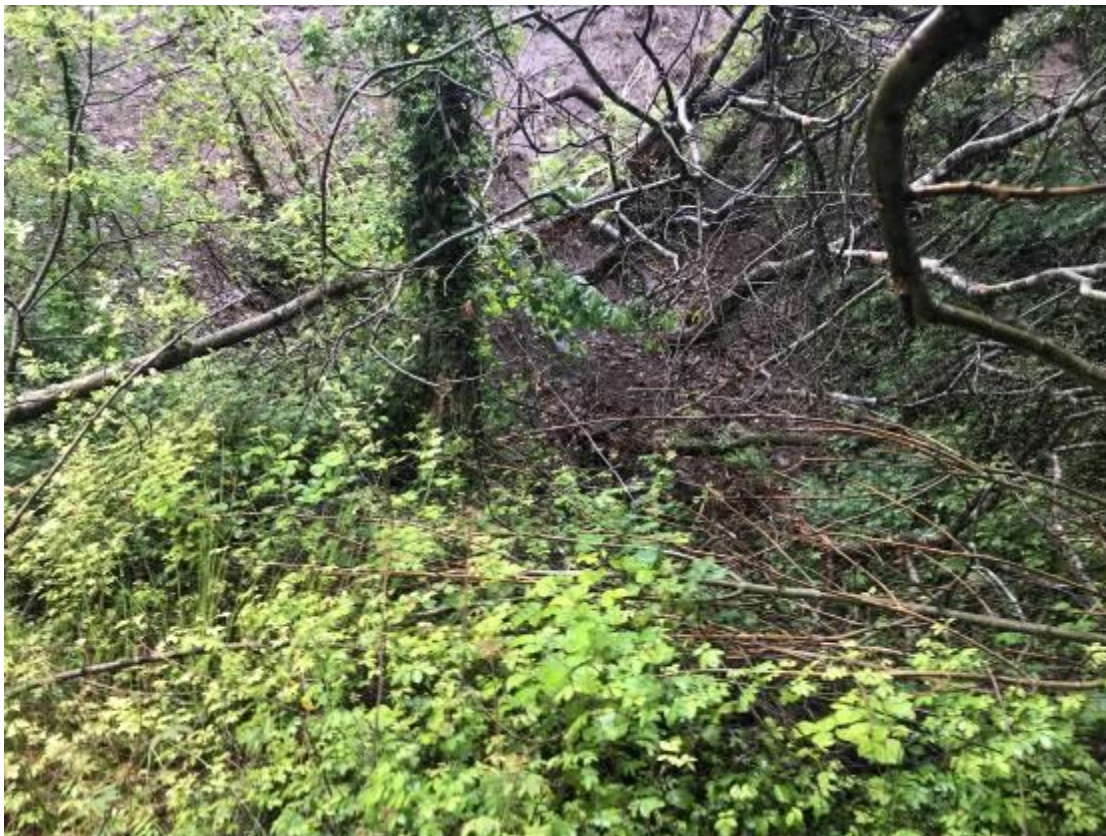
The flanks of the colliery and quarry spoil mounds were very steep and densely vegetated, preventing a close inspecting of material and topography (photographs 8, 17, 18 and 19).

**Photograph 8 – Steep densely vegetated flanks of Site 1**

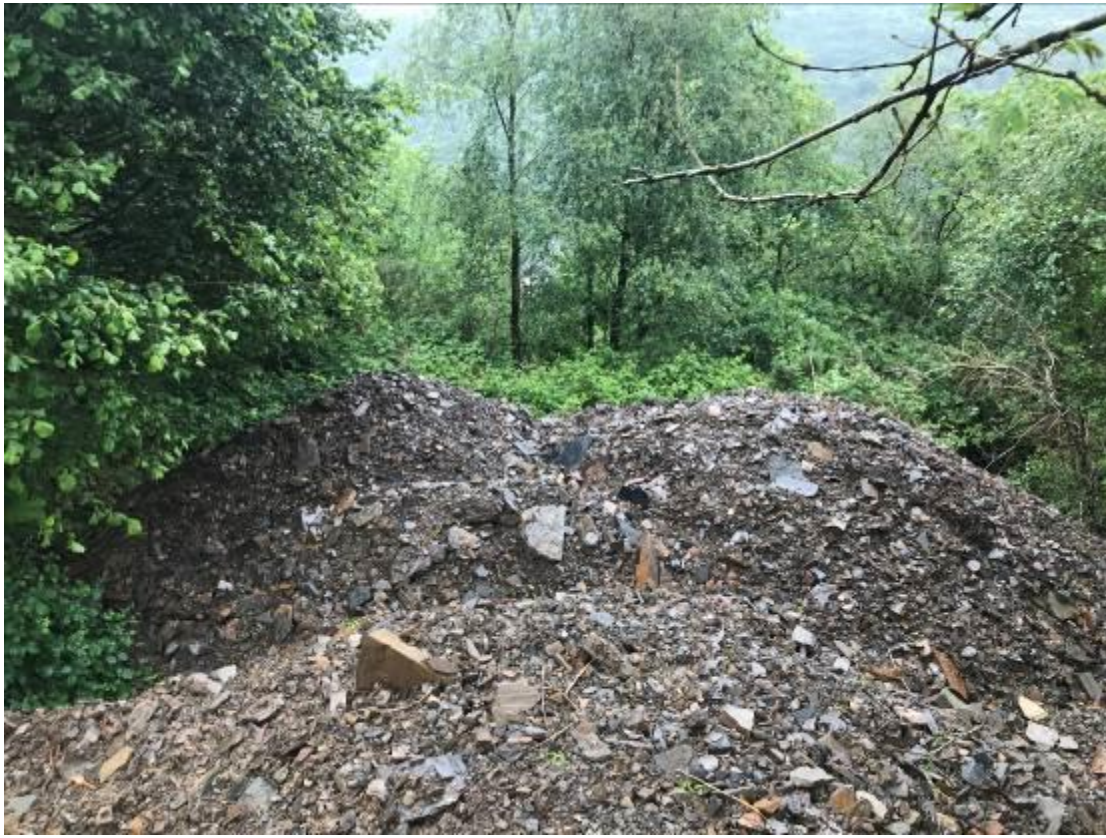
**Photograph 9 – Recent tipping of material at Site 1**

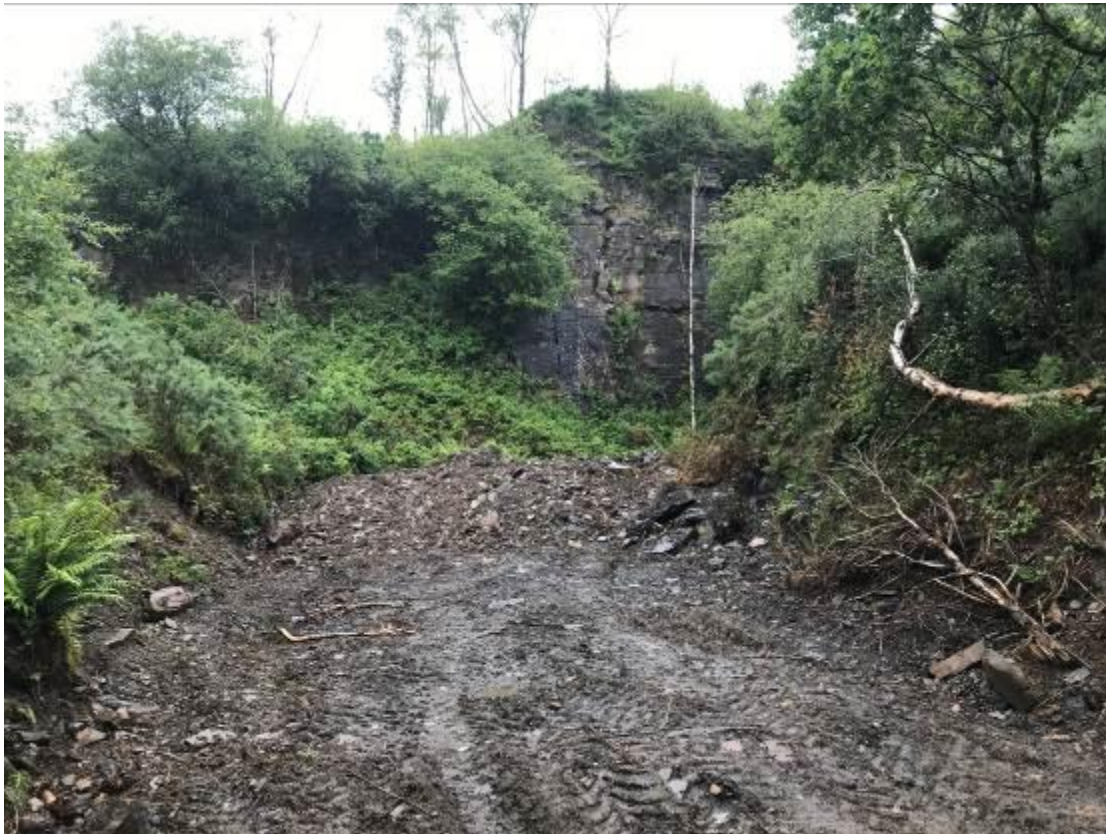
The inspection then viewed the floor and high walls of Cwar Pentwyn. Recent quarrying activity appeared to have taken place, with mounds of excavated material present. Evidence of human activity was also observed as a 'Lazy Spa' type pool, tent and camp bed were present, along with electricity extension cables leading downslope toward the properties named 'Glander' and 'Darren View' (photographs 11 to 16).

**Photograph 11 – High wall of Pentwyn Quarry showing recent tipping**

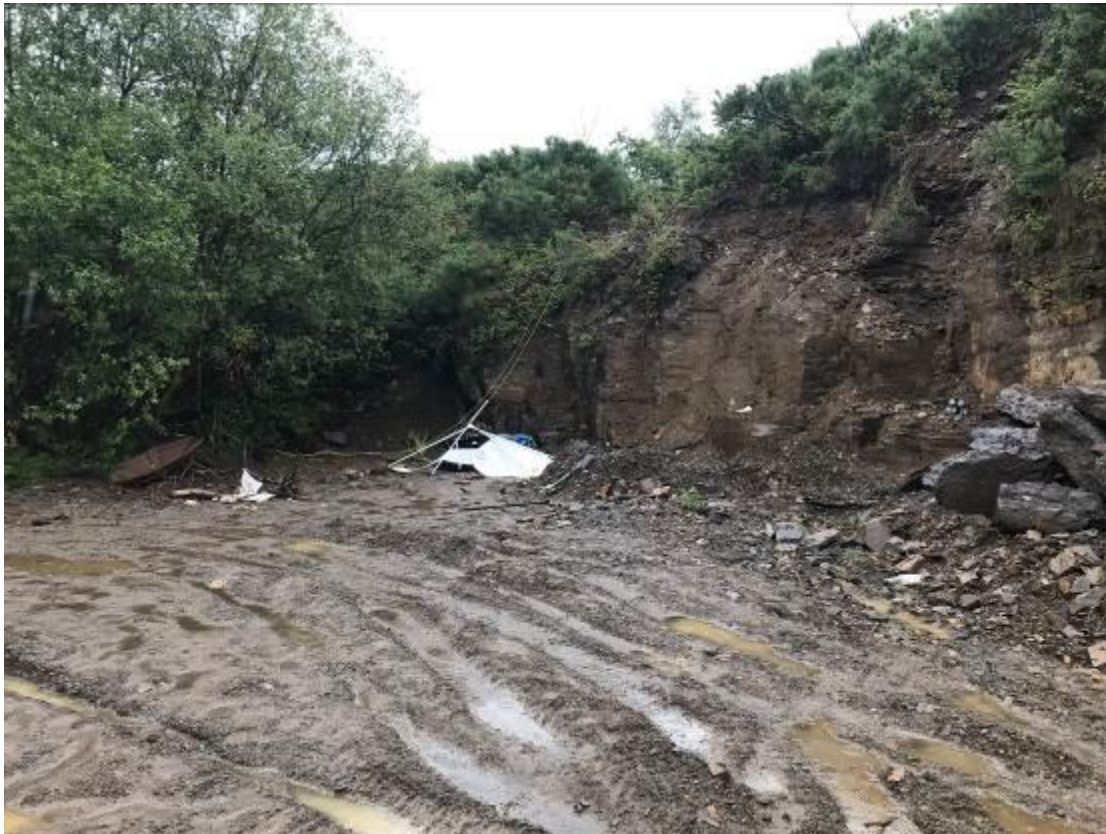
**Photograph 13 – Pentwyn Quarry recent excavations**

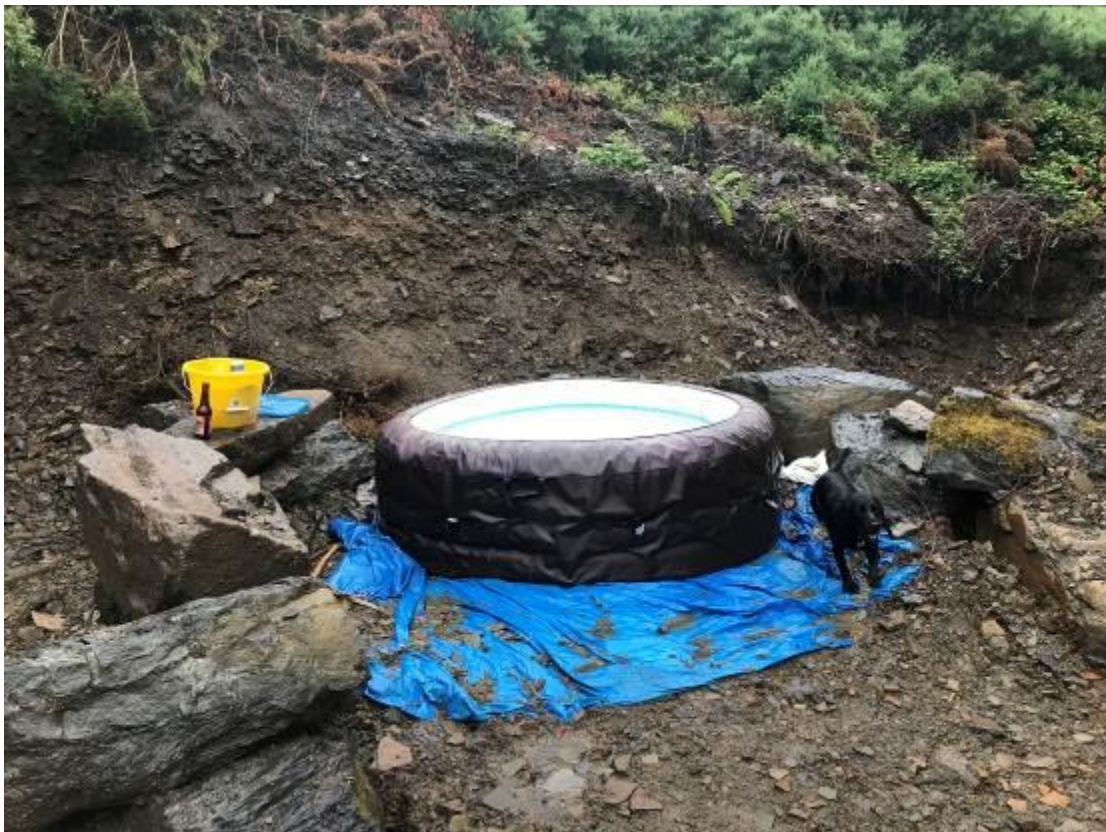
**Photograph 14 – ‘Lazy Spa’ located in quarry floor**

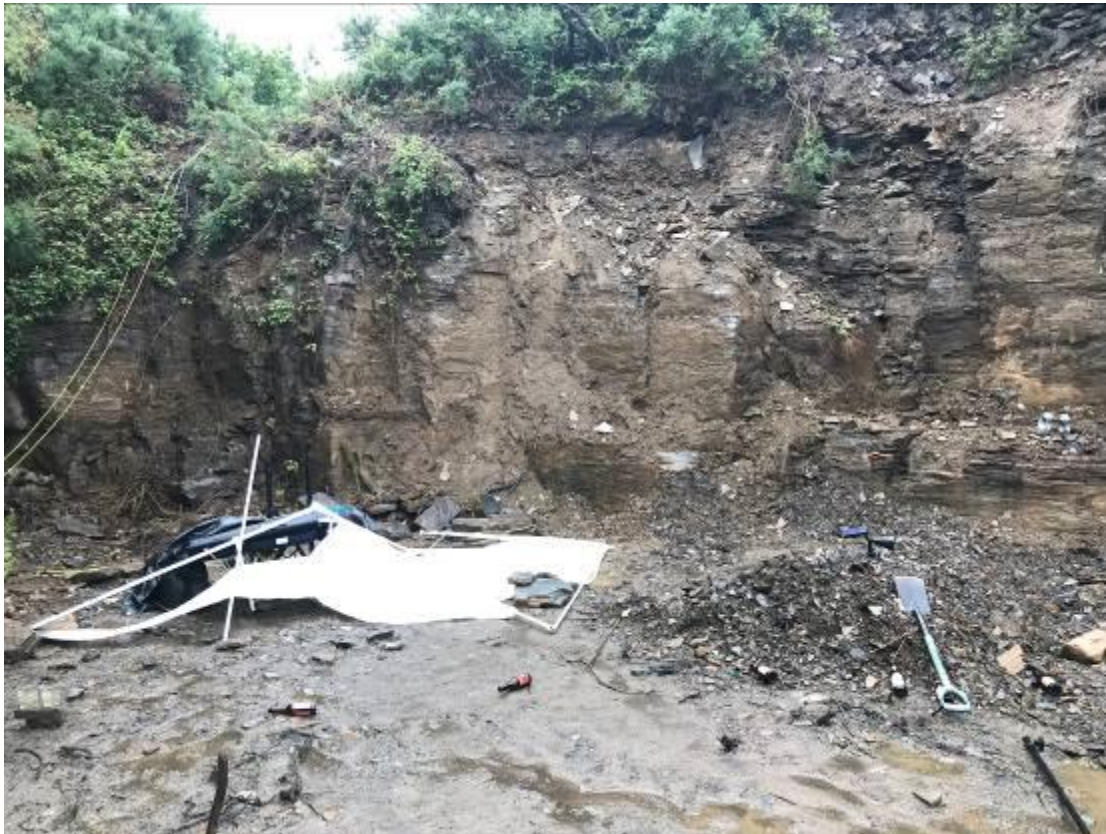
**Photograph 15 – Recently used shelter in quarry floor**

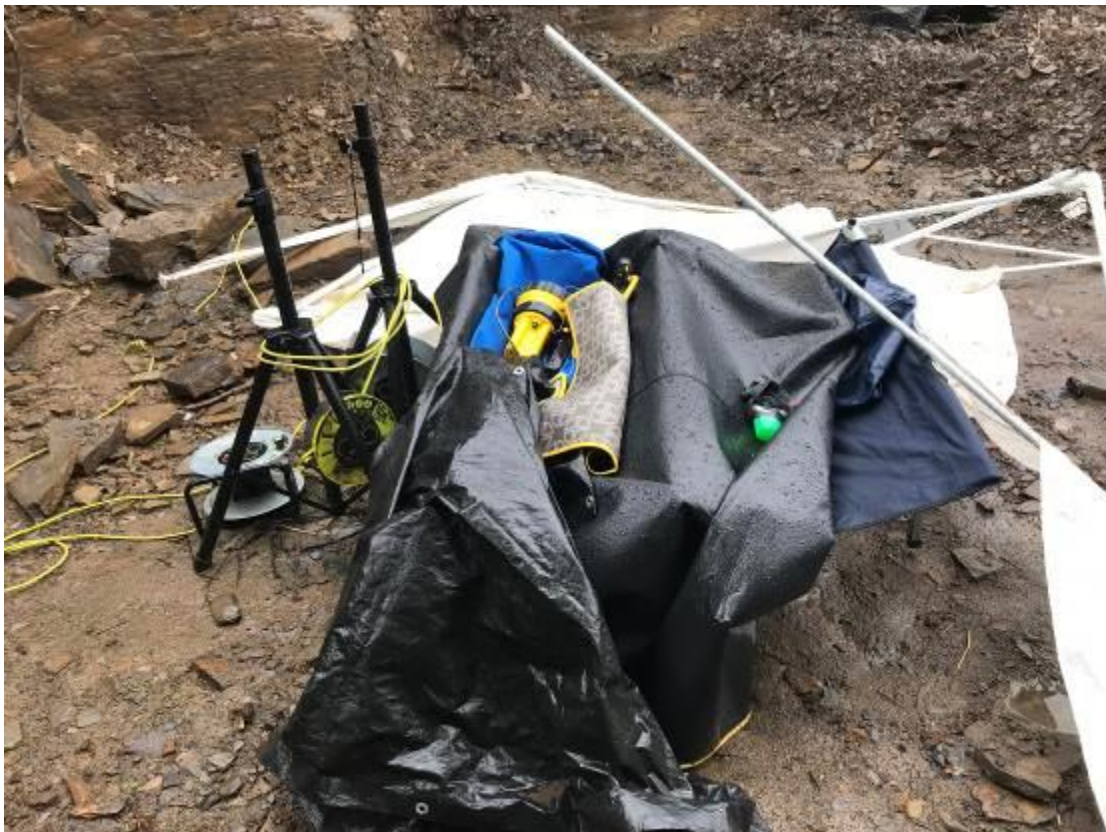
**Photograph 16 – Shelter showing electricity cables**

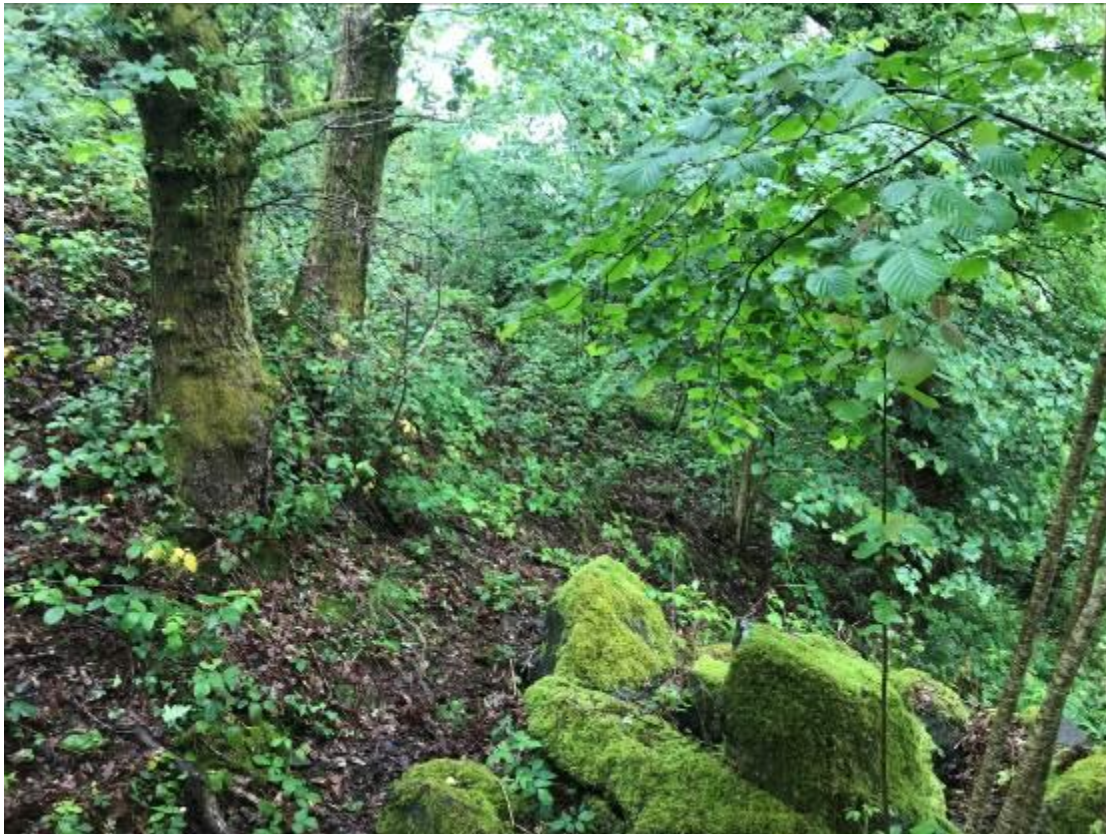
**Photograph 17 – Steep densely vegetated flanks of Site 1**

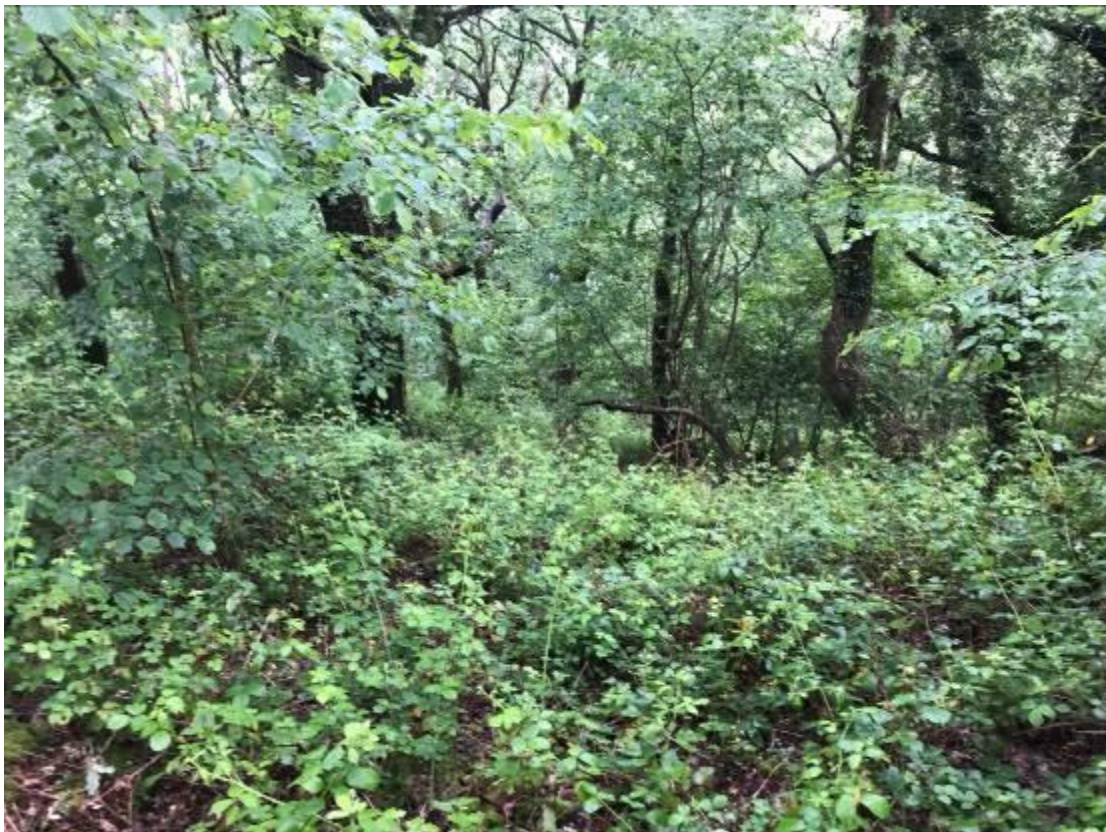
**Photograph 18 – Steep densely vegetated flanks of Site 1**

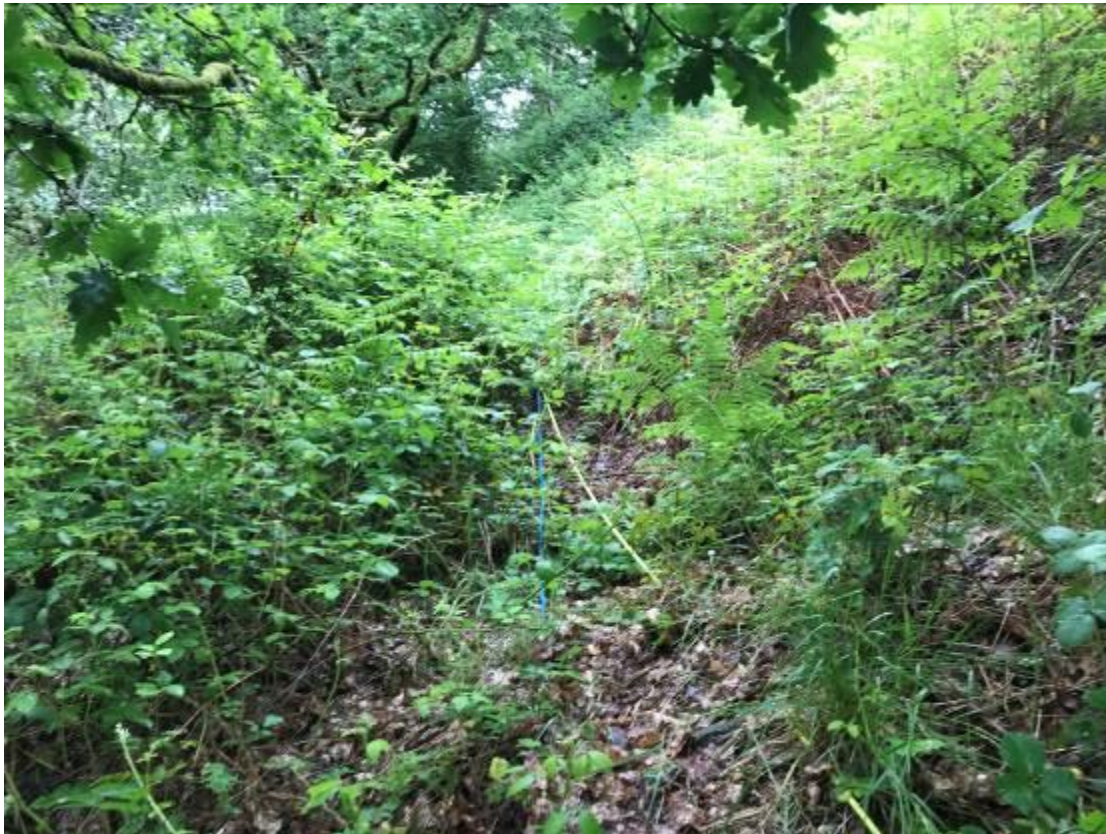
**Photograph 19 – Overgrown access path along toe of Site 1**

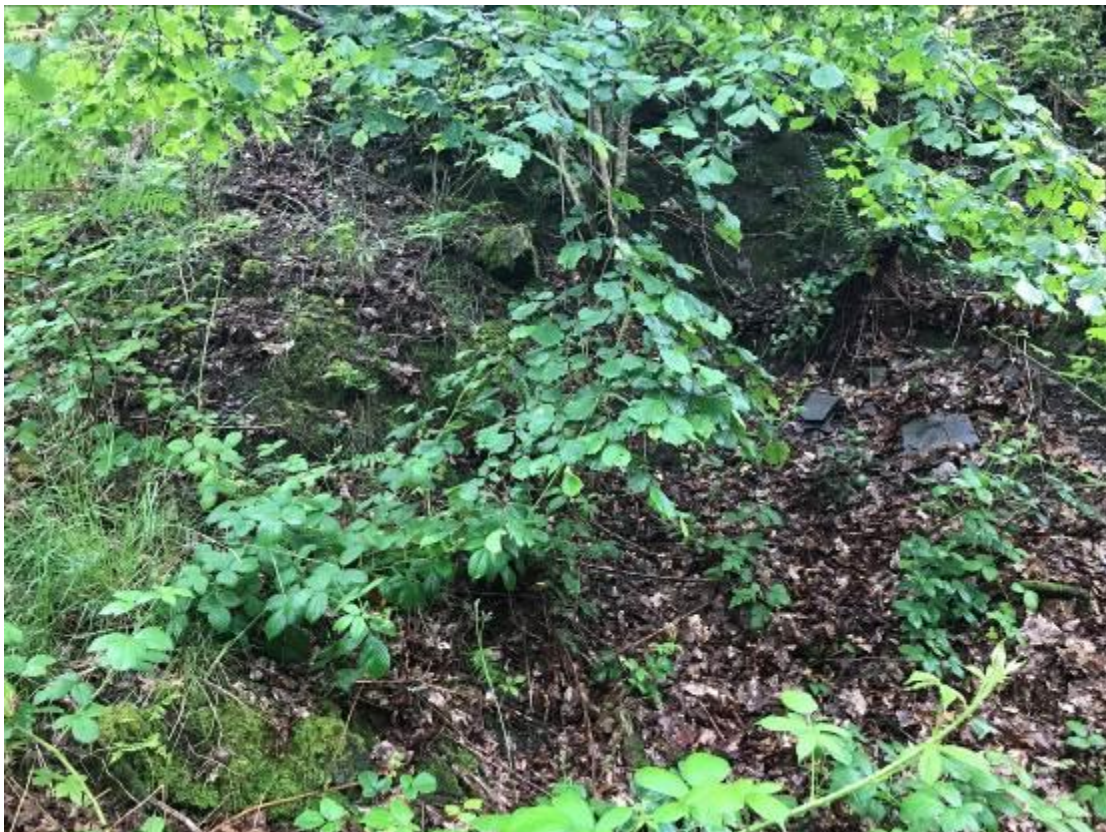
Very little evidence of recent instability was observed, with the exception of a small degraded shallow slip at approximate NGR 274910E 206861N (photograph 20) and some areas of soil creep.

Very little evidence of recent instability was observed, with the exception of a small degraded shallow slip at approximate NGR 274910E 206861N and occasional areas of soil creep. Surcharging of existing historic colliery and quarry spoil materials could take place following recent deposition of materials. A significant failure of the spoil heaps would impact on the access road to Pentwyn Farm and the properties along the access road. Blockage of the water course emanating from the mine entries could lead to a build-up of pore pressure and saturation of the spoil, leading to failure.

**Photograph 20 – Small slip on flank of Site 1**

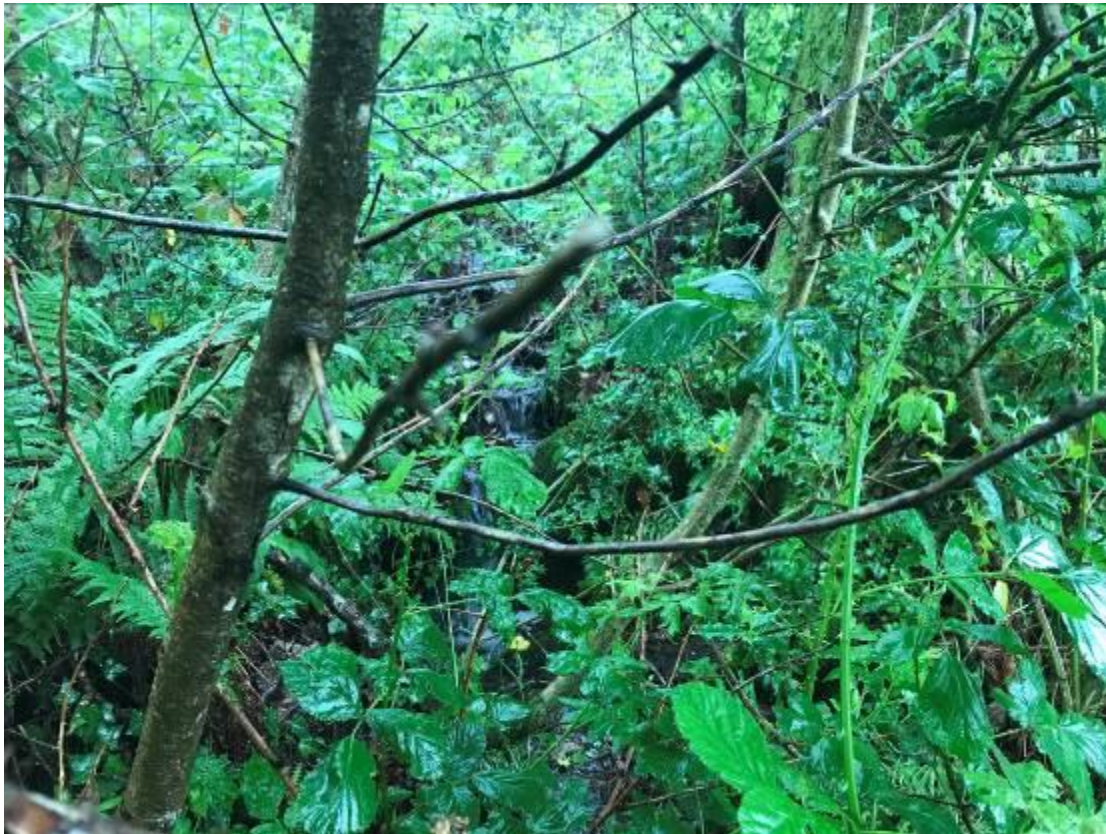
A spring was observed emanating from the vicinity of mine adit reference 274206-026 at NGR 274988E 206957N (photograph 21). The spring was observed as forming a small marshy area, subsequently flowing overland and downslope in a south-easterly direction.

**Photograph 21 – Minor watercourse at head of Site 2**

- Consider clearing vegetation to allow inspection of drainage routes at Site 2.
- Ensure drainage infrastructure to the rear of Godre'r Graig Primary School is regularly inspected and maintained.

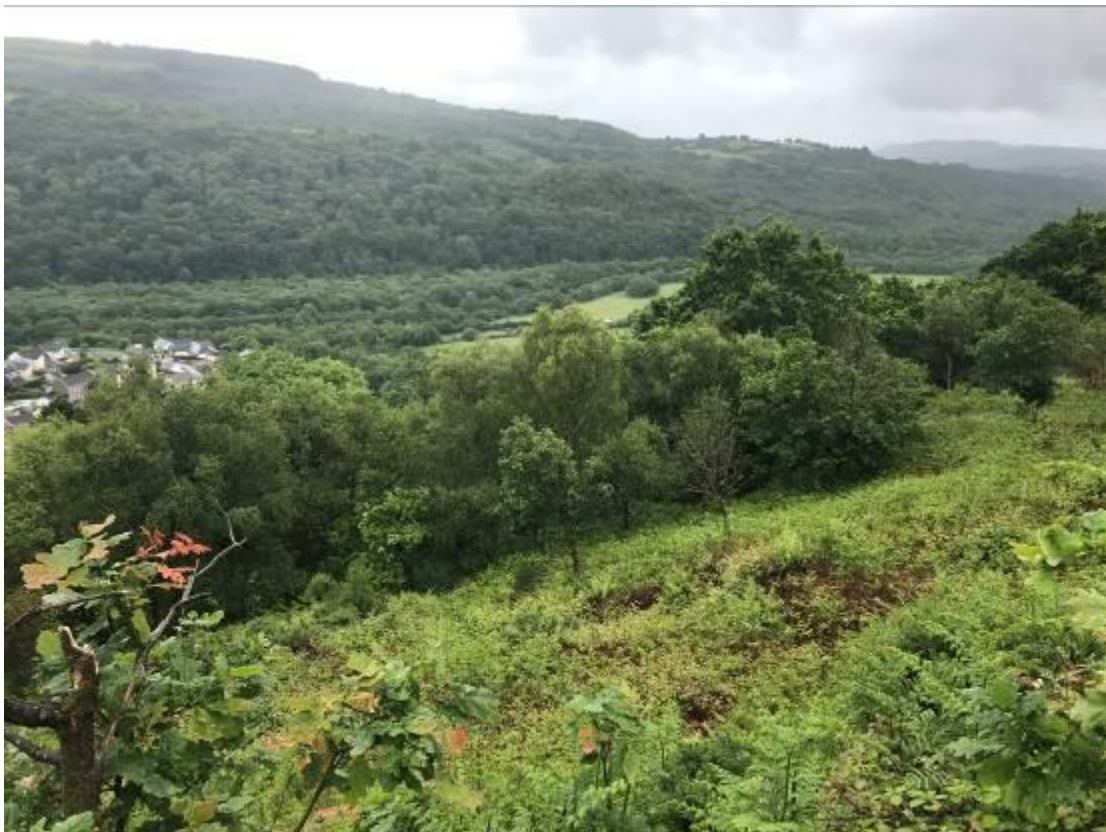
The inspection route then accessed the area encompassed by Site 2, crossing a derelict fence-line and heading east across an area of dense fern and bramble vegetation with a sporadic cover of trees. The density of vegetation prevented close inspection of materials or topography and access was extremely difficult (photographs 22, 24 and 25).

**Photograph 22 – General view of Site 2 showing dense vegetation coverage**

- Undertake an inspection during winter, when vegetation has died back to allow a more detailed viewing of the site with less vegetation constraints. The requirement for further inspections should be determined following the winter inspection.

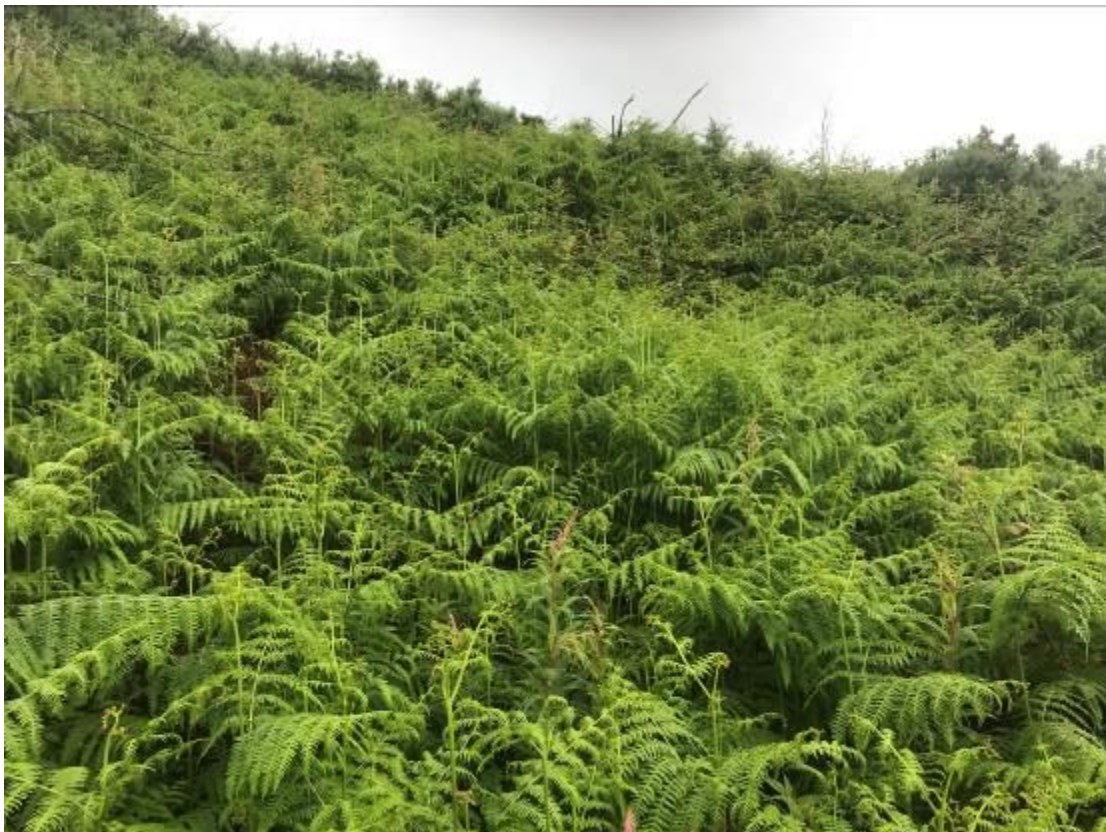
**Photograph 24 – Mid point of Site 2 showing dense undergrowth**

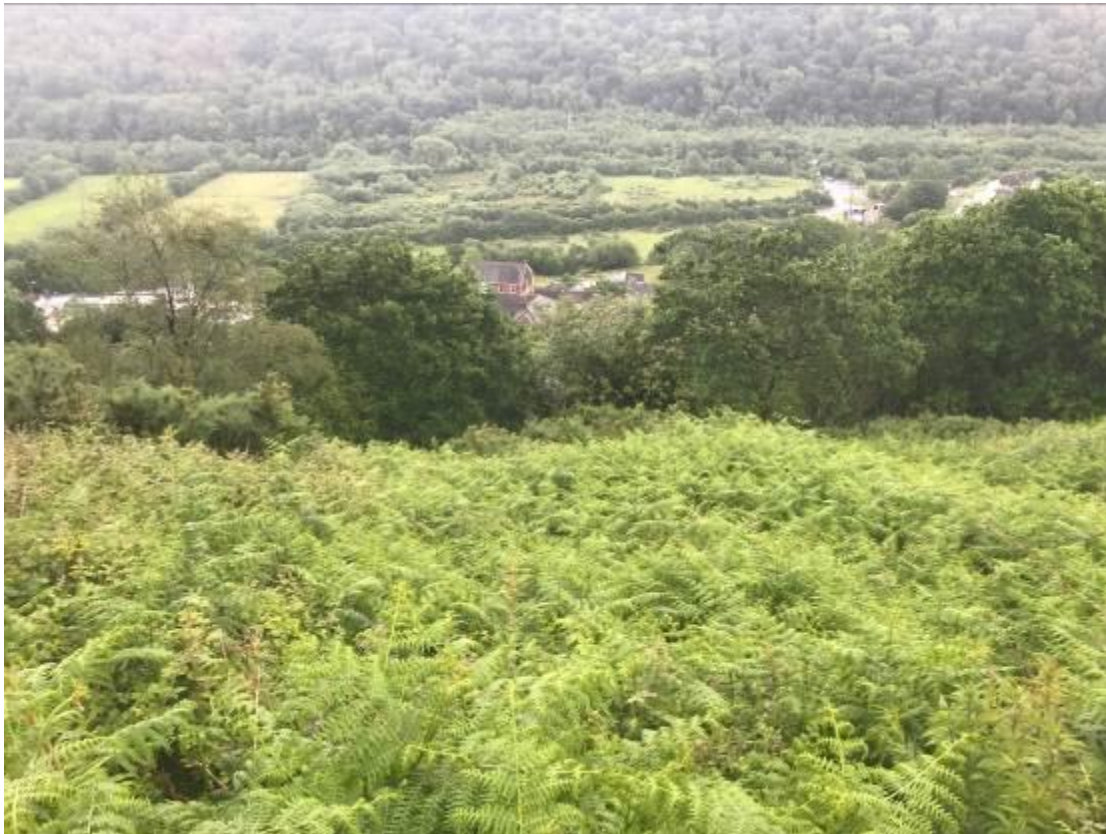
**Photograph 25 – View down-slope from crest of Site 2**

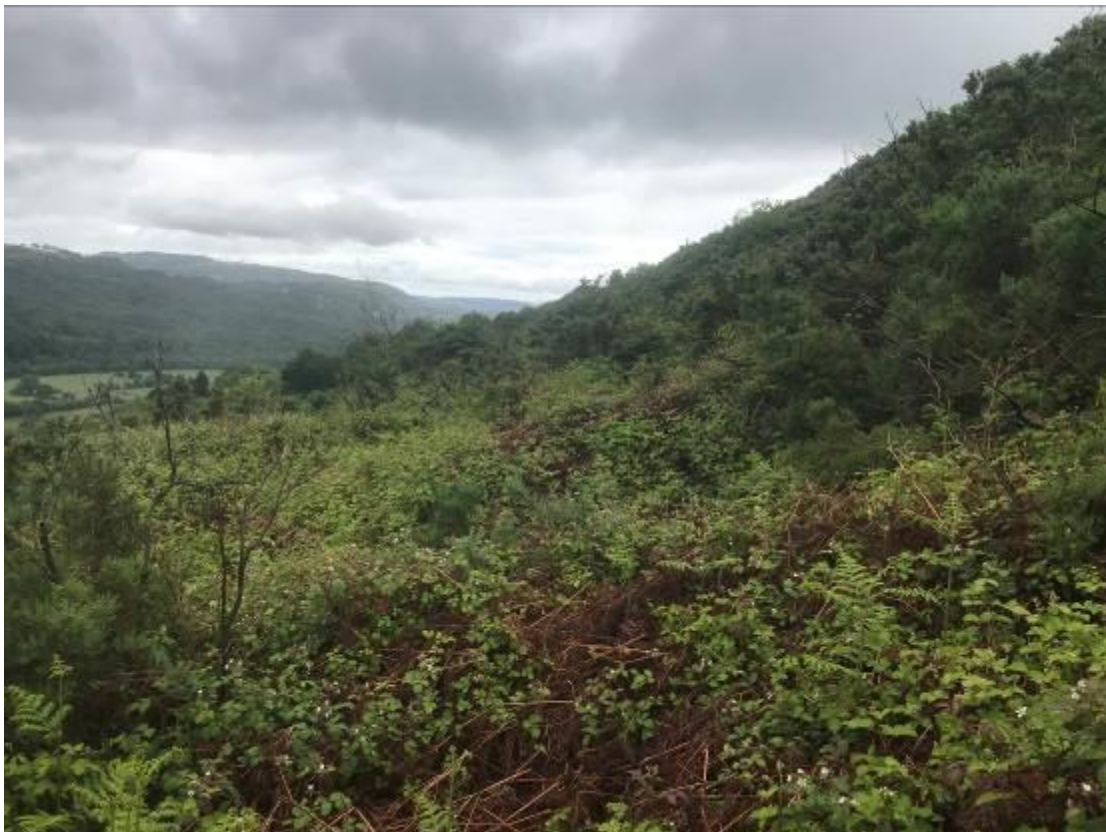
The inspection route then turned north east and viewed the series of recorded mine adits above Site 3, the entrances to which appeared to have collapsed many years ago. The colliery tips associated with these mine entries comprised a liner low mound of spoil forming a ridgeline at the head of Site 3 (photographs 26 to 28).

Evidence of slow soil creep and falls of rock from the escarpment above the line of adits was observed but these likely to present a low risk to public safety.

**Photograph 28 – View of Site 3 showing collapsed adit positions**

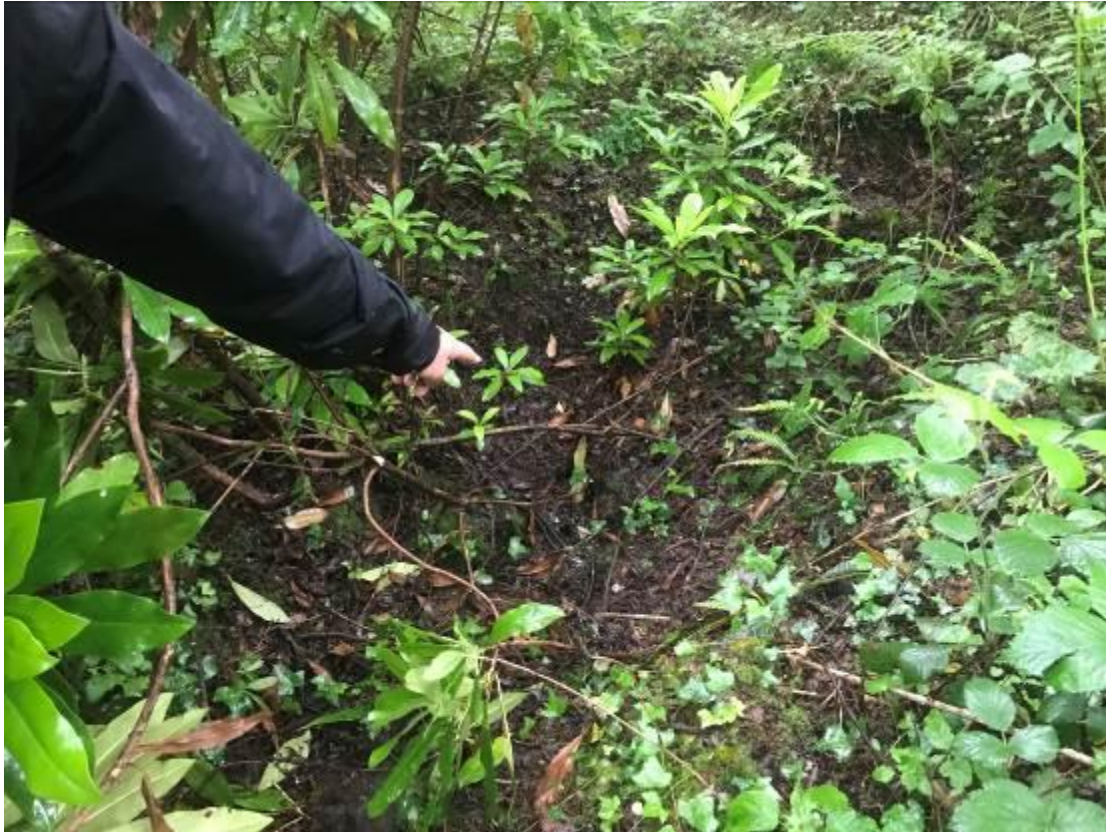
The watercourse disappeared and reappeared at several locations, probably through the coarse quarry spoil present, appearing again as a spring type feature at NGR 275067E 206915N (photograph 29). The watercourse then flowed in an unlined channel to enter a screened chamber at NGR 275135E 206891N (photograph 30), before entering a final chamber to the rear of Godre'r Graig Primary School at NGR 275157E 206892N (photograph 36). The watercourse then appeared to be culverted beneath the school.

**Photograph 29 – Moderate seepage at SW section of Site 2**

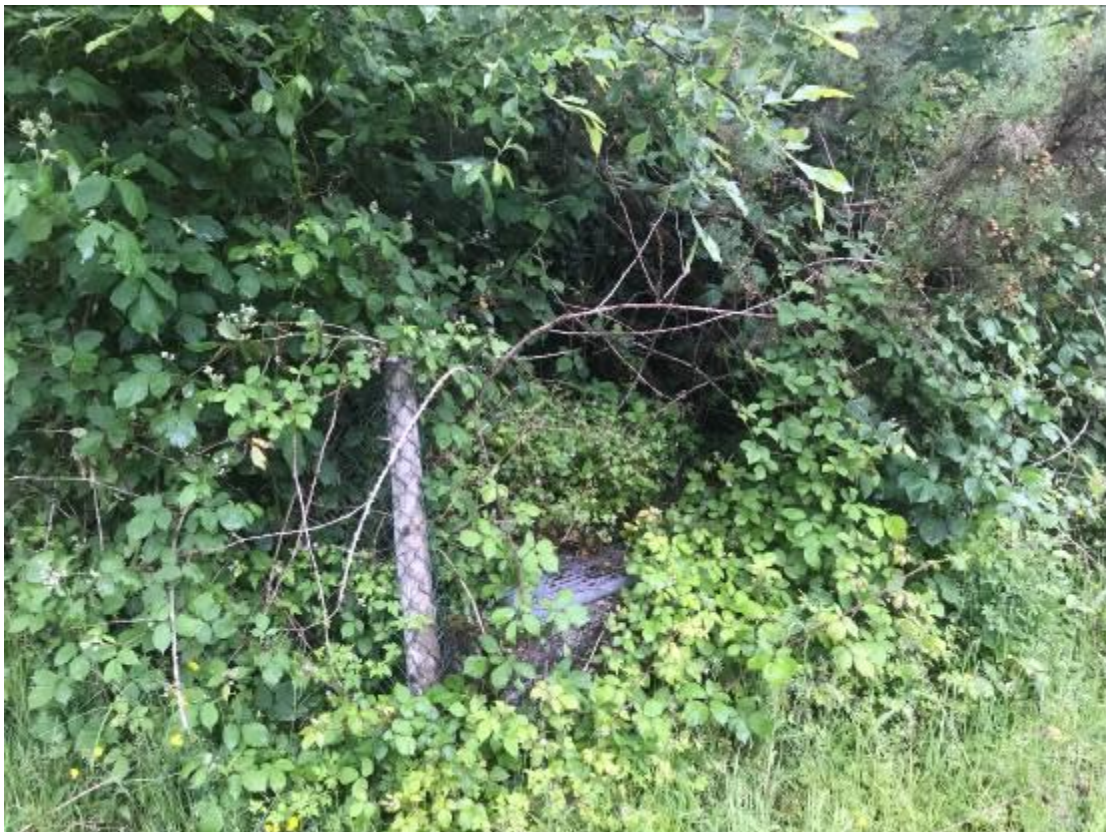
Blockages of the drainage infrastructure to the rear of Godre'r Graig Primary School would result in flooding and potential slope instability.

**Photograph 30 – Inlet chamber to rear of school**
