**The Coal  
Authority**

## **Site Inspection Report**

### **L44 – Godre’r Graig Tips**

**Date: July 2019**

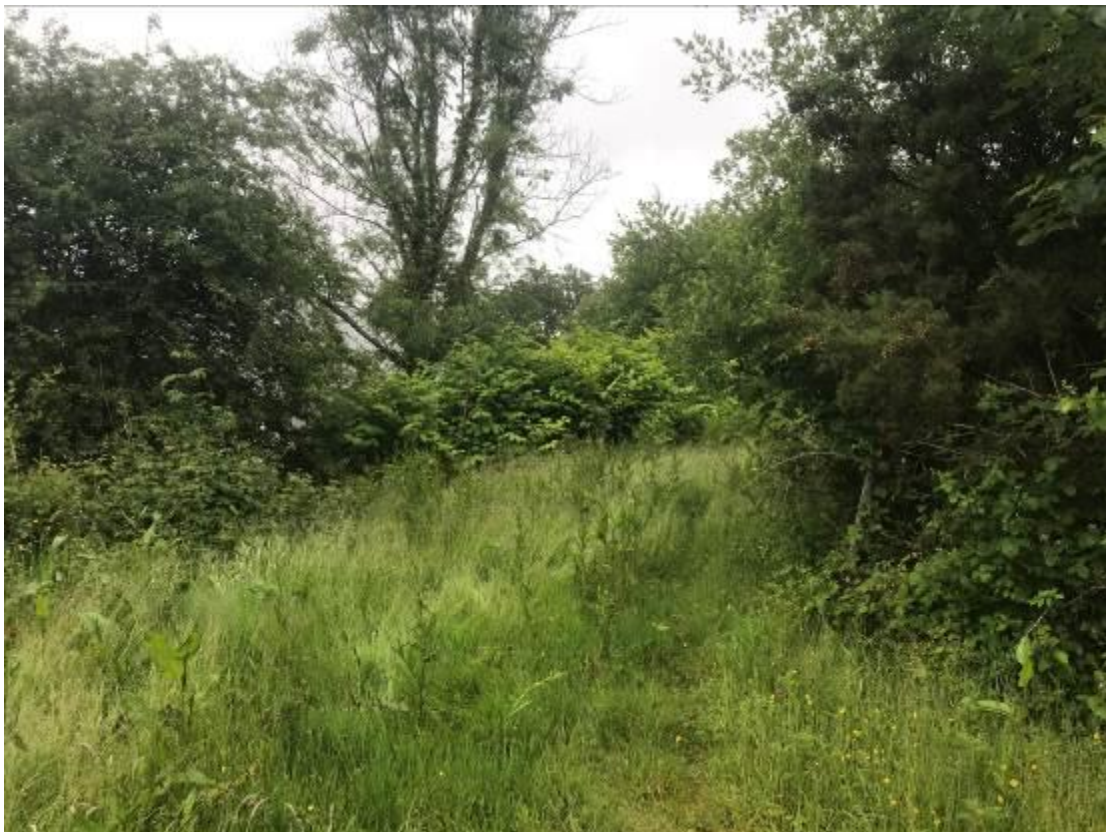
A derelict stable and several stands of Japanese Knotweed were observed present in this area (photographs 32 to 34).

**Photograph 32 – Field to rear of school showing Japanese Knotweed**

- Consider undertaking a slope stability analysis for Site 2 based on available information supplemented by ground investigation.
- Consider spraying of Japanese Knotweed to rear of school.

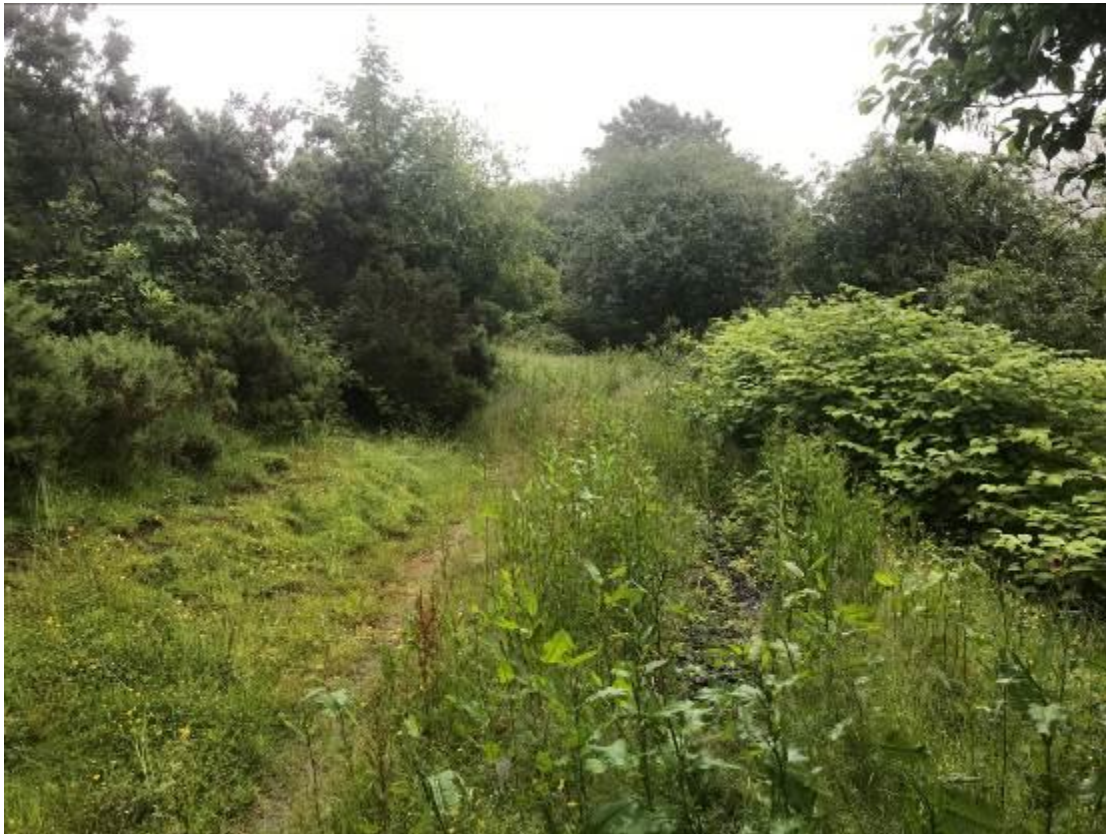
The inspection route traversed the slope behind Godre'r Graig Primary School, viewing the route of the watercourse referenced above and the drainage chambers to the rear of the school. A stone filled cut off drain with several manhole chambers was observed in the grazing field to the rear of the school, along with a spring located at approximate NGR 275164E 206992N. Flows from the spring were captured by the stone cut off drain (photographs 33, 35 and 37).

**Photograph 33 – Stone filled cut off drain to rear of school**

- Consider clearing vegetation to allow inspection of drainage routes at Site 2.
- Ensure drainage infrastructure to the rear of Godre'r Graig Primary School is regularly inspected and maintained.

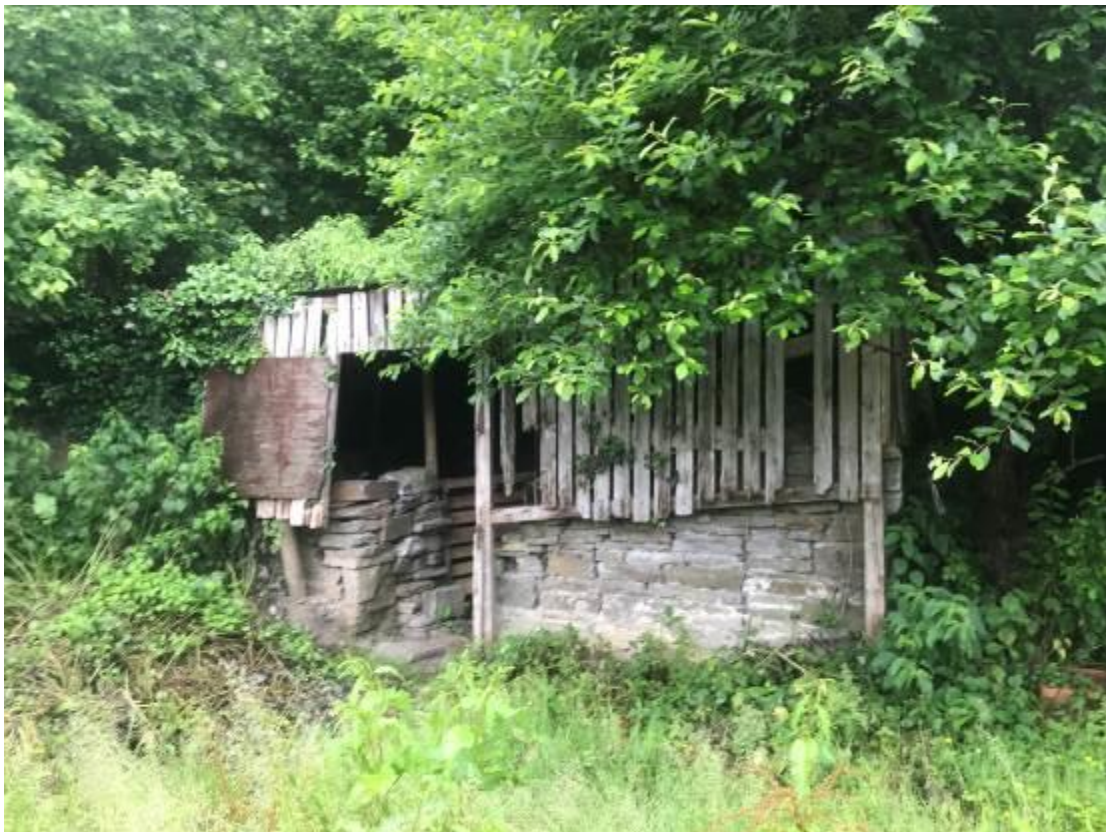
**Photograph 34 – Derelict stable to rear of school**

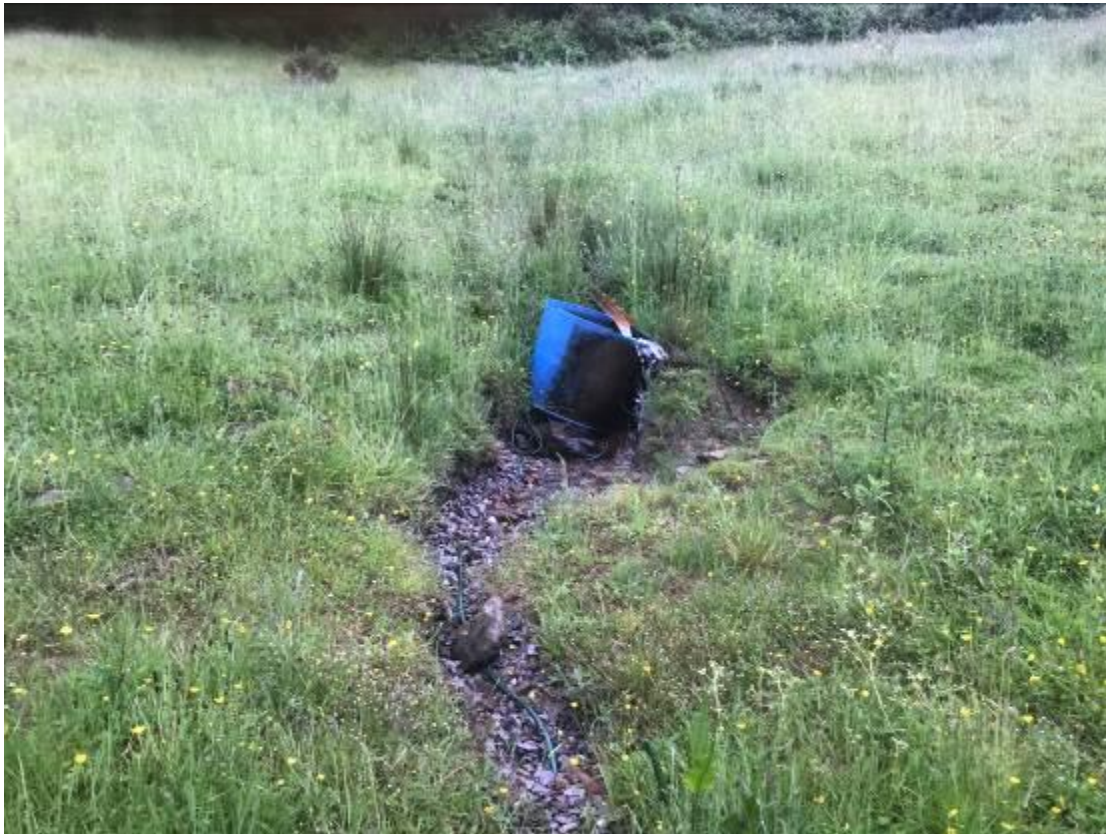
**Photograph 35 – Strong seepage to rear of school**

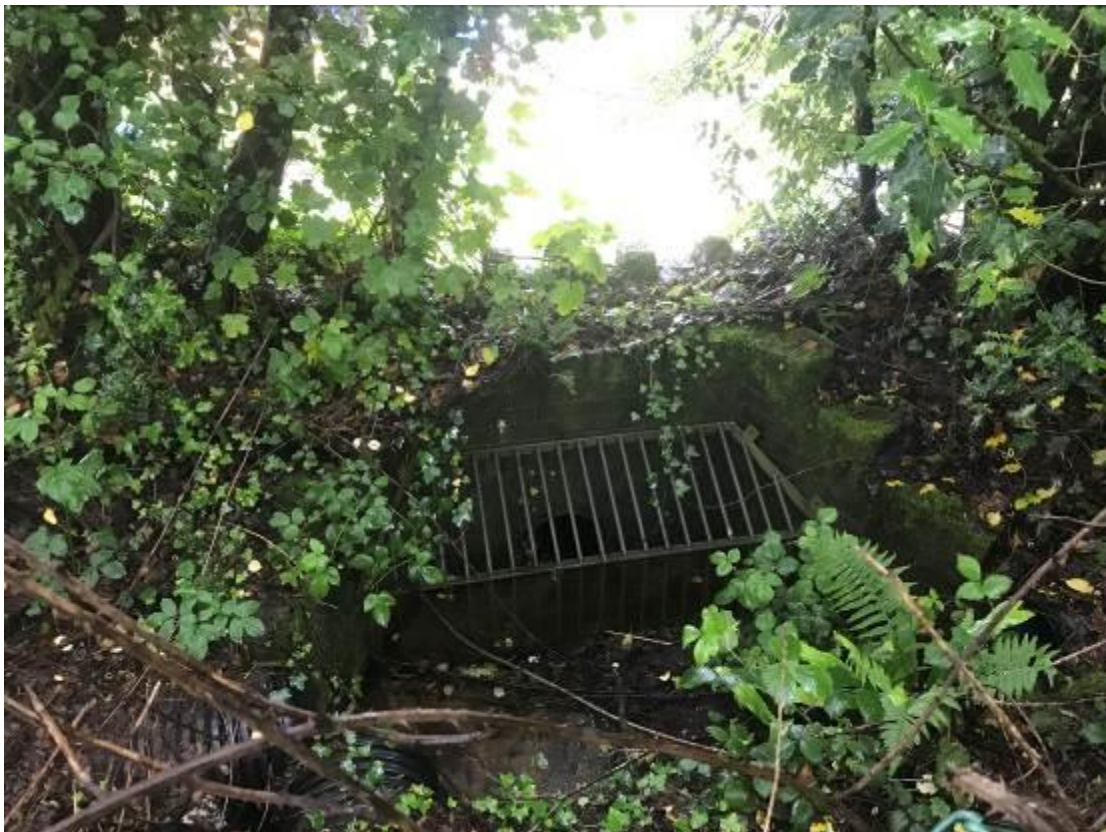
The watercourse disappeared and reappeared at several locations, probably through the coarse quarry spoil present, appearing again as a spring type feature at NGR 275067E 206915N (photograph 29). The watercourse then flowed in an unlined channel to enter a screened chamber at NGR 275135E 206891N (photograph 30), before entering a final chamber to the rear of Godre'r Graig Primary School at NGR 275157E 206892N (photograph 36). The watercourse then appeared to be culverted beneath the school.

Blockages of the drainage infrastructure to the rear of Godre'r Graig Primary School would result in flooding and potential slope instability.

**Photograph 36 – Inlet chamber at rear of school**

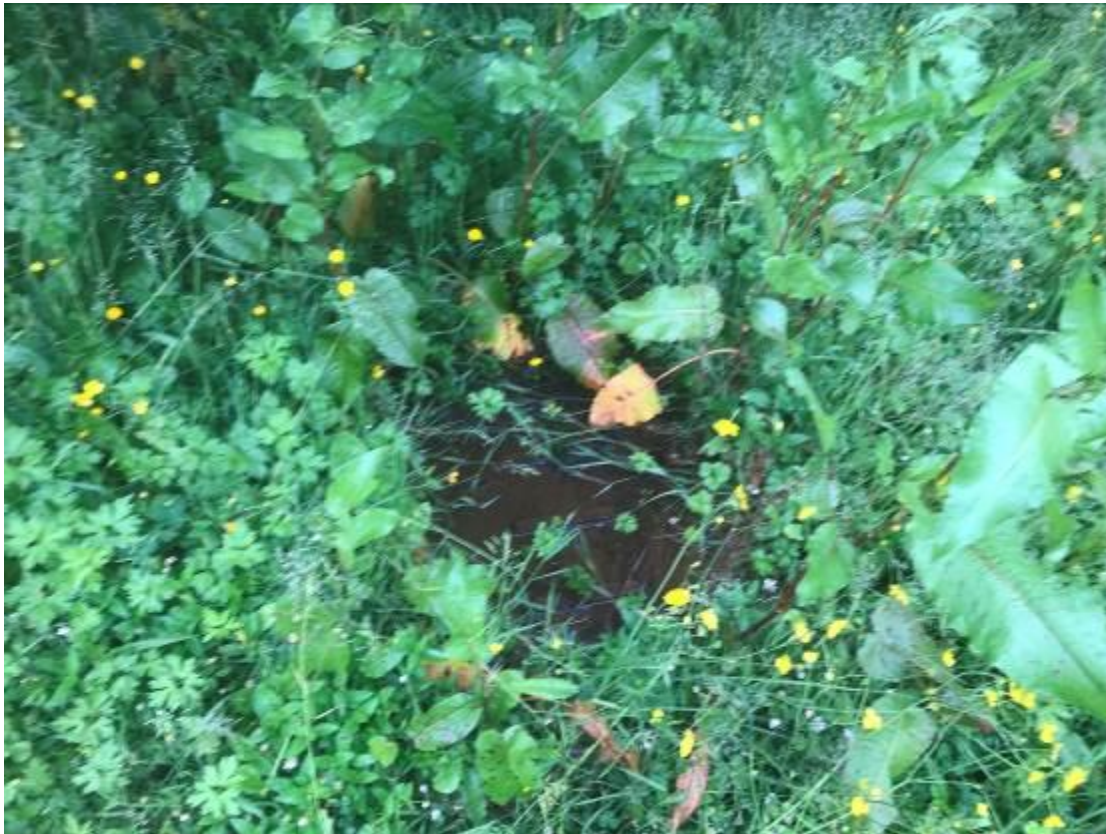
**Photograph 37 – Manhole cover on line of stone filed cut off drain**
