## **Godre'r Graig Primary School, Godre'r Graig Preliminary Investigation and Additional Assessment**

Report Reference: ESP.7234e.02.3302

## Godre'r Graig Primary School Preliminary Investigation and Additional Assessment

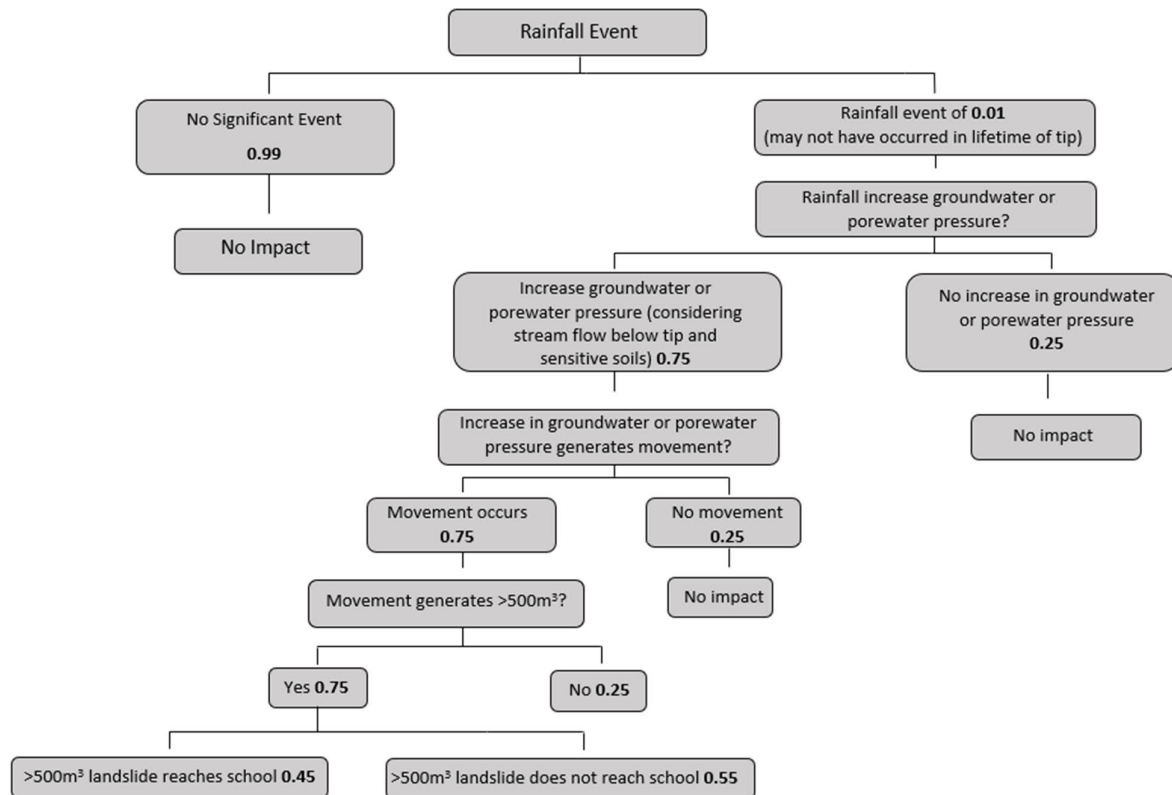
In order to assess the risk from Hazard 2, "impact from debris avalanche initiating from quarry spoil", an event tree was produced to provide a qualitative, indicative value of approximate annual probability for such an event occurring. Based on the event tree and the qualitative risk analysis matrix detailed in the previous report (ESP, 2019 -Section 7), a medium risk was identified.

Using the probabilities assigned in the event tree, for a 1 in 100 year rainfall event (which is equivalent to 0.01), it suggests that the estimated annual probability of a landslide hitting the school is 0.0019, or  $1.9 \times 10^{-3}$ .

This annual probability correlates to a 'possible' likelihood i.e. the event could occur under adverse conditions over the design life. Using a consequence of 'moderate', for a >500m³ landslide hitting the school, the qualitative risk assessment is of medium risk.

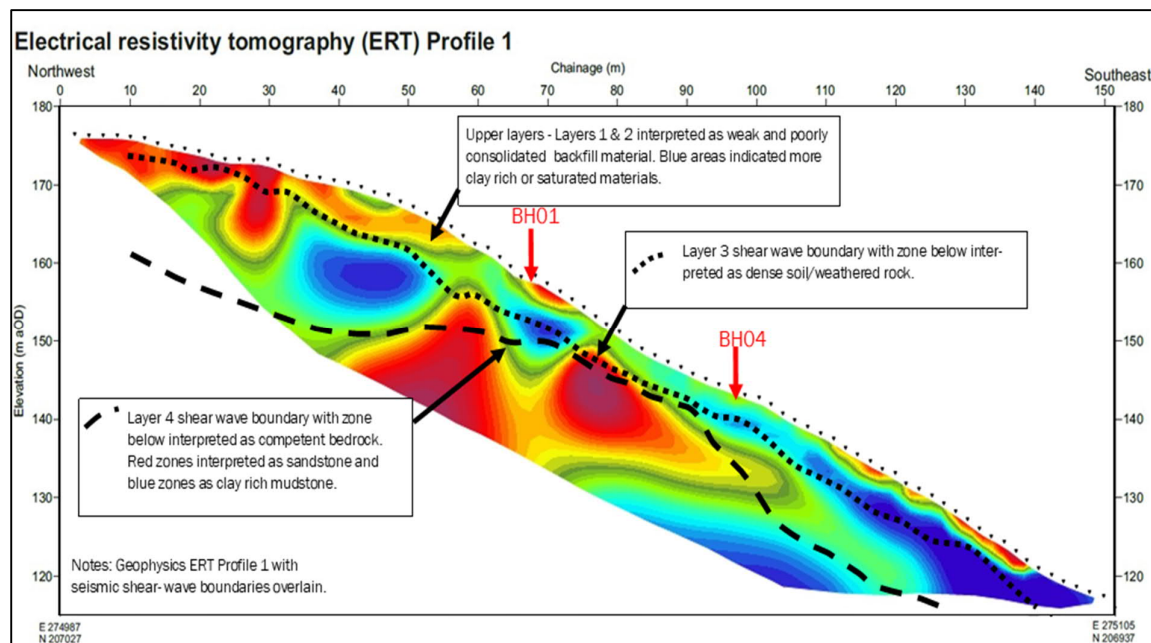
**Insert 9:** Summary of geophysical data (ERT and Seismic data) interpolated from Terradat report (2019). Full report displayed in Appendix K.

In the lower portions of the slope, the more conductive material is present at shallower depths and becomes indistinguishable from the unit interpreted as mudstone bedrock. Trial pitting in the area indicates this portion of the layer may represent clay rich Glacial Diamicton.

Laterally across the area, the resistivity survey indicates a deeper portion of dry backfill material to the west with a pinching out of the conductive backfill layer. This coincides with a marked drop in the S-wave refraction boundary and is indicative of deeper rockhead. The more conductive backfill is consistently present to the east which may be representative of the excavation related to the Upper Pinchin coal seam. On the lower portions of the slope, the Profile 2 indicates a possible shallowing out of the backfill material to the east and may represent the western extent at this level. Profile 2 corresponds with the location of former adits identified by the Coal Authority and in the historical mapping.

The seismic survey generally shows good correlation between the P and S-wave boundaries of layer 3 (dense soil/weak rock) and termination of the cable percussive boreholes on presumed weathered Upper Coal Measures. Comparison of BH05 shows good correlation between the P and S-wave Layer 4 (competent rock).

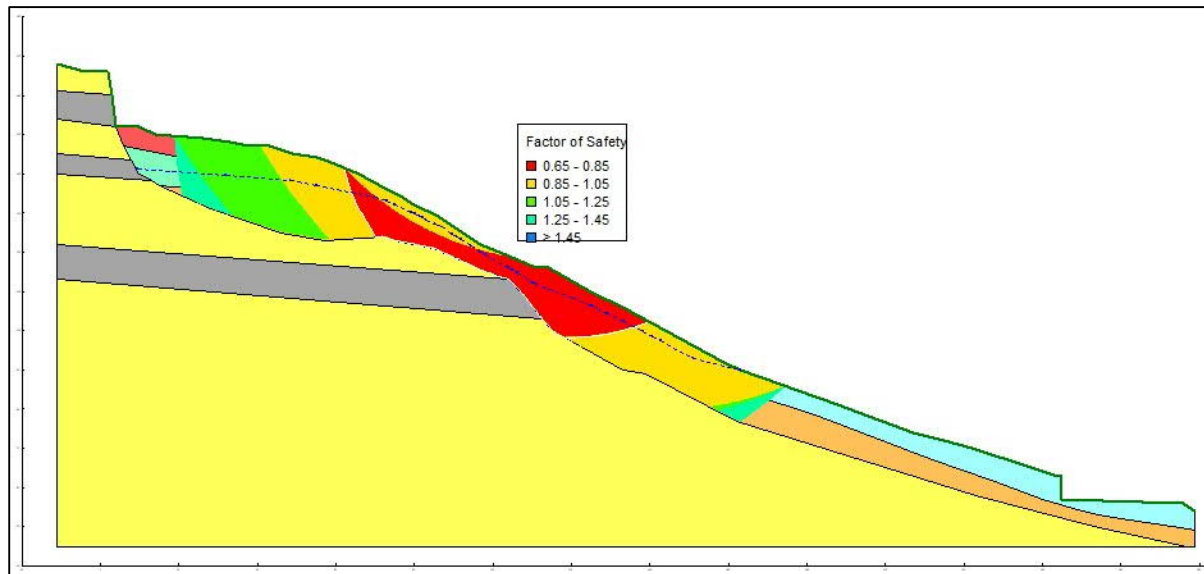
**Insert 11:** Contoured failure planes in Quarry Spoil Tip using Reasonable Case Parameters.

Analyses of the section has shown that for the strength parameters outlined in Table 9 and on the assumed piezometric surfaces shown, a minimum factor of safety of around 0.6 can be assumed when considering the current slope geometries. The model shows numerous potential failures below a Factor of Safety of 1, suggesting that the Quarry Spoil Tip is unstable.

The site walkover, historical mapping and aerial photographic review show no sign of instability predicted by the modelling. It is therefore likely that the Reasonable Case Material Parameters adopted are too low as signs of movement would likely be visible at the Quarry Spoil Tip.

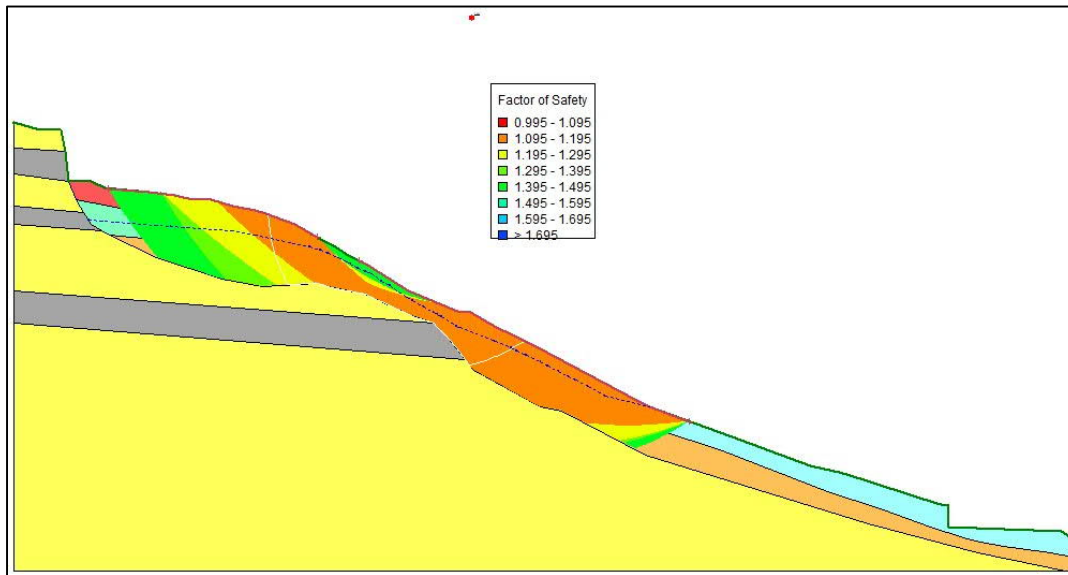
**Insert 12:** Contoured failure planes in Quarry Spoil Tip using Upper Range Parameters.

Analyses of the section has shown that for the Upper Range Parameters outlined in Table 10 and on the assumed piezometric surfaces shown, a minimum factor of safety of around 0.95 can be assumed when considering the current slope geometries. Much of the possible failure planes are however above unity, i.e. have a factor of safety of 1 or above, as can be seen on Insert 12 below.

The modelling shows that the Quarry Spoil Tip could be considered marginally stable, which is likely to represent the current condition, as the material would have been 'end tipped' and reached a state of stability on the hillside. Based upon the above, it is likely that the Upper Range Parameters are reasonable for modelling of the slope.

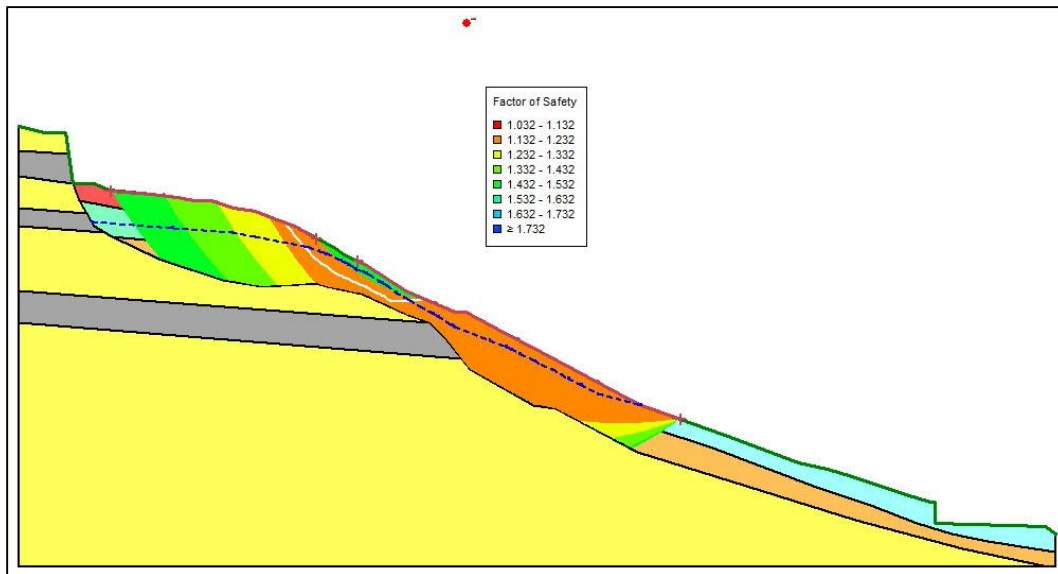
**Insert 13:** Contoured failure planes in Quarry Spoil Tip using Upper Range Parameters – DA1 C1.

The above inserts show that the worst-case design situation would be DA1, C2, with significantly lower FoS, or AFs being realised.

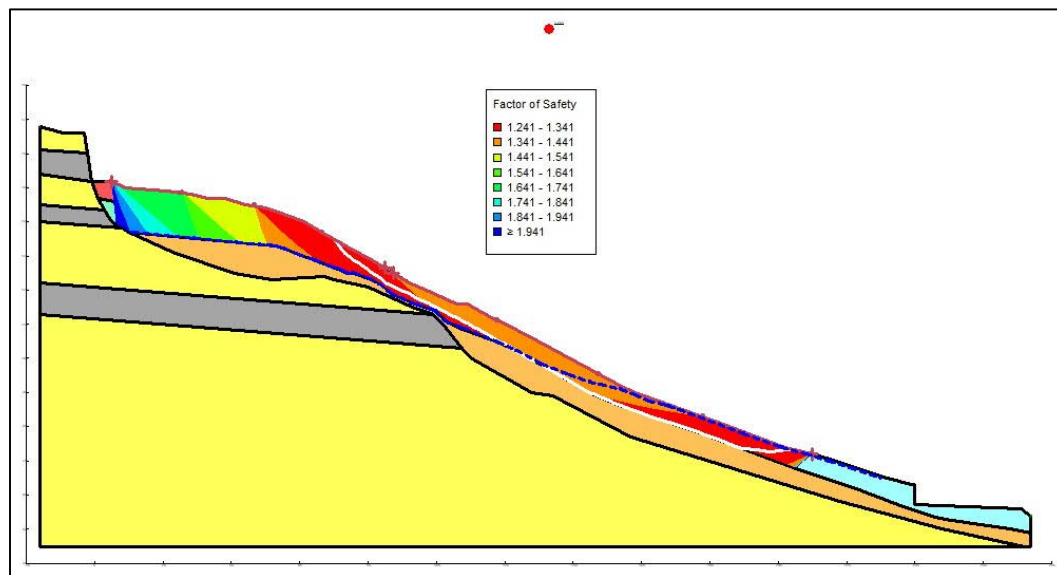
**Insert 15:** Contoured failure planes in Quarry Spoil Tip using Upper Range Parameters and groundwater at the tip base – global stability.

The above shows that an increase in groundwater height decreased the quarry Spoil Tip stability and reducing the groundwater level to 2m below the expected base of the tip increased stability.
