0 I T' N	Cwar Pentwyn Quarry /	Tip Ref Number		L044B
Coal Tip Name	Cilmaengwyn	Ownership Status		Private
Located in	Godre'r Graig, Neath-Port Talbot	Tip Category		D
Led by	Undertaken on behalf of Welsh G		Government	
Date	05/09/2023	Date of last Detailed Inspection	13	3/06/2019
Weather	Sunny	Dry		Calm
Comments on access and any limitations	Access to the site was gained via an access track situated just off Graig Road, which leads to Pentwyn Farm.  It should be noted that this inspection was conducted without the benefit of a detailed site plan. Dense vegetation significantly limited accessibility and visual inspection. Therefore, instability within these areas could exist, but was not detectable at the time of the inspection. The location of the tip on privately owned land also limited the coverage of this inspection.			
		S		0101
	Investigate ownership of the sany, have been taken with rehistoric spoil.			Status 2

Coal Tip Name  Cwar Pentwyn Quarry /		Tip Ref Number	L044B
Coal Tip Name  Cwal Fellwyll Quality / Cilmaengwyn	Tip Category	D	
Date of Inspection	05/09/2023	Inspection led by

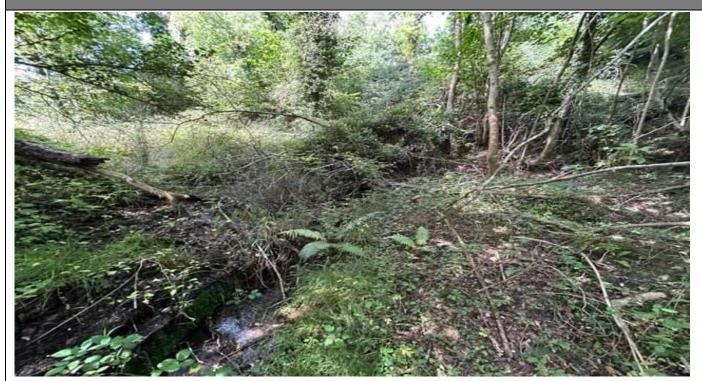
Photo No.	1	Comment
Feature ID	N/A	Comment

Adit (274206-025) located just to the south-west of the site boundary; associated with the 'Godre'r-Graig Higher / Pentwyn No. 3 Levels' coal tip.

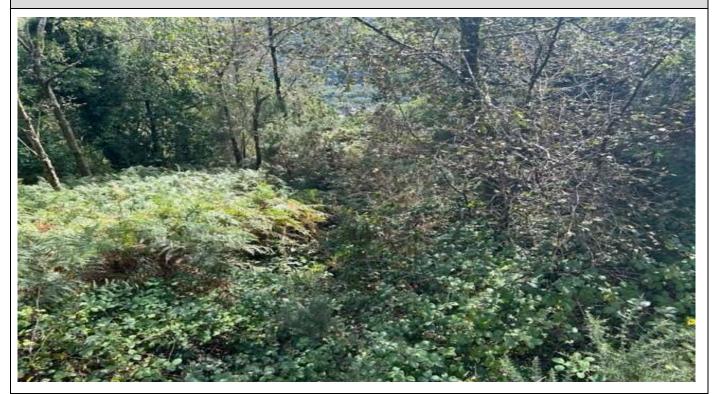
Photo No.	2		the site. Image conveys
Feature ID	23/L/01	Comment

View looking down the flank of the densely vegetated, eastern extent of the site. Image conveys associated accessibility issues.

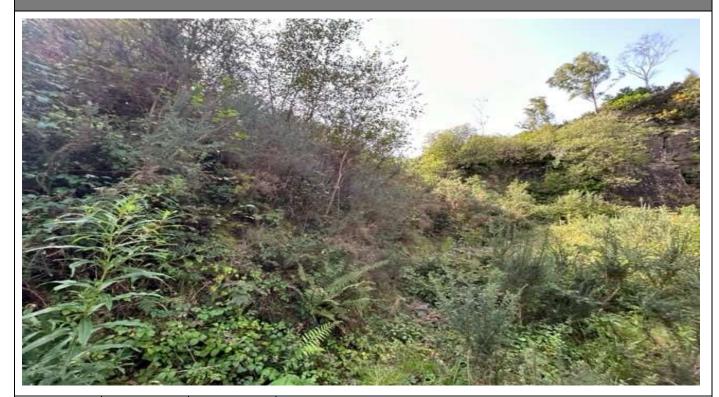
Photo No.	3	Comment
Feature ID	23/L/01	Comment

View looking towards the densely vegetated western extent of the site and adjacent quarry face.

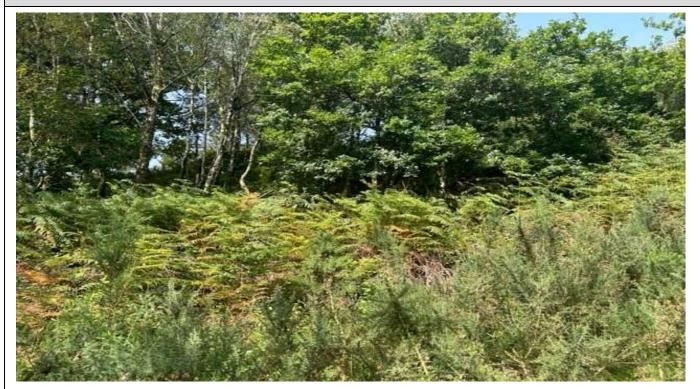
Photo No.	4	Comment	View looking towards the densely vegetated western extent of the site.
Feature ID	23/L/01	Comment

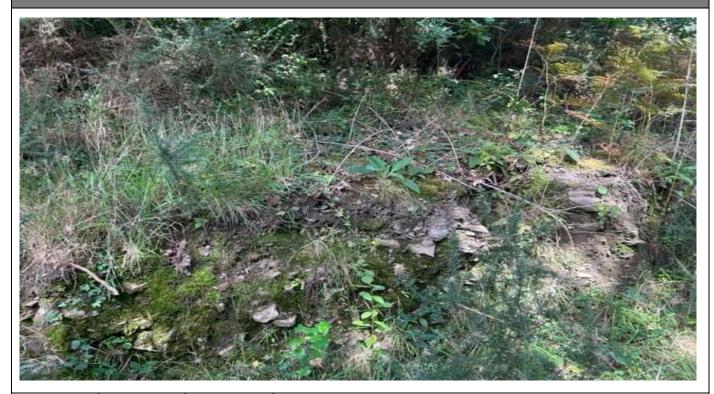
Photo No.	5	Comment
Feature ID	23/L/01	Comment

View looking towards a small exposure of sandstones, shales and clays; situated within the densely vegetated western extent of the site.

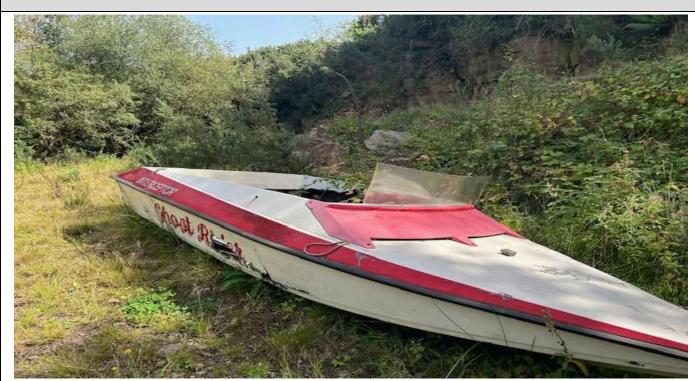
Photo No.	6	0	Evidence of human activity within the Quarry floor; abandoned boat.
Feature ID	23/L/04	Comment

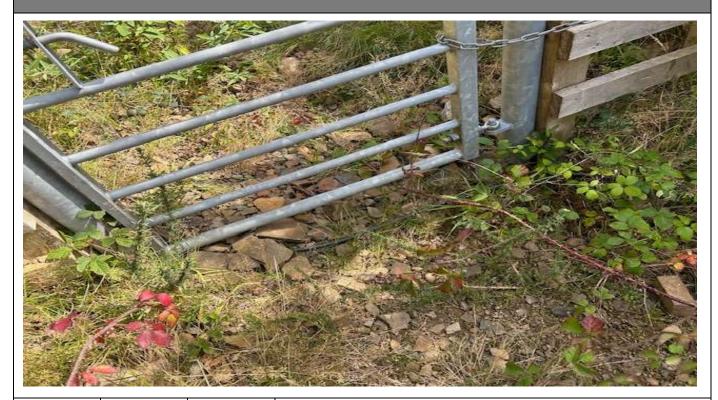
Photo No.	7	
Feature ID	23/L/04	Comment

23/L/04	Land Use		downslope (approx. 50 m).  Evidence of human activity within the Quarry floor, with	
23/L/04	Land Use		the presence of machinery, a boat and electricity	
			extension cables leading downslope (previously recorded	
			as extending downslope towards the properties named	
			'Glanderi' and 'Darren View').	
			Investigate company of the cite and establish what	
			Investigate ownership of the site and establish what measures, if any, have been taken with regard to placing	
			recent materials over historic spoil materials. Investigate	
	Recommendati	one	activity within Cwar Pentwyn to establish if planning or	
	Recommendati	0113	quarry regulations have been breached. Consider	
			undertaking a UAV LIDAR survey. Consider undertaking a geotechnical assessment to fully ascertain the	
			geotechnical characteristics of the tip.	
		CONTAMINATION / (	GEO-ENVIRONMENTAL	
ID	Feature	Location	Comment

Evidence of human activity within the Quarry floor, with the presence of electricity extension cables leading downslope (previously recorded as extending downslope towards the properties named 'Glanderi' and 'Darren View').

RAG Status: Capital & Maintenance Works	Investigate activity within Cwar Pentwyn to establish if planning or quarry regulations have been breached.			2
	Consider undertaking a UAV geotechnical assessment to f characteristics of the tip.	3		
General Remarks	This site comprises of a disused spoil tip located tip located downslope and adjacent to Cwar Pentwyn Quarry. Relatively recent quarrying activity appears to have been operated for the extraction of road building material, as evidenced by the spoil mounds and relatively recently re-furbished access track. The densely overgrown nature of the site significantly limited (and in most cases prevented) accessibility and visual inspection of the composition of the spoil material. The eastern extent of the site was completely overgrown and inaccessible. The limited exposures of the spoil accounting for the western extent of the site appeared to comprise of clays, sandstone and shale material; likely being associated with the adjacent Quarry as opposed to coal workings. However, there are three recorded adits (274206-11; 274206-19; 274206-25) located just to the south-west of the site boundary; as well as the closely associated 'Godre'r-Graig Higher / Pentwyn No. 3 Levels' coal tip just downslope (approx. 50 m). Therefore, despite no evidence of spoil material being identified (during this visit) within the given site boundary; the poor accessibility means that the possibility of the presence of spoil material cannot be completely discounted.

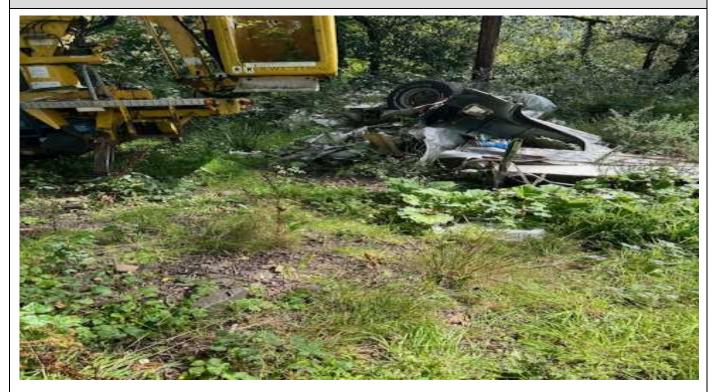
Photo No.	8	Comment
Feature ID	23/L/01	Comment

Machinery present on the north-eastern section of 'Godre'r-Graig Higher / Pentwyn No. 3 Levels' coal tip, located just downslope (approx. 50 m).

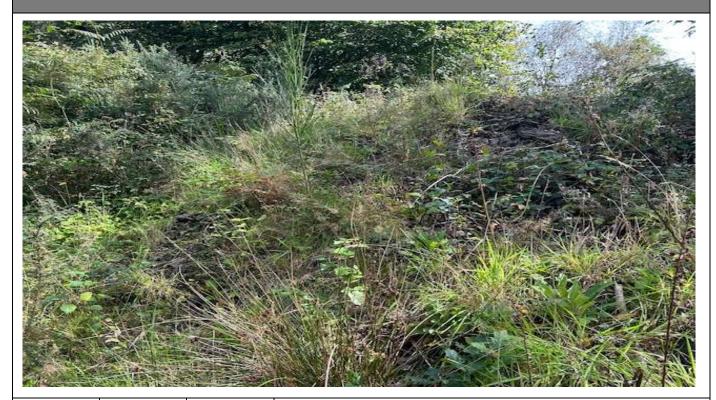
Photo No.	9	Comment
Feature ID	23/L/01	Comment

Sandstone quarry waste material deposited on the north-eastern section of 'Godre'r-Graig Higher / Pentwyn No. 3 Levels' coal tip, located just downslope (approx. 50 m).
