Coal Tip Name	Cwar Pentwyn Quarry / Cilmaengwyn	Tip Ref Number	L044B
		Ownership Status	Private
Located in	Godre'r Graig, Neath-Port Talbot	Tip Category	D
Led by		Undertaken on behalf of	Welsh Government
Date	08/11/2023	Date of last Detailed Inspection	05/09/2023
Weather	Overcast	Damp	Calm
Comments on access and any limitations	Access to the site was gained via an access track situated just off Graig Road, which leads to Pentwyn Farm. It should be noted that this inspection was conducted without the benefit of a detailed site plan. Dense vegetation significantly limited accessibility and visual inspection. Therefore, instability within these areas could exist, but was not detectable at the time of the inspection. The location of the tip on privately owned land also limited the coverage of this inspection.		
RAG Status: Capital & Maintenance Works	<p>Description</p> <p>Investigate ownership of the site and establish what measures, if any, have been taken with regard to placing recent materials over historic spoil.</p> <p>Investigate activity within Cwar Pentwyn to establish if planning or quarry regulations have been breached.</p> <p>Consider undertaking a UAV LIDAR survey. Consider

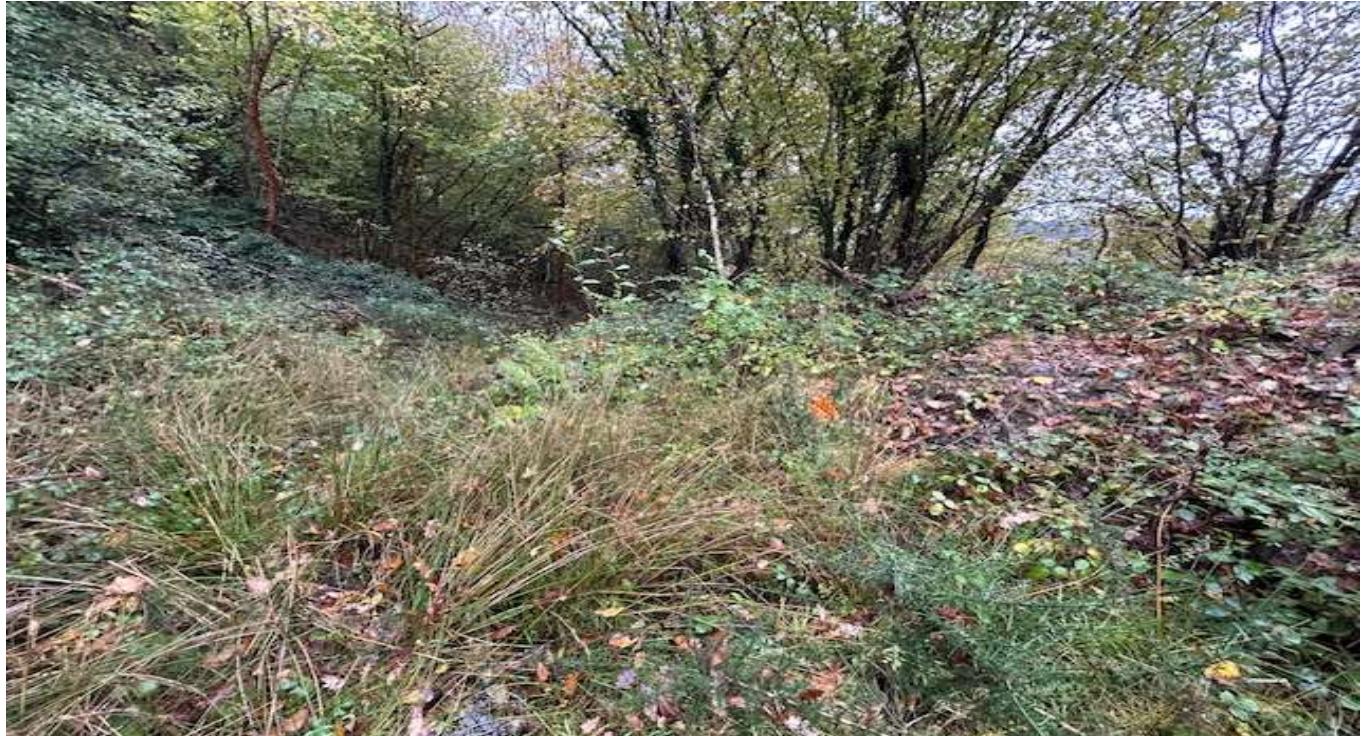
Photo No.	1	Comment	Sandstone quarry waste material deposited on the north-eastern section of 'Godre'r-Graig Higher / Pentwyn No. 3 Levels' coal tip, located just downslope (approx. 50 m).
Feature ID	23/L/03

23/L/03	Land Use	E - 274880 N - 206890	Relatively recent quarrying activity appeared to have taken place, with machinery and mounds of excavated material present. Sandstone quarry waste material has been deposited on the north-eastern section of 'Godre'r-Graig Higher / Pentwyn No. 3 Levels' coal tip, located just downslope (approx. 50 m).
23/L/04	Land Use	E - 274868 N - 206891	Evidence of human activity within the Quarry floor, with the presence of machinery, chairs, a boat and electricity extension cables leading downslope (previously recorded as extending downslope towards the properties named 'Glanderi' and 'Darren View').
Recommendations			Investigate ownership of the site and establish what measures, if any, have been taken with regard to placing recent materials over historic spoil materials. Investigate activity within Cwar Pentwyn to establish if planning or quarry regulations have been breached. Consider undertaking a UAV LIDAR survey. Consider undertaking a geotechnical assessment to fully ascertain the geotechnical characteristics of the tip.

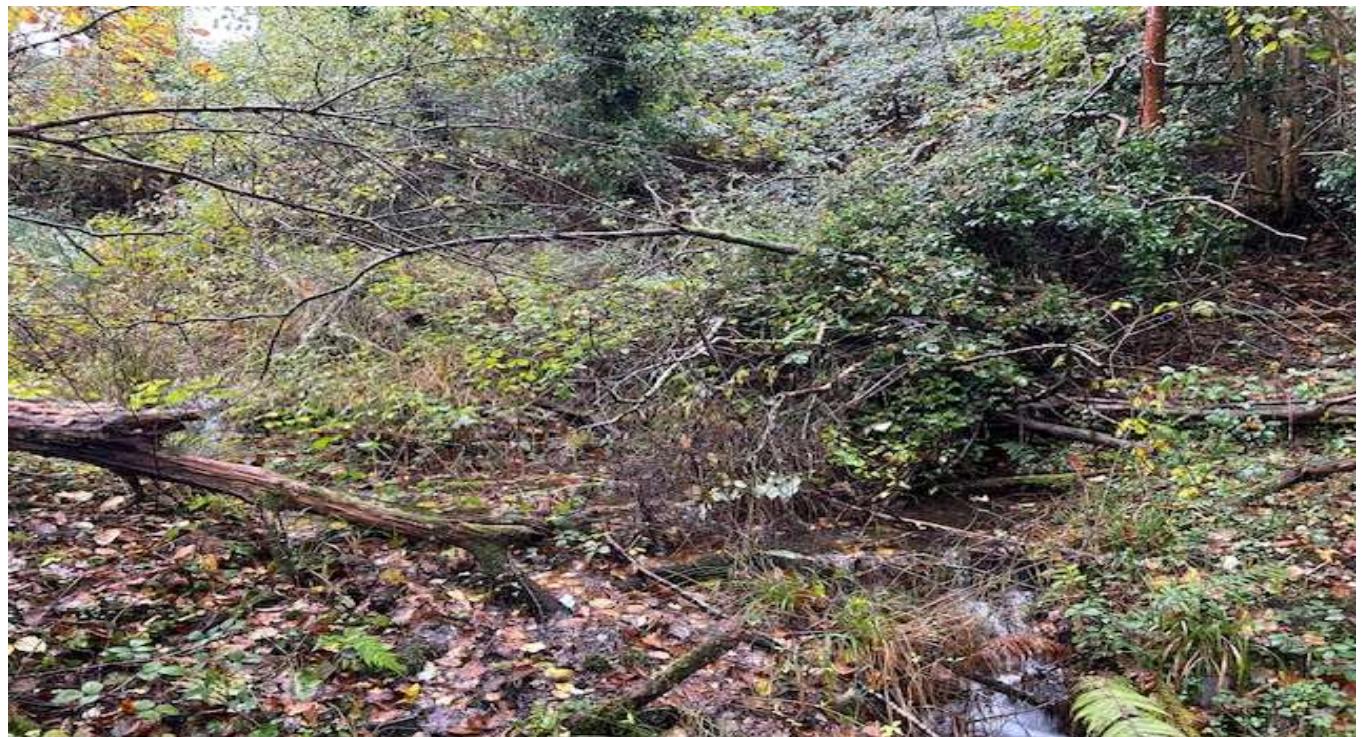
Photo No.	2	Comment	Adit (274206-025) located just to the south-west of the site boundary; associated with the 'Godre'r-Graig Higher / Pentwyn No. 3 Levels' coal tip.
Feature ID	N/A

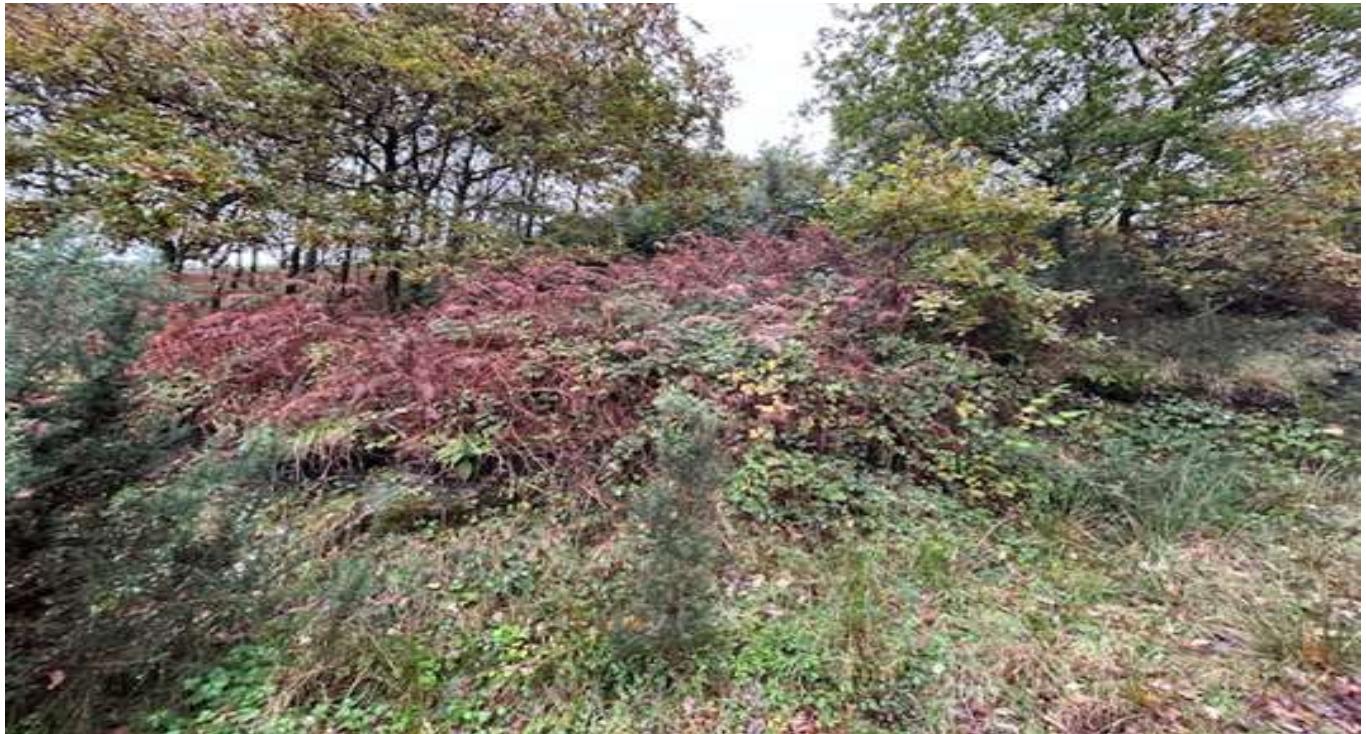
Photo No.	3	Comment	View looking towards the densely vegetated western extent of the site.
Feature ID	23/L/01

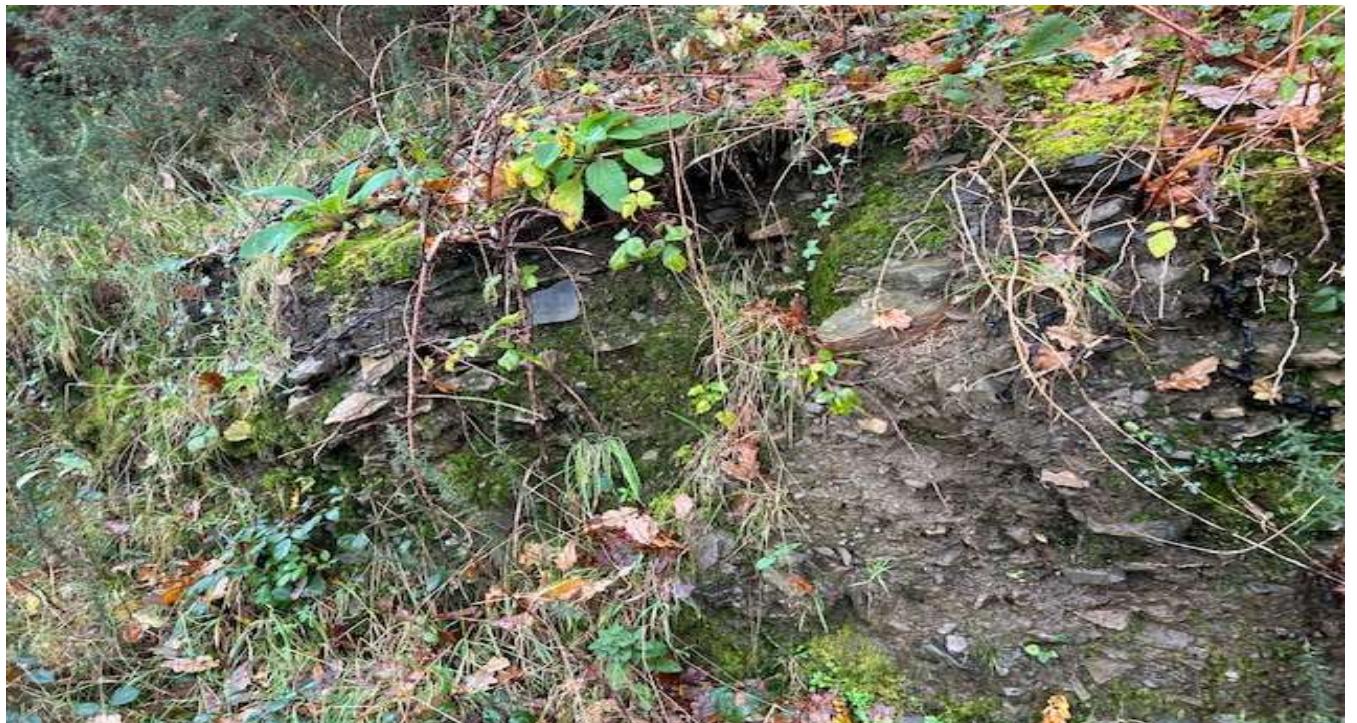
Photo No.	4	Comment	View looking towards a small exposure of sandstones, shales and clays; situated within the densely vegetated western extent of the site.
Feature ID	23/L/01

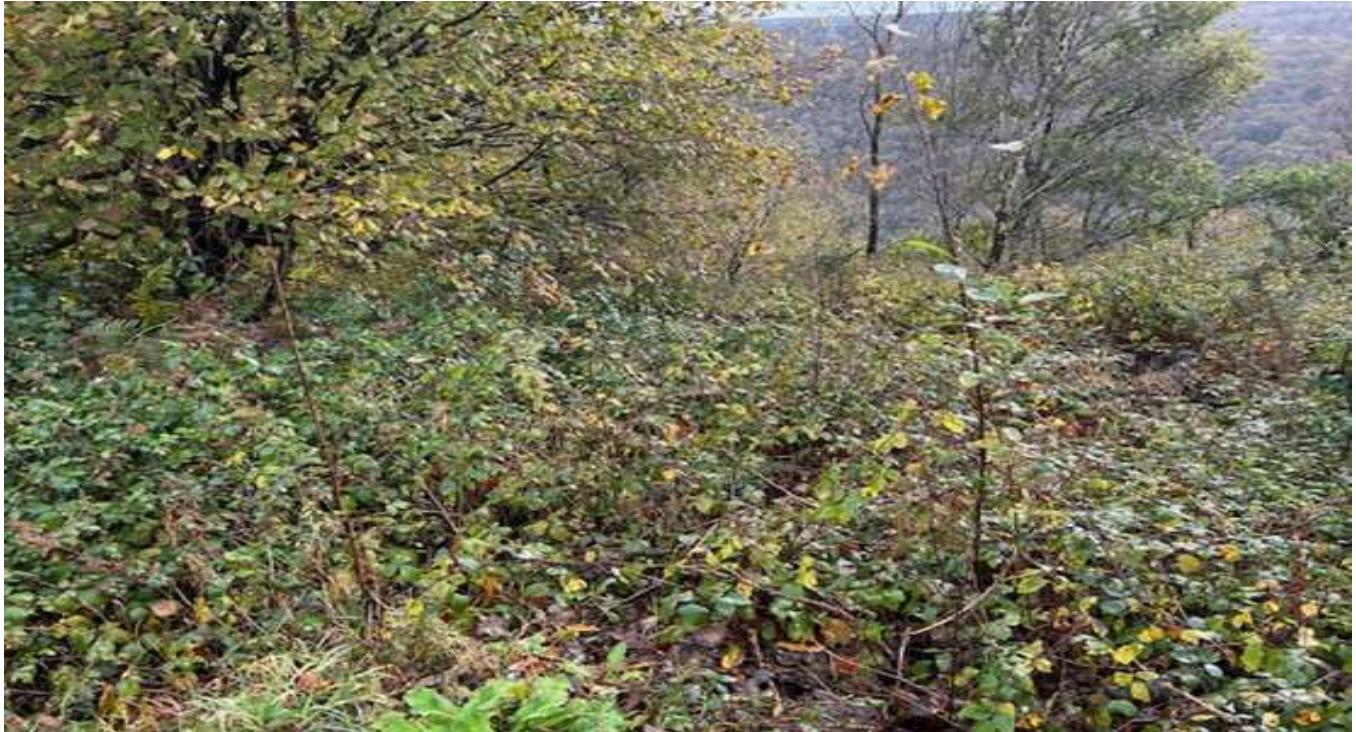
Photo No.	5	Comment	View looking down the flank of the densely vegetated, eastern extent of the site. Image conveys associated accessibility issues.
Feature ID	23/L/01

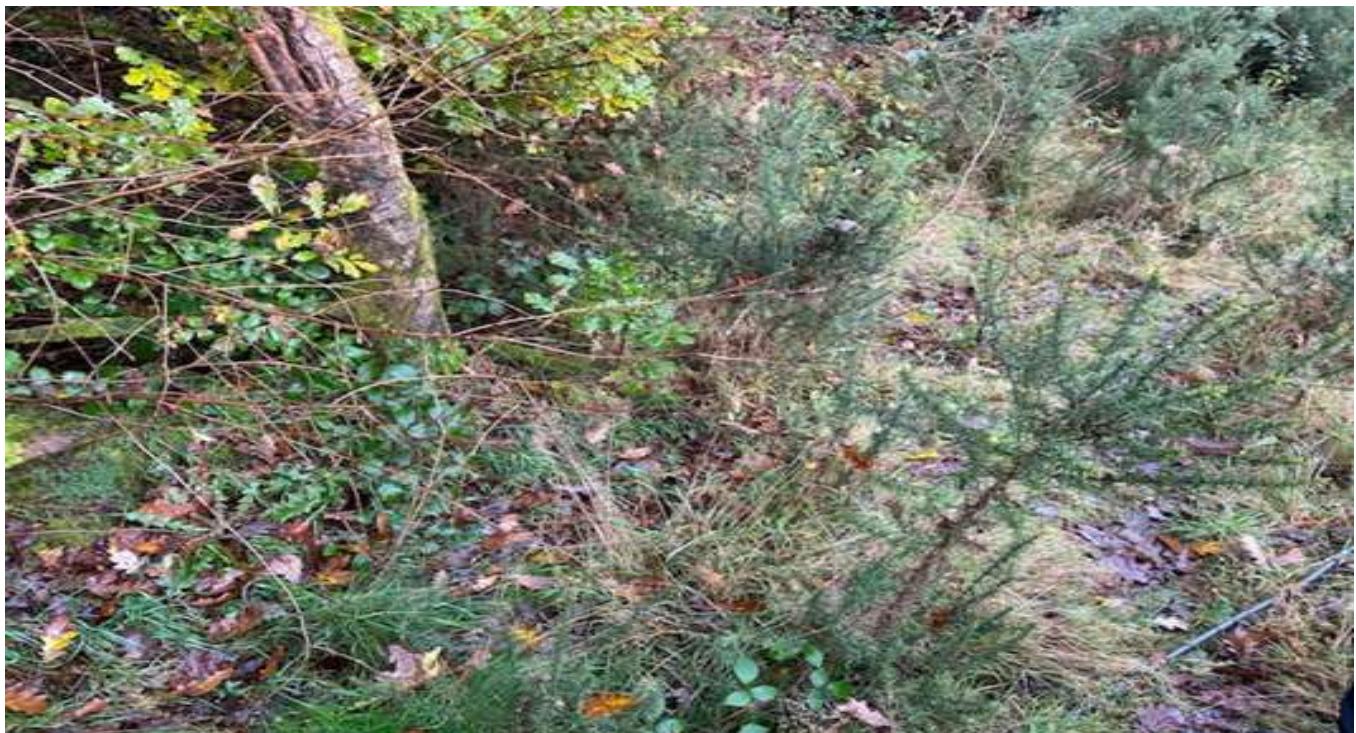
Photo No.	6	Comment	Evidence of human activity within the Quarry floor, with the presence of electricity extension cables leading downslope (previously recorded as extending downslope towards the properties named 'Glanderi' and 'Darren View').
Feature ID	23/L/04

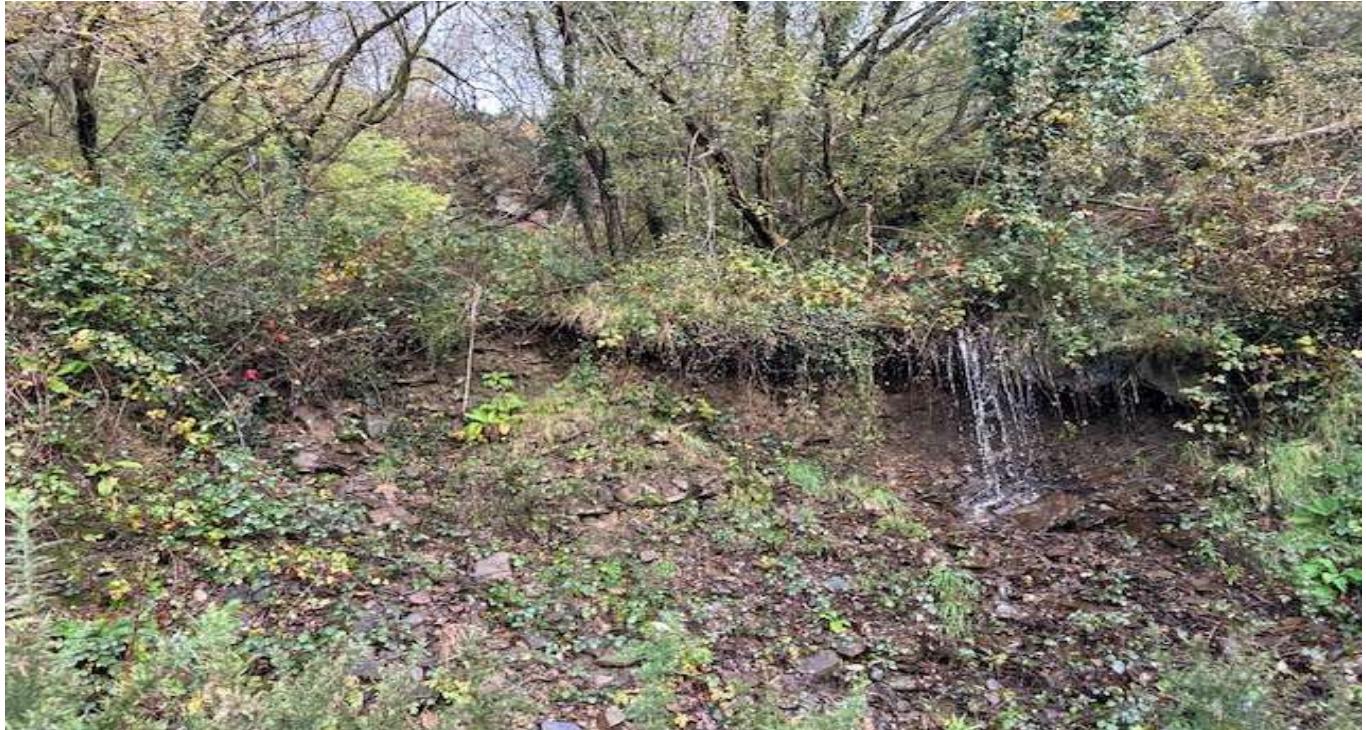
Photo No.	7	Comment	Issues (E - 274889, N – 206911) convey over an excavated face to the North of the site boundary.
Feature ID	23/G/01

OBSERVATIONS			
GEOTECHNICAL			
ID	Feature	Location	Comment
23/G/01	Ponding	E - 274845 N - 206869	Issues (E - 274889, N - 206911) convey over an excavated face to the North of the site boundary. Flows convey towards the flat-lying ground/quarry floor, adjacent to the northern perimeter of the western section of the site. Resultant minor ponding and associated saturated ground conditions present.
Recommendations			
DRAINAGE			
ID	Feature	Location	Comment
N/A			
Recommendations			
ENGINEERING INFRASTRUCTURE			
ID	Feature	Location	Comment
N/A			
Recommendations			
INSTRUMENTATION & MONITORING			
ID	Feature	Location	Comment
N/A			
Recommendations			
LAND USE			
ID	Feature	Location	Comment
23/L/01	Vegetation Cover	E - 274877 N - 206856	The surfaces of the site are densely vegetated with grass, bracken, brambles, gorse and trees.
23/L/02	Signage	E - 274774 N - 206738	'Private Property Keep Out' signage situated on the access track which leads to Pentwyn Farm.

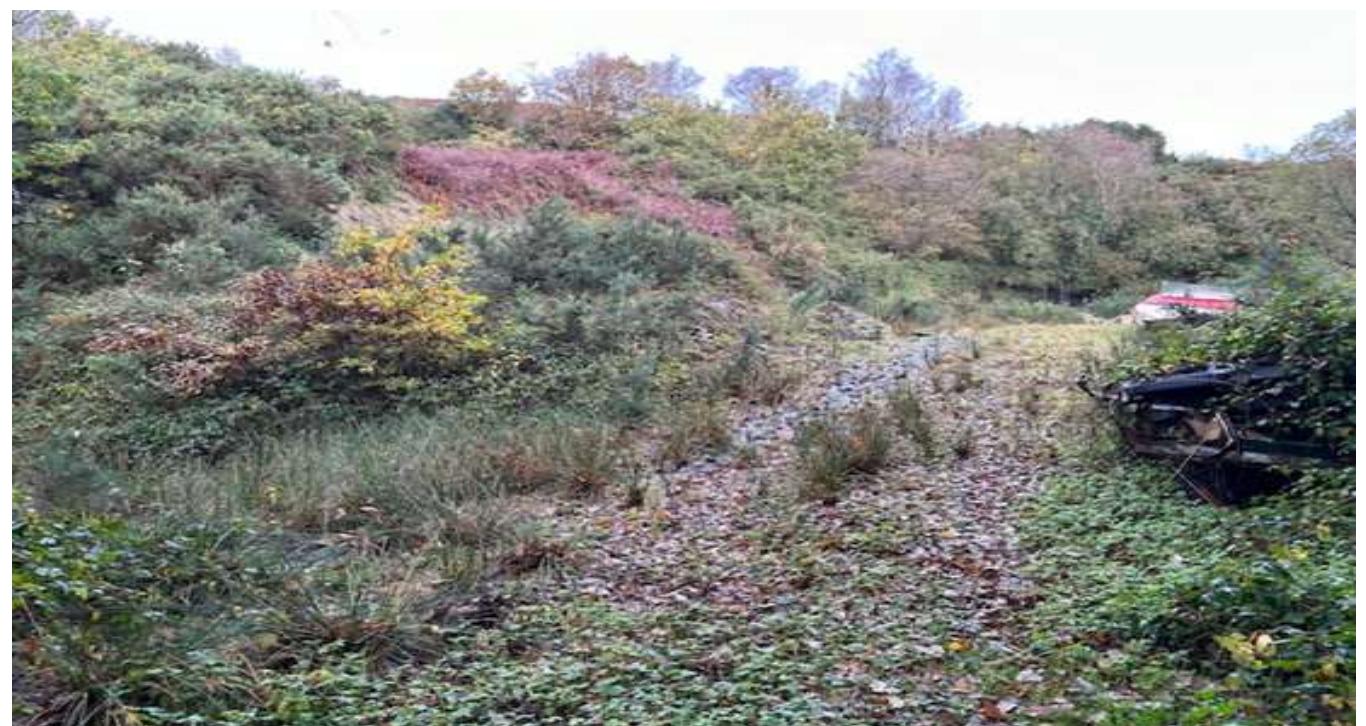
Photo No.	8	Comment	Flows convey towards the flat-lying ground/quarry floor, adjacent to the northern perimeter of the western section of the site. Evidence of human activity within the Quarry floor; abandoned boat.
Feature ID	23/G/01 23/L/04

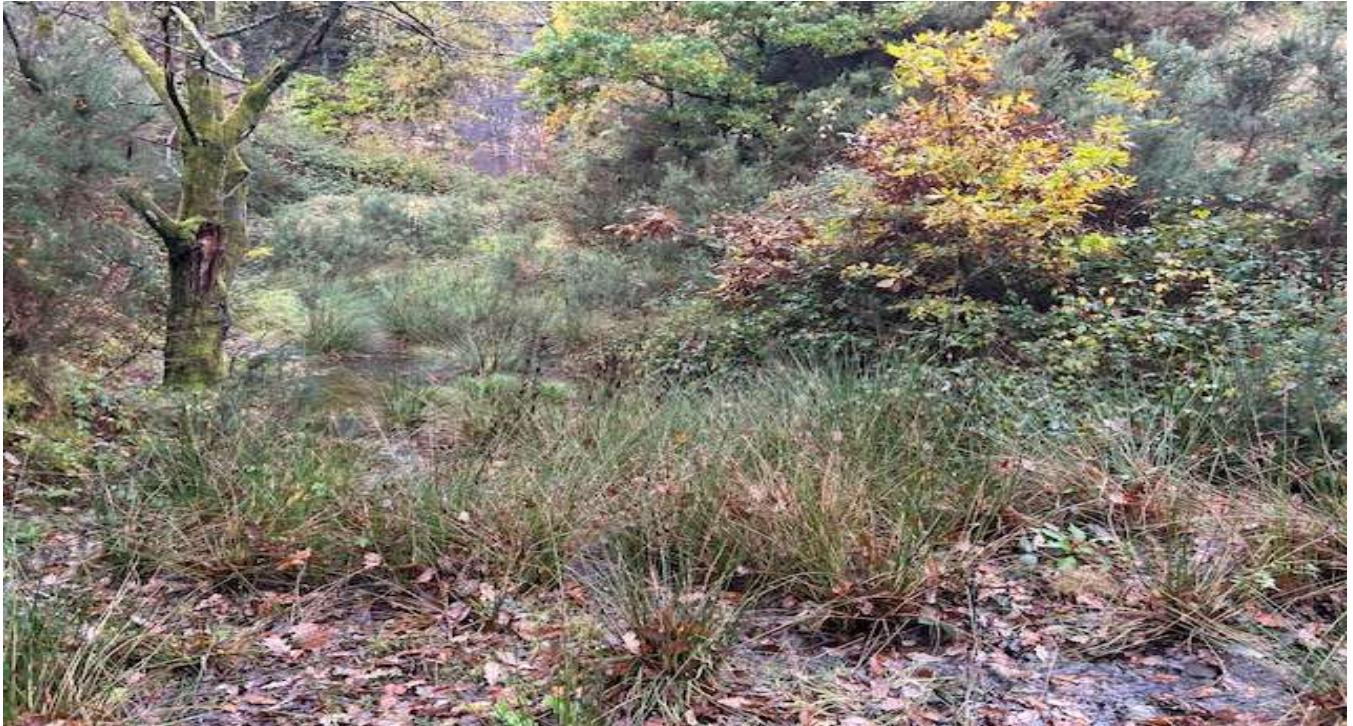
Photo No.	9	Comment	Minor ponding and associated saturated ground conditions present.
Feature ID	23/G/01
