| <b>Coal Tip Name</b> | <b>Cwar Pentwyn Quarry / Cilmaengwyn</b> | | <b>Tip Ref Number</b> | <b>T11695</b> | | | |
| <b>Located In</b> | <b>Godre'r Graig, Neath-Port Talbot</b> | | <b>Tip Category</b> | <b>D</b> | | | |
| <b>Inspection Led By</b> | | <b>Date of Inspection</b> | <b>09/09/2024</b> | <b>Date of last Inspection</b> | <b>08/11/2023</b> | | |

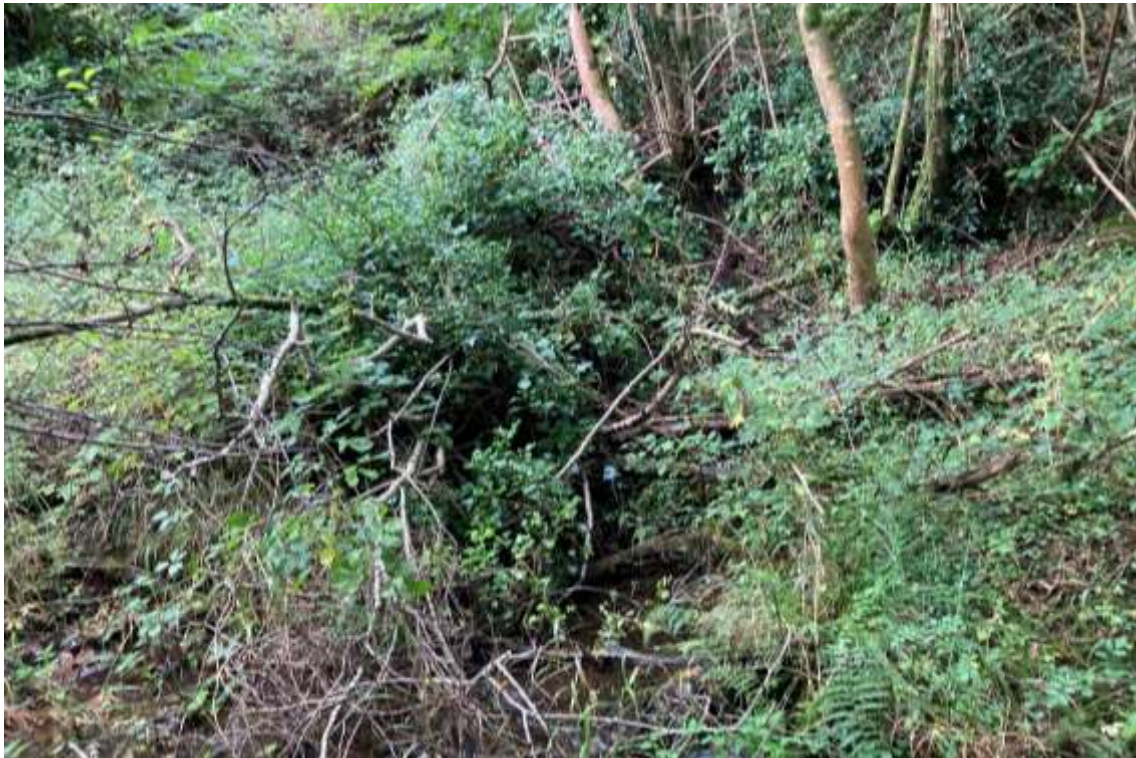
| <b>Photo No.</b> | 1 | <b>Comment</b> | Adit located just to the south-west of the site boundary; associated with the 'Godre'r-Graig Higher / Pentwyn No. 3 Levels' coal tip. |

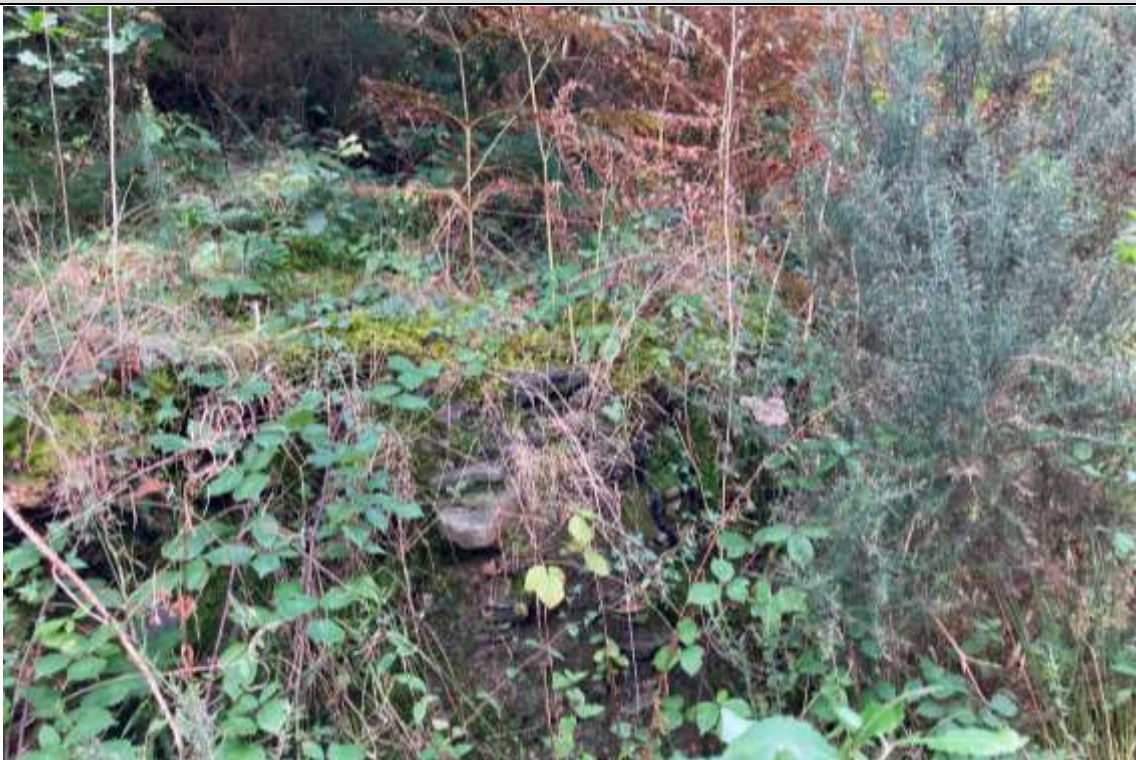
| <b>Photo No.</b> | 2 | <b>Comment</b> | View looking towards a small exposure of sandstones, shales and clays; situated within the densely vegetated western extent of the site. |

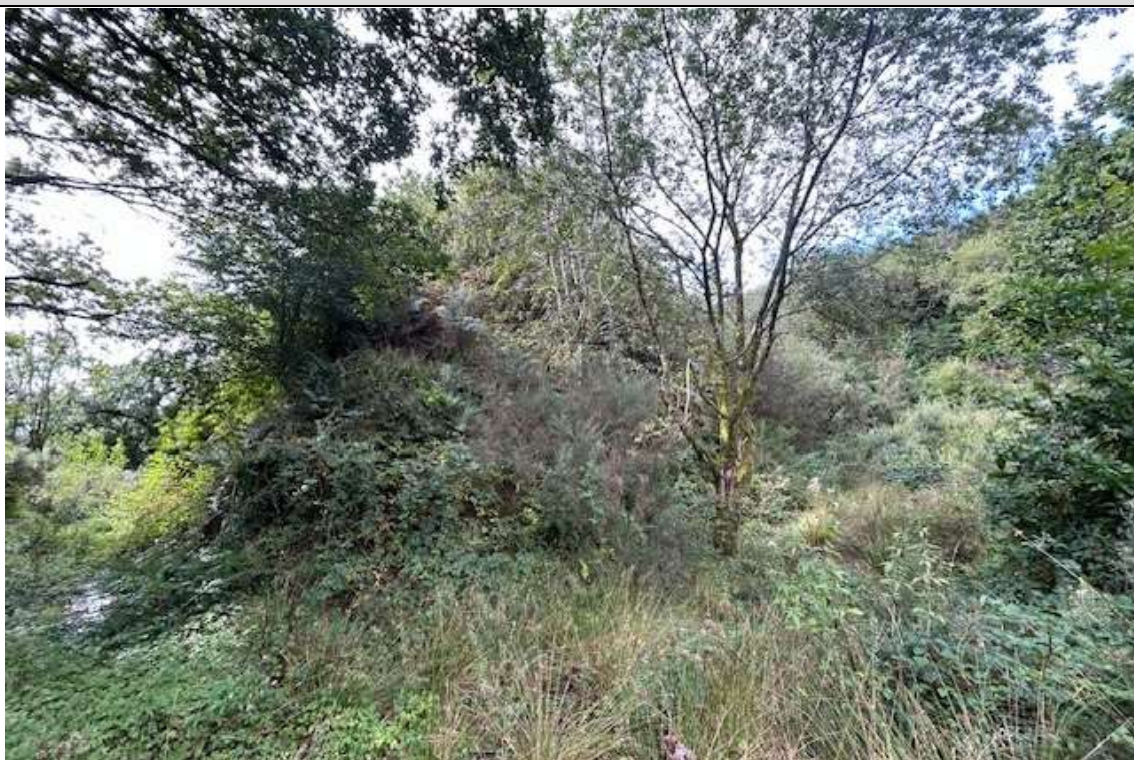
| | | | i. | Vegetation limiting accessibility and visual inspection. | | | |

| <b>Photo No.</b> | 4 | <b>Comment</b> | View looking towards the densely vegetated western extent of the site. Minor ponding and associated saturated ground conditions present. |
