| <b>Coal Tip Name</b> | | Cwar Pentwyn Quarry / Cilmaengwyn | | <b>UID</b> | | T11695 | |
| <b>Located in</b> | | Godre'r Graig, Neath-Port Talbot | | <b>Tip Category</b> | | D | |
| <b>Inspection Led by</b> | | | <b>Date of Inspection</b> | | 18/07/2025 | <b>Date of last Inspection</b> | |

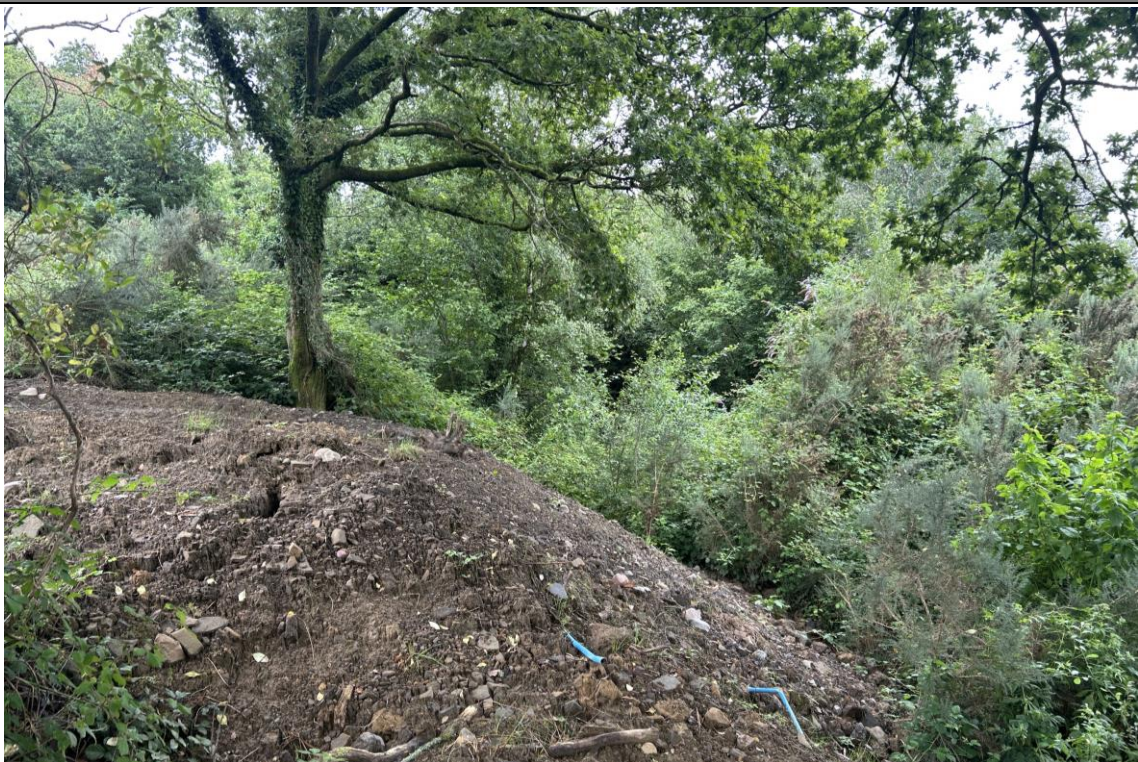
| 25/L/03 | Land Use | | Relatively recent quarrying activity; with machinery and mounds of excavated material present. Sandstone quarry waste material has been deposited on the north-eastern section of 'Godre'r-Graig Higher / Pentwyn No. 3 Levels' coal tip, located just downslope (approx. 50 m). Further excavated material has been tipped here, however no obvious evidence of further quarrying activity was identified on the site. | New |

| Feature ID | 25/L/03 | | |

| Recommendations | | | <ul style="list-style-type: none"> <li>- Investigate ownership of the site and establish what measures, if any, have been taken with regard to placing recent materials over historic spoil.</li> <li>- Investigate activity within Cwar Pentwyn to establish if planning or quarry regulations have been breached.</li> </ul> | |

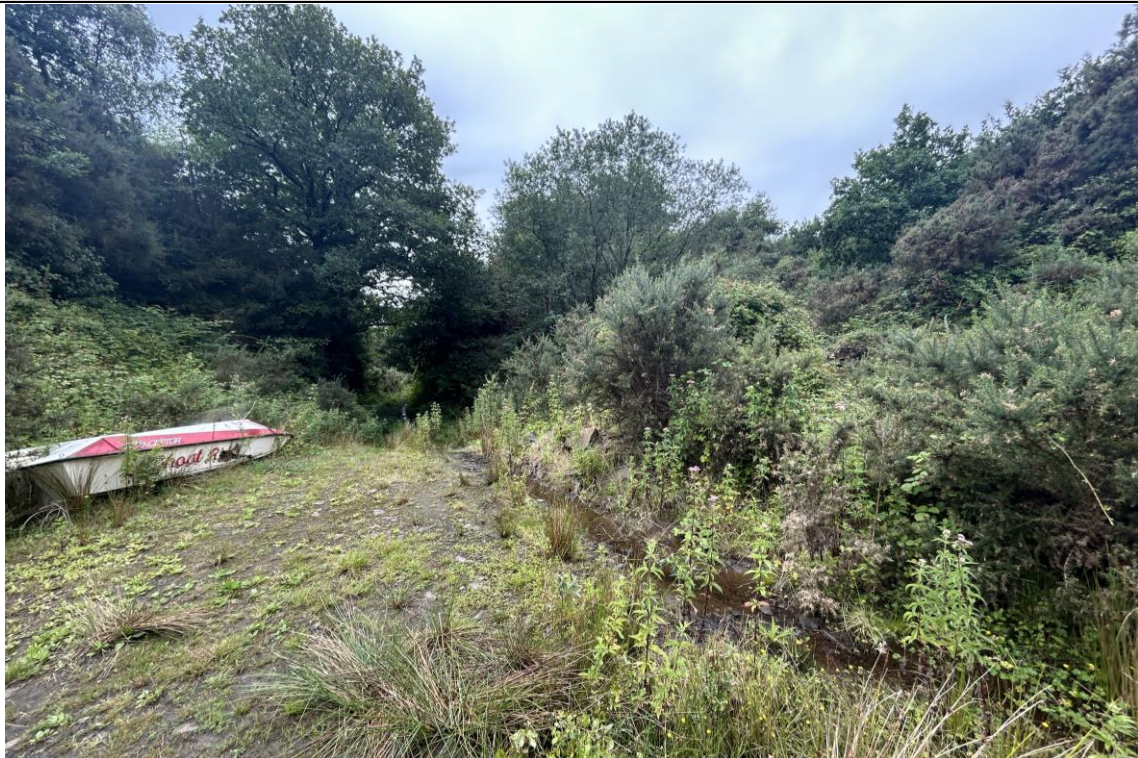
| OBSERVATIONS | | | | |
|---|---|---|---|---|
| 25/G/01 | Ponding | | Issues convey over an excavated face to the North of the site boundary. Flows convey towards the flat-lying ground/quarry floor, adjacent to the northern perimeter of the western section of the site. Resultant minor ponding and associated saturated ground conditions present. | None |

| 25/L/04 | Land Use | | Evidence of human activity within the Quarry floor, with the presence of machinery, chairs, a boat and electricity extension cables leading downslope (previously recorded as extending downslope towards the properties named 'Glander' and 'Darren View'). | None |

| Feature ID | 25/G/01 | | |

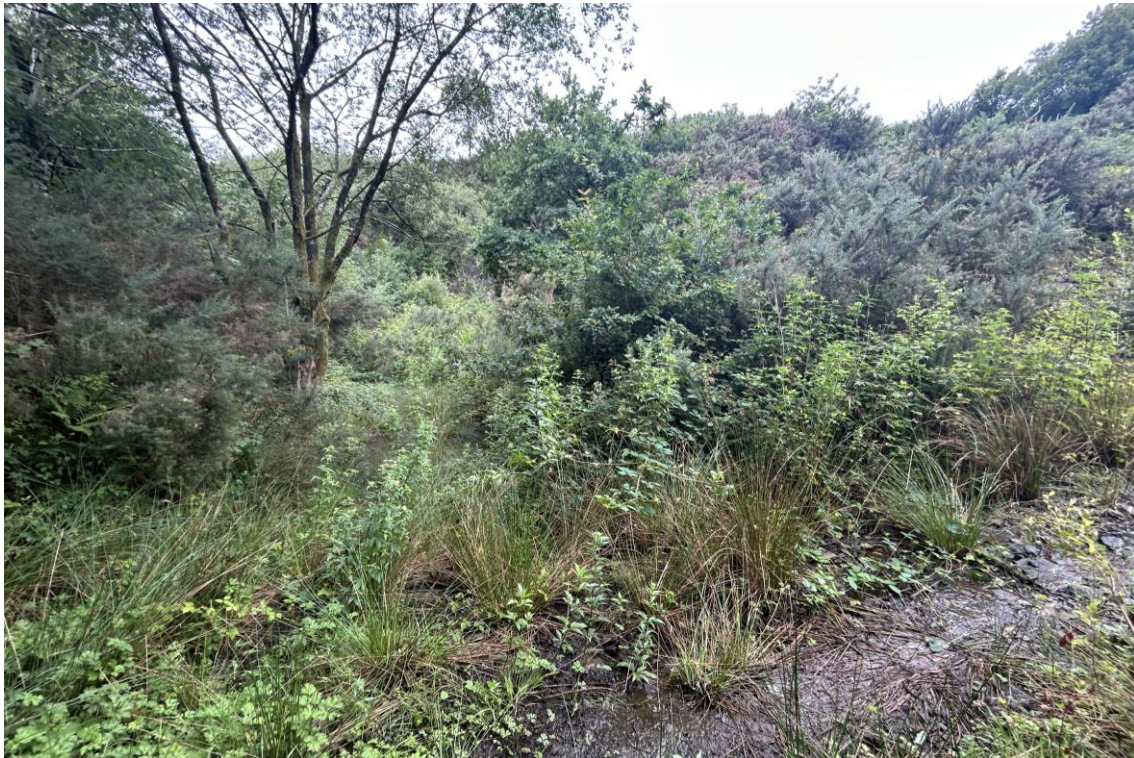
| <b>Photo No.</b> | 3 | <b>Comment</b> | Flows convey towards the flat-lying ground/quarry floor, adjacent to the northern perimeter of the western section of the site. |

| <b>Feature ID</b> | 25/G/01 | | |
