## Questions and Comments on Tip 2 Stability Reports

**171 Graig Road, Godre'r Graig, Ystalyfera, Swansea  
(Formerly Godre'r Graig Infants School)**

JANUARY 10, 2023

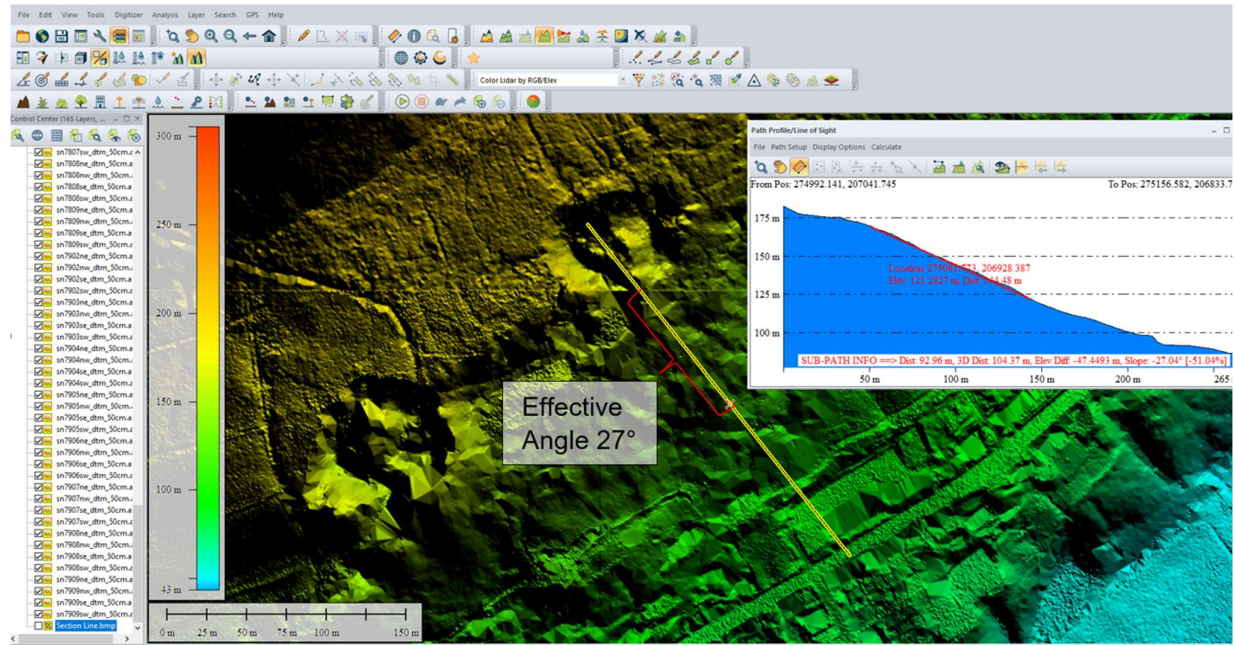
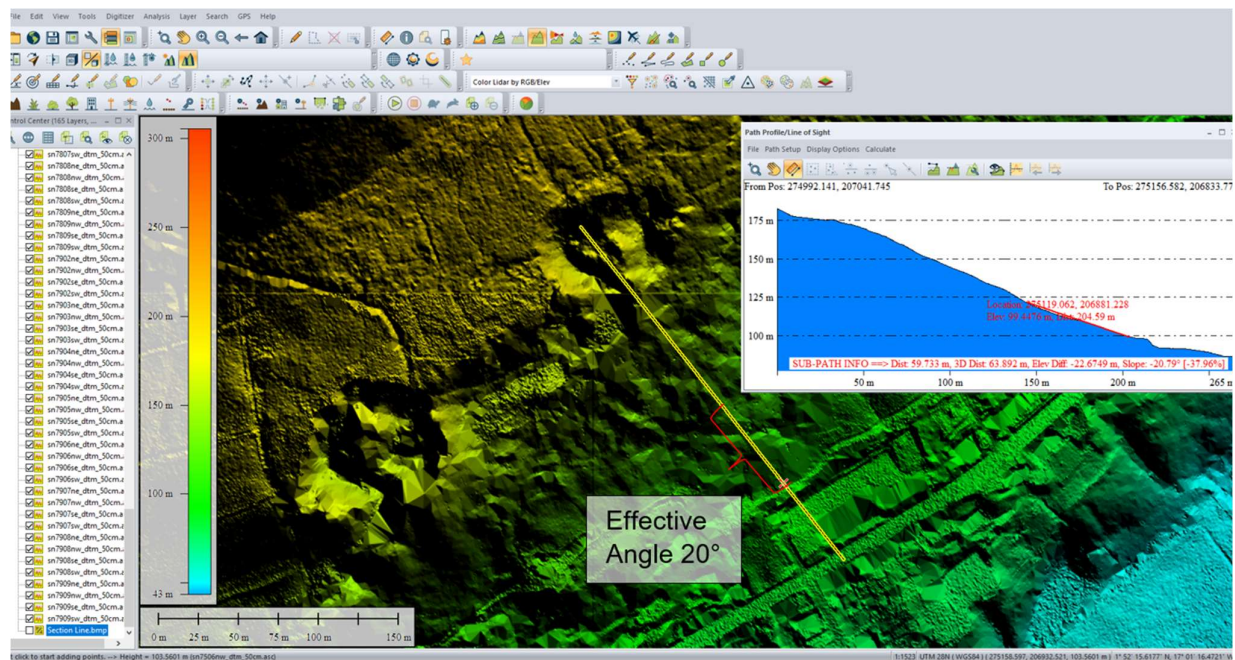
NPTC suggest that ESP.7234.02.3302 Figure 2 shows relatively short sections of slope steeper than 30° and some measurements taken on natural hillside (outside the mapped extents of Tip 2) to be 36° - presumably the angles on the natural hillside are not over steep and have an acceptable Factor of Safety. NPTC should confirm?

The effective slope angle (toe to crest) was estimated to be approximately 27°. The effective slope angle is usually the critical angle for analysis, especially when NPTC are suggesting volumes in excess of 500m<sup>3</sup> may be mobilised in a mass movement event. The angles presented in ESP's Figure 2 suggest that tens of cubic metres may be of concern based on the critical slip plane shown and not the 500m<sup>3</sup> reported as the volume of concern.

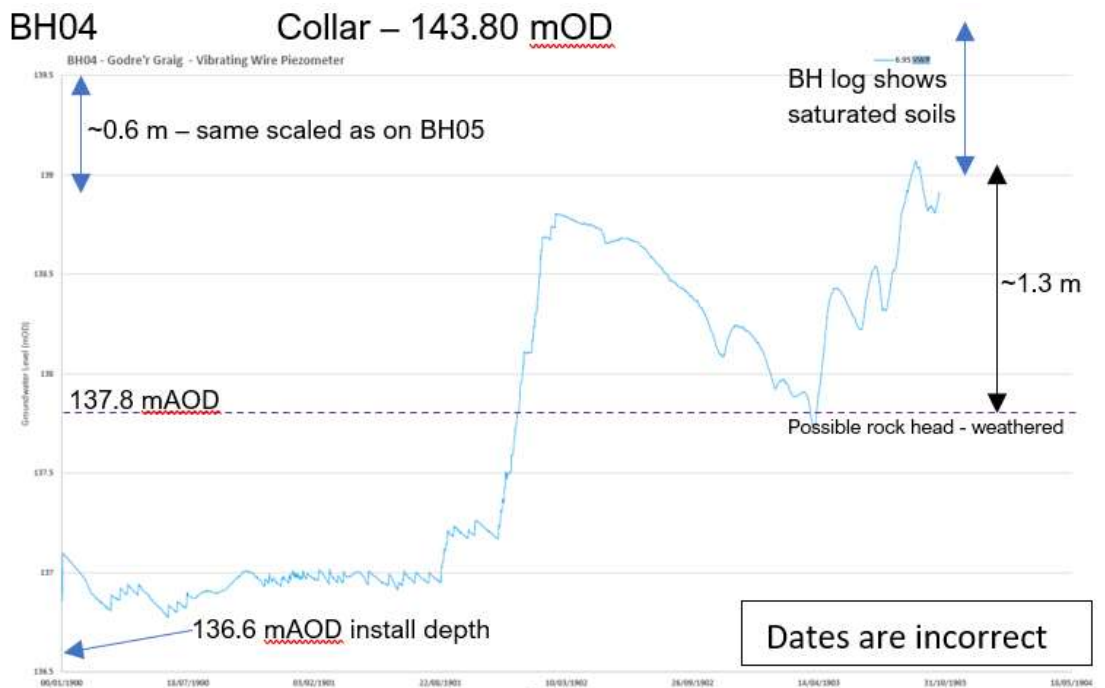
The dates on the data logger for BH04 vibrating wire piezometer plot are incorrect. What inferences can be made on the gradient of the piezometric levels on the plots?

Would all the piezometric data presented (VWP and standpipe dips with notes on rainfall intensity) on one graphical representation of the data give with rain gauge data give a slope level understanding of the water table?

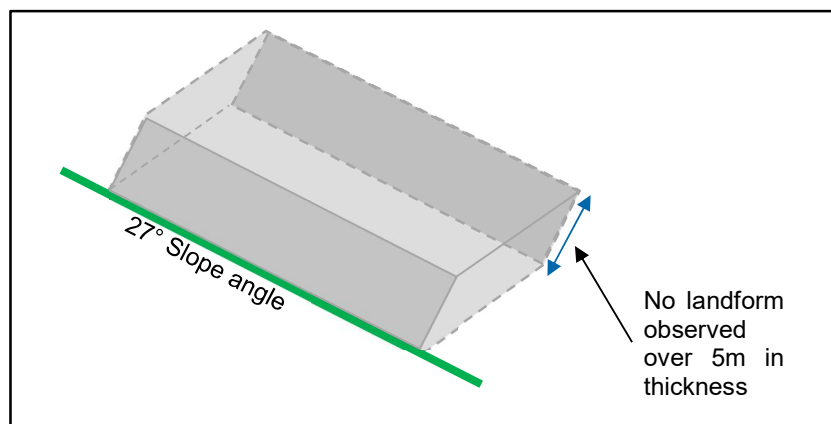
**Figure 3.13-3 Pictorial representation of cross section through the Coarse Discard to satisfy 87,395m<sup>3</sup>**

The approximate boundary of Tip 2 was estimated to be 9,000m<sup>2</sup> (see Figure 3.13-2). Using NPTC's consultant's estimate of Tip 2's volume of 87,395m<sup>3</sup>.  $87,395\text{m}^3 \div 9,000\text{m}^2 = 9.71\text{m}$  thickness of end tipped coarse discard across the slope. The topography of the slope suggests that this is incorrect as the tipped material tapers into the hillside (See Figure 3.13-3 below). Especially as the thickest deposit as modelled is in the old quarry workings.

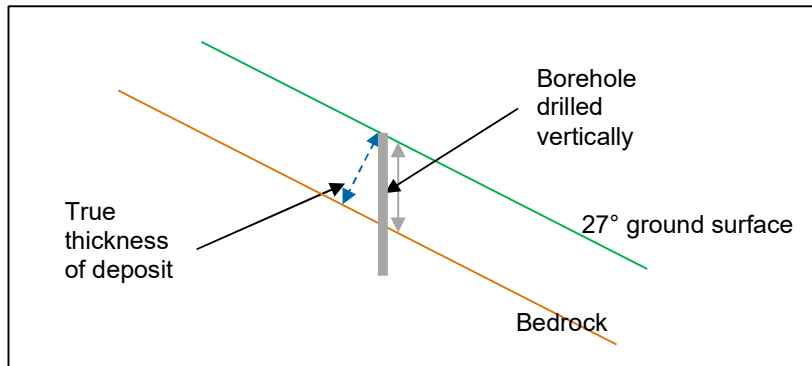
**Figure 3.13-4 – Graphical Depiction of drilled depth versus thickness**

Note no adjustment was made from vertical to normal to slope profile as shown in Figure 3.13-4 below.

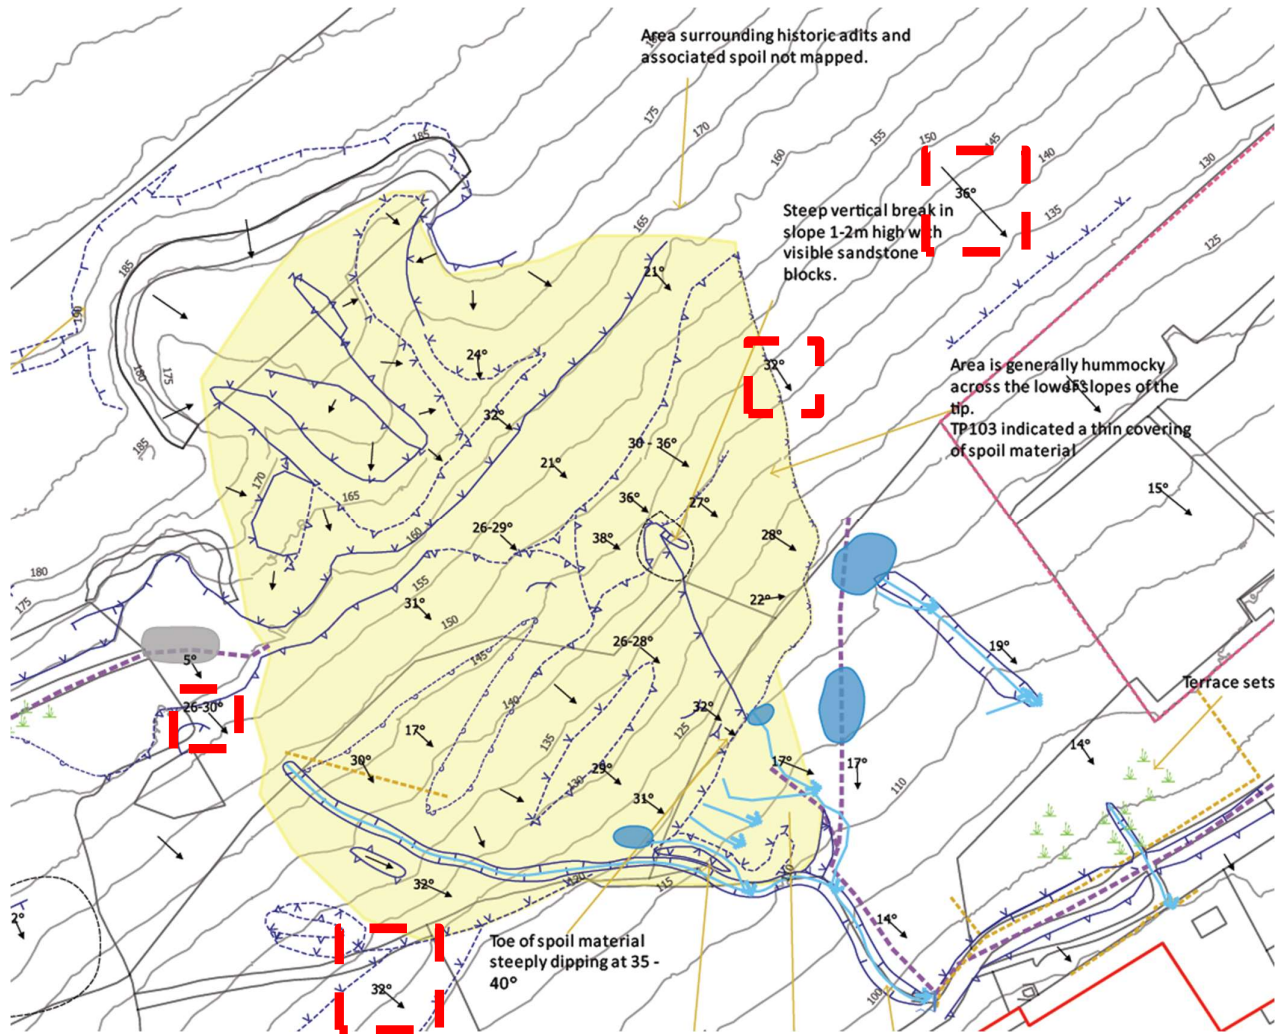
ESP Figure 2 – Geomorphological Mapping

*Slope angles measured on the tip (visually and via topographic survey) are provided in the report. Many slopes are steeper than 27° (Tegwch suggested maximum) with slopes as steep as 38°, see Figure 2 in ESP.7234.02.3302.*
