## **Godre'r Graig Primary School, Godre'r Graig Preliminary Investigation and Additional Assessment**

Report Reference: ESP.7234e.02.3302

## Godre'r Graig Primary School Preliminary Investigation and Additional Assessment

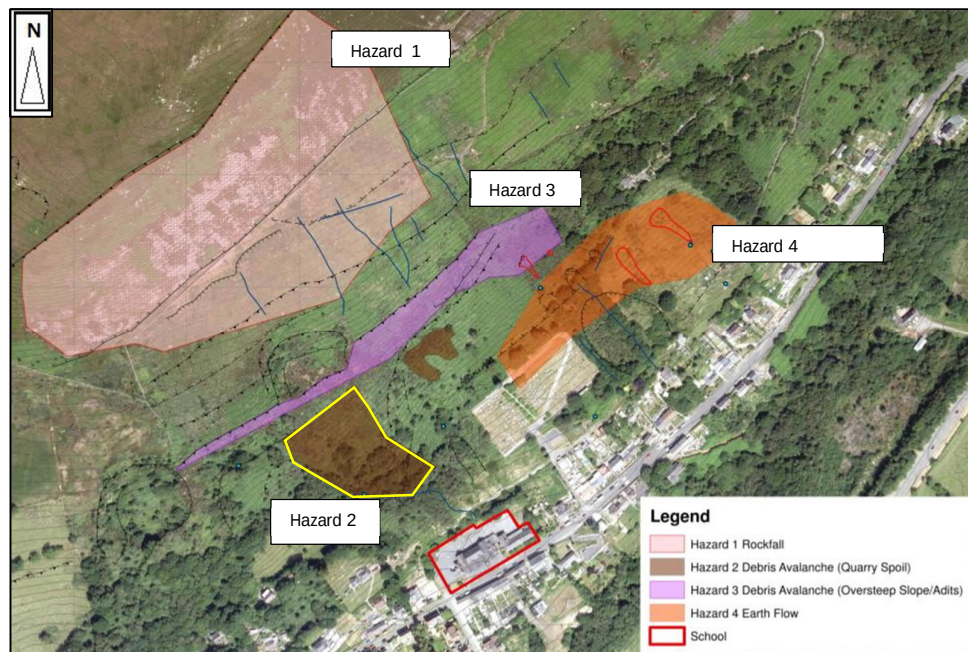
A Landslide Hazard and Risk Assessment for the terrain above the school was undertaken primarily to identify risks from potential landslides. The assessment identified four types of landslide hazards in the study area, two of which are natural and two are man-made. The hazards are outlined below, and their locations shown on Insert 3:

- Hazard Type 1: Rock fall initiating from outcrops of the Rhondda Sandstone
- Hazard Type 2: Impact from debris avalanche initiating from quarry spoil.
- Hazard Type 3: Impacts from debris avalanches originating from the over steep slope associated with the working of the Upper Pinchin seam.
- Hazard Type 4: Shallow earth slides.

**Insert 3:** Extract from Hazard Location Map taken from previous report ESP, 2019. Site 2 is highlighted in yellow.

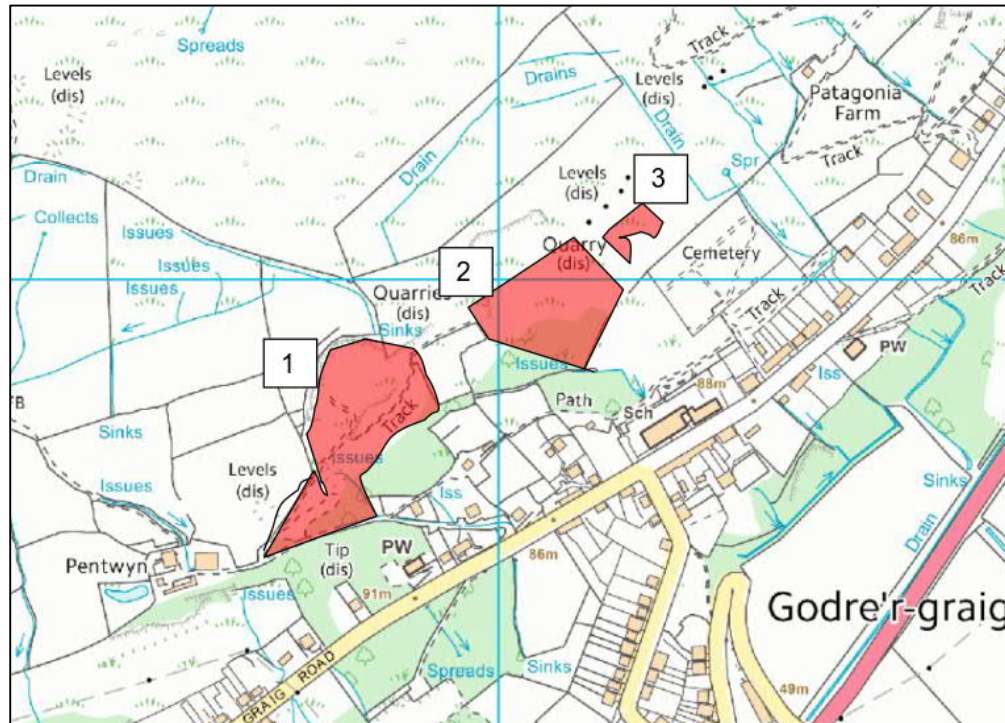
**Insert 4:** Extract from Coal Authority Report. Site Locations shown by red polygons.

- Although they suggest it unlikely, they speculated that a major failure of the spoil tip would be able to reach Godre'r Graig School;
- Consider clearing vegetation to allow inspection of drainage routes at Site 2;
- Consider undertaking a slope stability analysis for Site 2 based on available information supplemented by ground investigation; and
- Undertake an inspection during winter, when vegetation has died back to allow a more detailed viewing of the site with less vegetation constraints. The requirement for further inspection should be determined following the winter inspection.

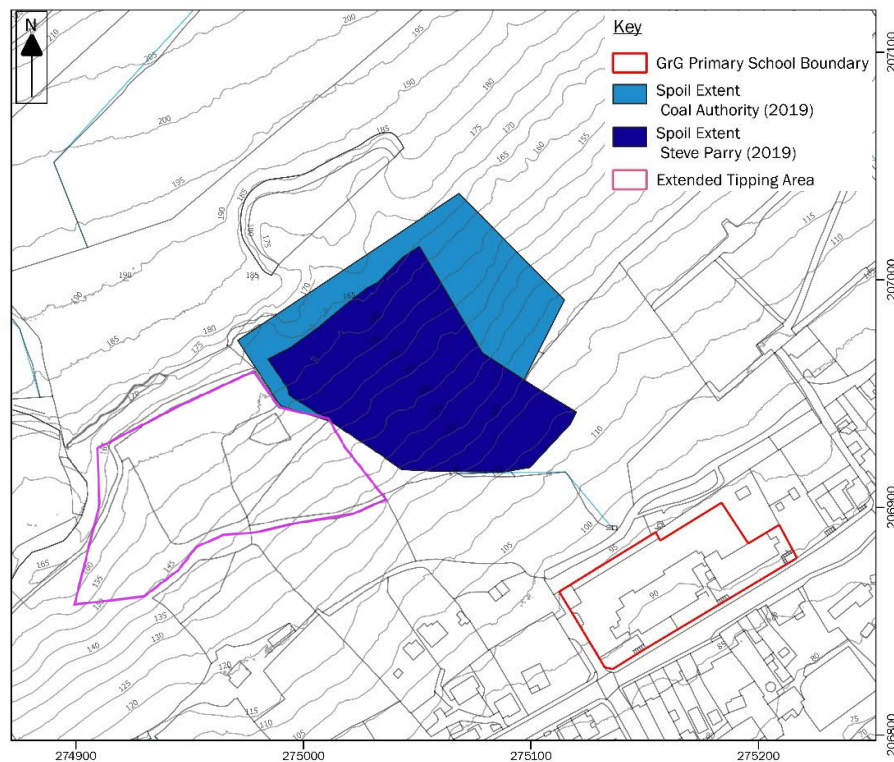
**Insert 5:** Preliminary Spoil Extent Boundaries identified by the Coal Authority and ESP/PEGS (2019).

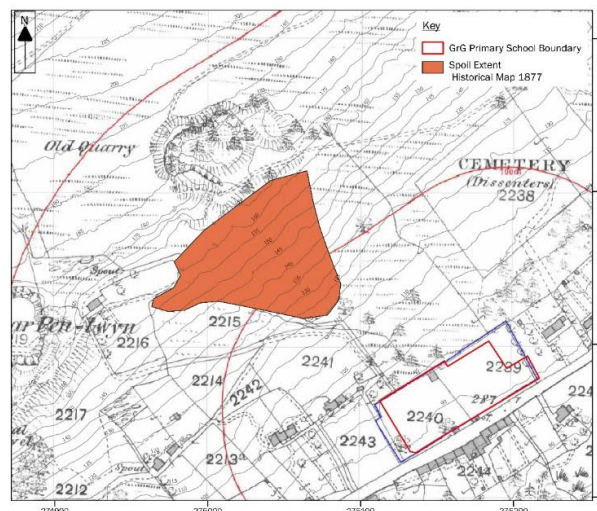
**Insert 6:** Preliminary Spoil Extent Boundaries identified from historical mapping (1:2,500 scale map, published 1877)

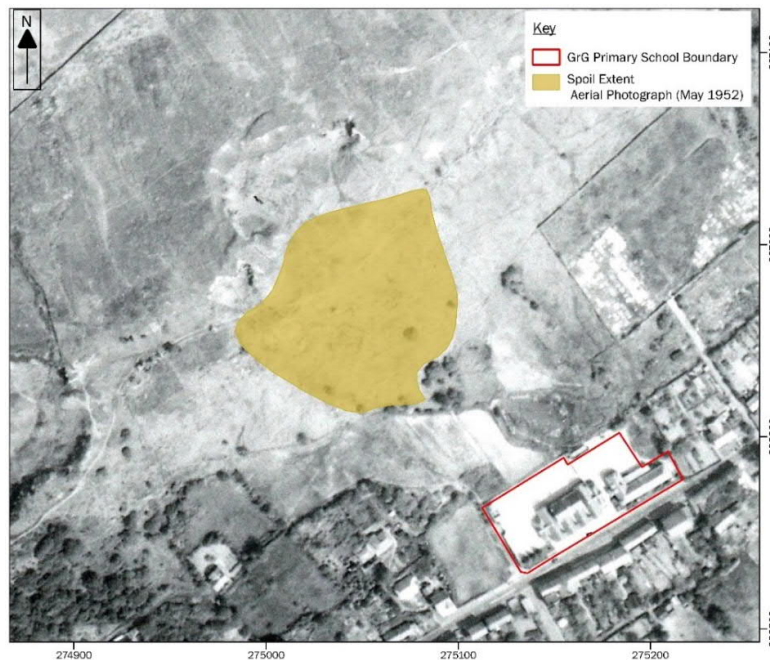
**Insert 7:** Preliminary Spoil Extent Boundaries identified from aerial photography (27th May 1952, Stereo Pair -5032, 5033).
